EFFECTS OF HEAVY AXLE LOADS IN FREIGHT SERVICE

by Ryan McWilliams

TTCI
Transportation
Technology Center, Inc.

April 2000[®]

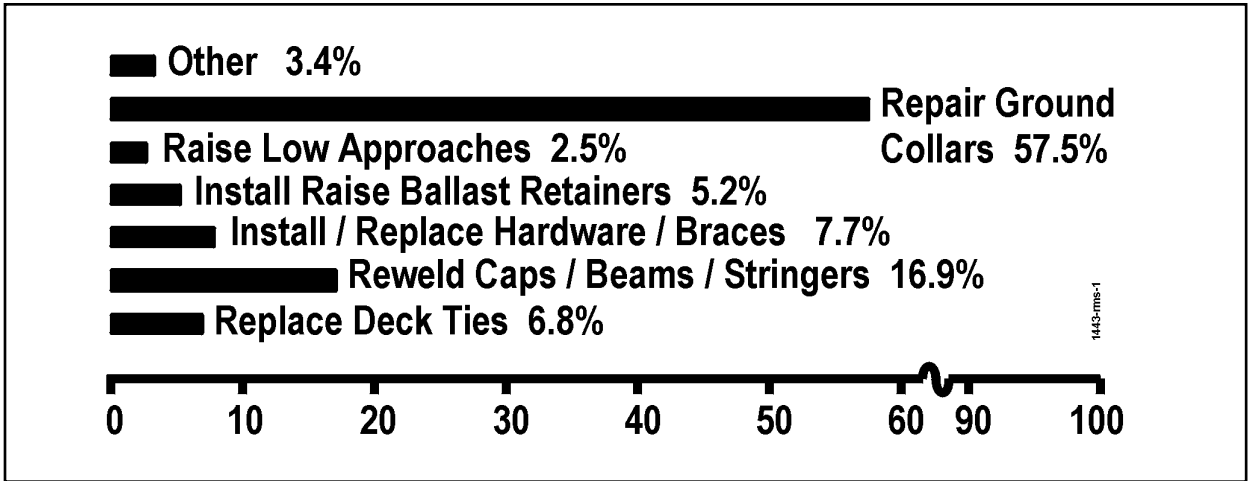
Exhibit 2. Steel Bridge Expenditures for Traffic Related Repairs

Bridge maintenance reports from the Union Pacific's South Morrill, and Powder River Subdivisions are showing that even though overall annual bridge maintenance expenditures have only shown a slight increase since 1997, the mix of repairs has shifted in recent years toward categories related to axle loads on steel structures. Trestle pile pumping seems to be the most prevalent of these categories. This steel structure pile pumping problem has consumed nearly 88 percent of the total budget related to traffic over these lines in the past two years. Floor beams also have a high repair frequency on this line.

All pile pumping repairs over the South Morrill and Powder River subdivisions have been performed on steel bridges. Exhibit 2 shows traffic related expenditures for steel bridges since 1992.

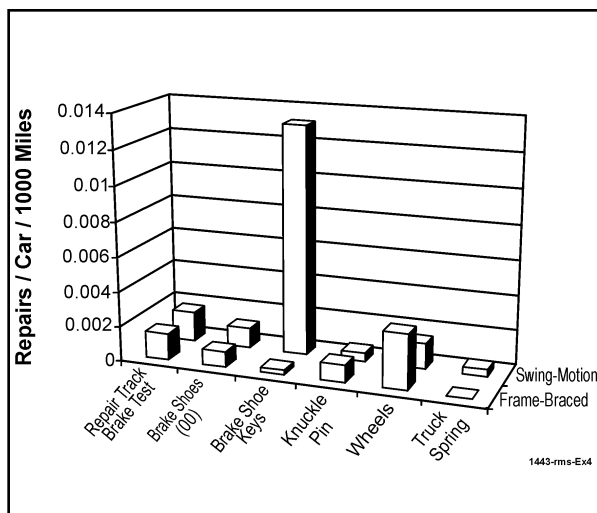
Exhibit 4. Truck Repairs on 315-kip Gondolas per 1,000 miles

Exhibit 4 shows the maintenance repairs made to date. All of the reported wheel repairs have been hand brake related, and the brake shoe key problem is related to either a bad batch of keys, or the possibility of the wheel flange contacting the brake shoe due to out of dimensional specification trunion castings.

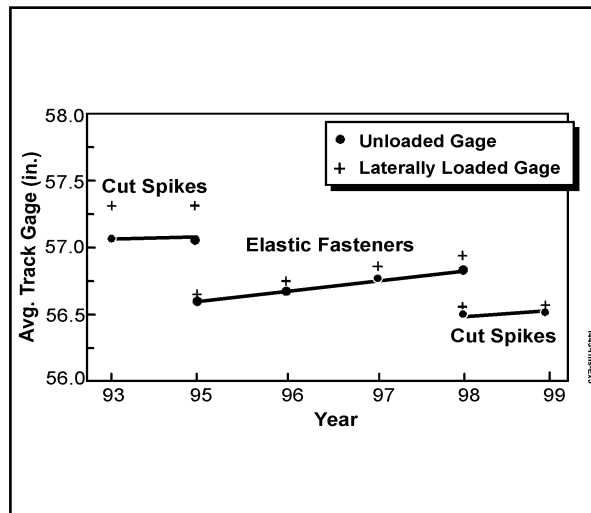
Exhibit 5. Track Gage under Loaded and Unloaded Conditions

The wood tie gage strength test site at Oakvale, West Virginia, has provided a good comparison to tests performed at FAST. The observations have shown the effects of smaller tie plates in a more humid/moist environment on a high-degree curve. Tie plate cutting became evident at this test site, and those plates were consequently replaced with larger footprint plates and cut spikes.

The effect of HAL on gage widening in wood tie track on Norfolk Southern was relatively low with a rate of 0.128 inch per 100 MGT with elastic fasteners. The rate was higher than it had been with cut spike fasteners and large (18-inch) tie plates. And, although the smaller elastic fastener plates suffered from a higher rate of plate cutting, the elastic fastener ties had a higher gage widening strength than the ties with cut spikes. Exhibit 5 shows relative gage widening strength as the difference between loaded and unloaded gage.
