Investigation of Fatigue Cracking of Open Deck DPG Spans

by A.S. Uppal, and D.E. Otter
A.M. Itani,* E.M. Maragakis,*

TTCI
Transportation
Technology Center, Inc.

July 2000

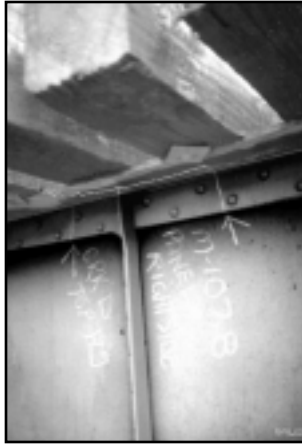
- **Fillet of top flange angles.** Deflection of ties creates eccentric loading on the flange angles, resulting in their outstanding legs moving up and down under train loading. With the accumulation of sufficient cycles of reversible loading, this could cause the fillet of the angles to crack. Exhibit 2 shows a fatigue crack initiated under the ties in the fillet of the top flange angle.

Exhibit 2. Fatigue Crack in the Fillet of Outside Flange Angle

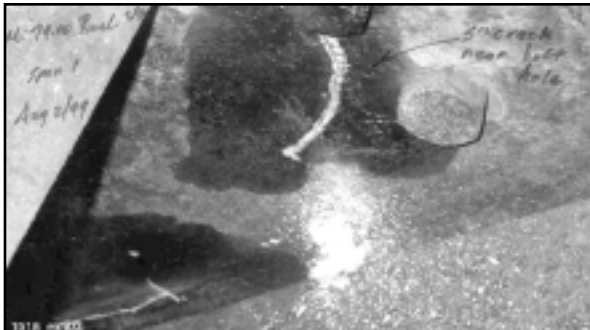
- **Transverse cracks in upper areas of webs.** Out-of-plane displacement of the top flange and the upper area of the web generate localized tensile stresses in a compression zone. These stresses could be aggravated by rivet or bolt holes that act as stress raisers. Fatigue cracks have initiated at rivet holes and propagated into the interior of the web. Also, depending on the magnitude of the tensile stress and the load cycles, fatigue cracks have occurred in the top flanges. Exhibit 3 shows a crack in the top flange that initiated at a bolt hole.

Exhibit 3. Fatigue Crack in Top Flange Initiated at a Bolt Hole

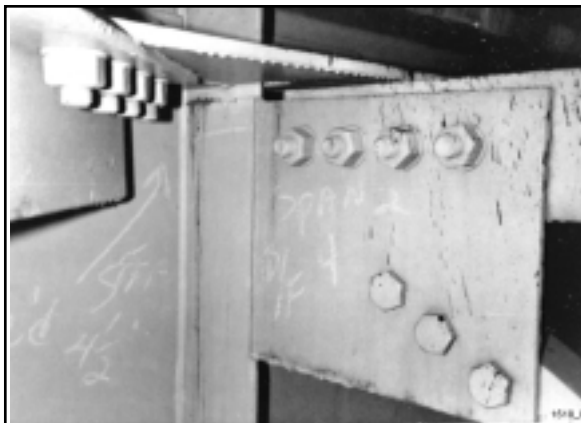
Exhibit 4. Fatigue Crack in Cross Frame, Stiffener and Web Connection

- **Rigid Connections.** Welds connecting a cross frame to the web in the welded girder span sometimes create a very rigid connection preventing out-of-plane movements. This together with poor weld details sometimes sets up high tensile stresses that with accumulation of sufficient load cycles can result in fatigue cracks. Exhibit 4 shows a fatigue crack that initiated in the weld at top of cross frame to web stiffener connection.
