## Thermite Weld Failure Survey

by Joseph Kristan

July 2000

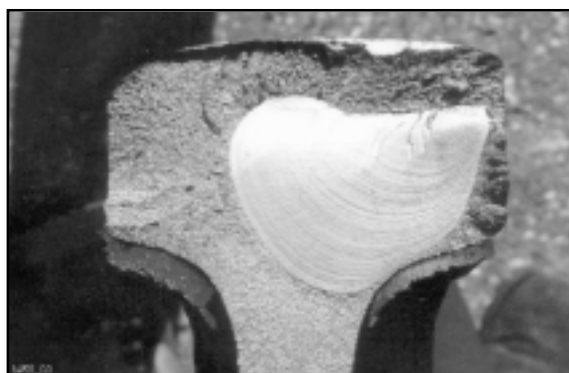
- The most prevalent defect observed in the examined welds was fatigue fractures in the head (detail fractures) initiating at micro-defects (non-metallic and metallic inclusions, micro-voids, pores, etc.) in the weld (44 percent of total observed defects).
- Other defects documented from examination of defective thermite welds as indicated by detector car examination include shrinkage (12 percent), slag inclusions and porosity (12 percent), and columnar grain formations (7 percent).

**Exhibit 3. Fatigue Fracture (Detail Fracture) Initiating at Micro-Defect in Weld**

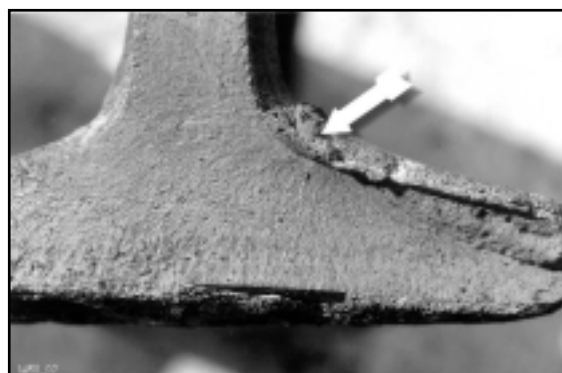
**Exhibit 4. Fatigue Defects from Metal Run-Out at Rail Surface**

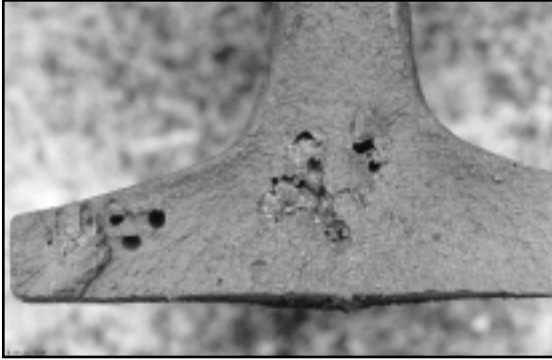
- The most common defect (40 percent of total reported failures) was slag inclusions and/or gas entrapment (porosity) forming mainly at the web/base fillet (56 percent of slag inclusion/gas entrapment occurrences).
- Other defects include fatigue initiated due to weld metal run-out between the rail and mold at the web/base fillet region and/or the base of the rail (32 percent), hot tears (15 percent), columnar grain formations (5 percent), pull-aparts (hot) (3 percent), grinding burns (3 percent), and sand inclusions (2 percent).

**Exhibit 5. Thermite Weld with Slag/Porosity**
