## Evaluation of Bainitic Rail for Crossing Diamond Applications

by David D. Davis and Don Guillen

August 2000

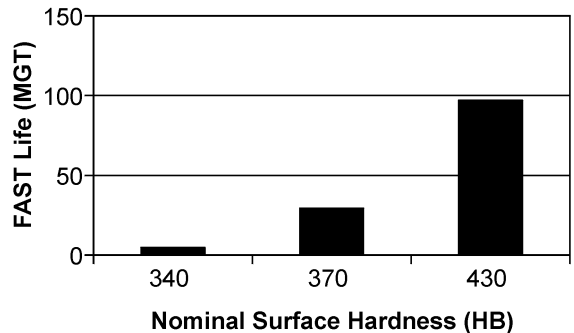
**Exhibit 1. FAST Crossing Diamond Running Rail Test Summary**

Comparison of the service life of the three sets of running rails tested in the crossing diamond is given in Exhibits 1 and 2. The bainitic steel performed very well, as its superior strength and toughness provided a more durable and stable flangeway corner.

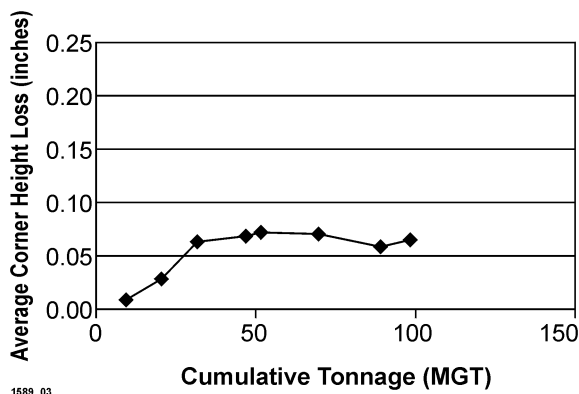
**Exhibit 3. Average Flange Corner Running Surface Height Loss**

- The J6 rail has shown little deformation over 96 MGT. Average deformation of the eight main track flangeway corners was 0.06 inch.
- The reduced corner deformation has kept the flangeway gaps closer to the original 1 7/8-inch minimum design gap. With AREMA practice 3/8-inch radius corners, the effective running surface gap is 2 5/8 inch. This has resulted in lower than expected dynamic loads at the flangeway corners.

One of the reasons for the good performance of the bainitic rail is the relatively small amount of deformation seen on the running surface at the flangeway gaps. As Exhibit 3 shows, the bainitic rail has accumulated about 0.06 inch of deformation at one inch from the flangeway gap. One would expect about 0.15 and 0.25 inch of deformation on the corner of a pearlitic rail diamond or an AMS casting diamond, respectively. This lack of deformation has kept the flangeway gaps smaller with the bainitic rail, thus minimizing vertical dynamic loads.

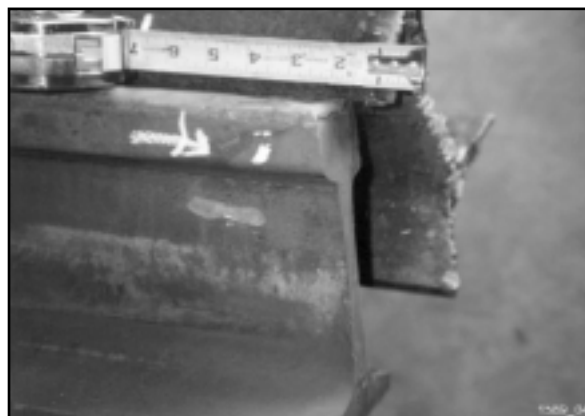
**Exhibit 4. Bainitic Rail Crossing Diamond Horizontal Head Crack**

- One corner failed with a horizontal crack that began at the flowed metal lip on the flangeway gap face. The corner that failed had the widest flangeway gap at about 2 1/8 inch (2 7/8-inch running surface gap).

The first running rail failure occurred at 96 MGT at an interior flangeway corner. The rail developed a running surface spall about 0.5 inch from the flangeway. The surface sheared in the direction of the flangeway turning into a horizontal crack. The crack was about 7 inches long when discovered. It was found by visual inspection when the crack appeared at the surface of the rail at the flangeway corner. Exhibit 4 shows the crack after the rail was removed from the diamond. The crack extended the full railhead width for about 2 inches, tapering back to less than 2 inches wide at 4 inches from the gap. The growth of the crack to this length before detection can be interpreted in two ways: (1) J6 is tough, or (2) the crack grew very rapidly. The former is more likely, as the crack was oriented ideally for detection with a vertical probe. Also, the diamond received only about 2 MGT of traffic in the previous two weeks. It is highly unlikely that the defect initiated and grew to that size prior to the last two inspections.
