Hot-Mix Asphalt Trackbed Performance Evaluation at Alps, New Mexico

by Dingqing Li, *Jerry G. Rose,

Summary

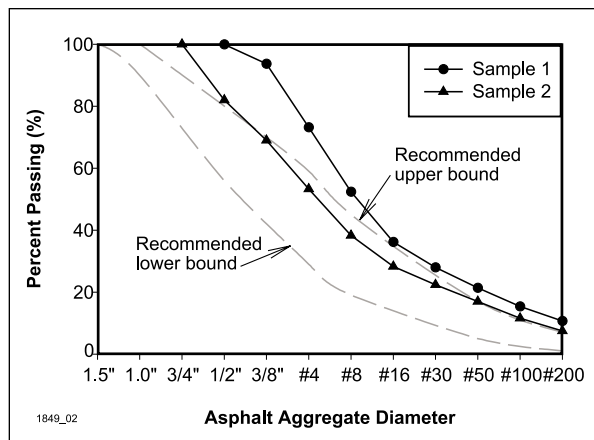
Exhibit 2. Asphalt Aggregate Size Distribution

All the collected samples were tested in a laboratory to determine material characteristics and their comparisons with the specifications or recommendations. Exhibit 2 shows the aggregate size distributions for the two HMA core samples and the range recommended by the Asphalt Institute.² As shown, the aggregate sizes are slightly finer than recommended.

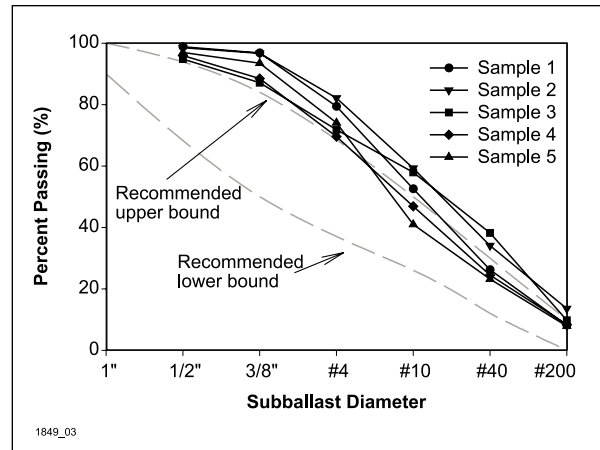
Exhibit 3. Subballast Grain Size Distribution

The gradation results of the subballast samples and the range recommended by the American Railway Engineering and Maintenance of Way Association (AREMA) Manual are shown in Exhibit 3. As illustrated, the actual sizes of subballast materials are finer than those recommended.

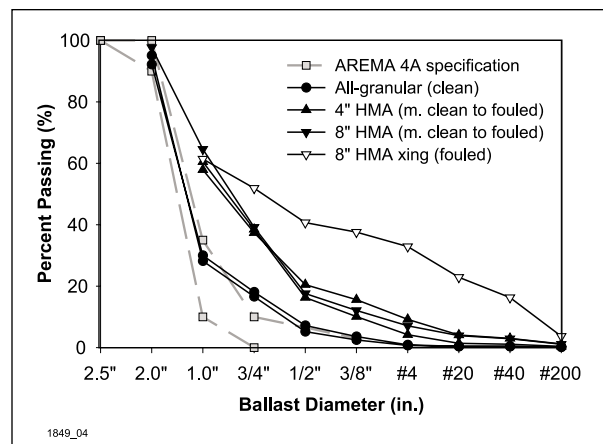
Exhibit 4. Ballast Grain Size Distribution

The ballast degradation results are compared among the 1994 control “all-granular” test section, the 4-inch HMA section, and the 8-inch HMA section in Exhibit 4 after approximately 240 MGT. As illustrated, the ballast degradation for the two HMA sections (classified as moderately clean to fouled) was only slightly higher than for the control “all-granular” section (classified as clean).

Only three isolated problem areas are evident in the 2.2 miles of HMA track. At one site, mud-pumping occurred when a temporary construction road crossing made of subballast was not entirely removed. The gradation result for the fouled ballast is also included in Exhibit 4.

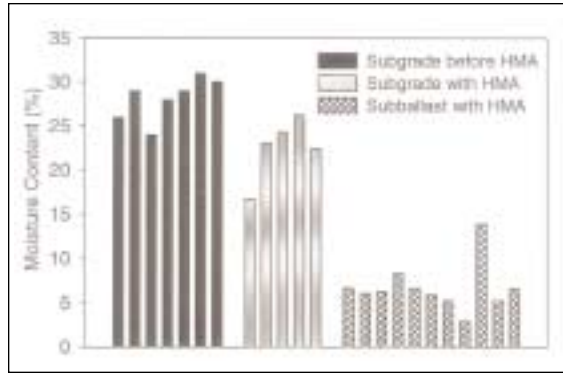
Exhibit 5. Subgrade and Subballast Moisture Content

The moisture contents of the subgrade and subballast samples collected in the summer of 2000 are shown in Exhibit 5. For comparison, the moisture contents obtained for the subgrade samples collected prior to HMA installation are also shown in Exhibit 5. As illustrated, subballast moisture contents are low, typically 5 to 7 percent, indicating that the HMA has provided an impervious layer and no excess water has developed under it. The comparison of the results before and after

the HMA construction shows that subgrade moisture content has been reduced.
