Field Performance of Bainitic Steel Rail Crossing Diamonds

by David D. Davis, Don Guillen,

©November 2001

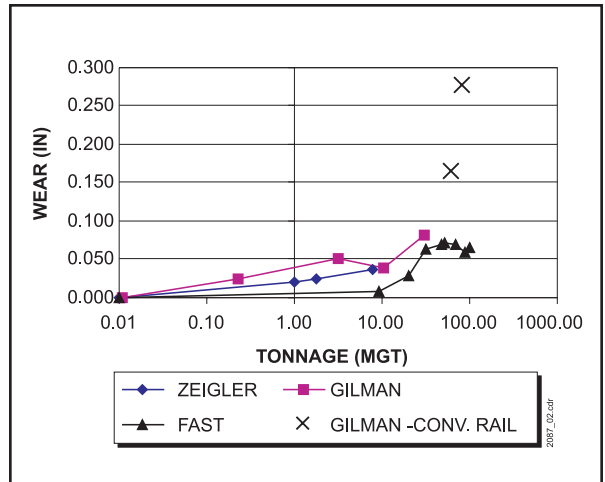
Exhibit 2. Average Running Surface Height Loss for Bainitic Rail Diamonds

Exhibit 2 shows the running surface performance of the bainitic rail diamonds in test. The two revenue service crossings are performing similarly to date. At 10 MGT, the two diamonds have averaged 0.04 inch of running surface height loss (labeled as wear) measured at 1 inch from the flangeway. By comparison, the FAST diamond had about 0.01 inch of running surface height loss at 10 MGT.

These deformation rates are very low compared to conventional pearlitic rail diamonds. For comparison, wear at removal from track for the previous two pearlitic diamonds at Gilman is shown in Exhibit 2. At 100 MGT, the pearlitic diamonds averaged about 0.25 inch of wear at the flangeway corners. The FAST

bainitic rail diamond had an average of about 0.07 inch under 100 MGT of more severe loading.

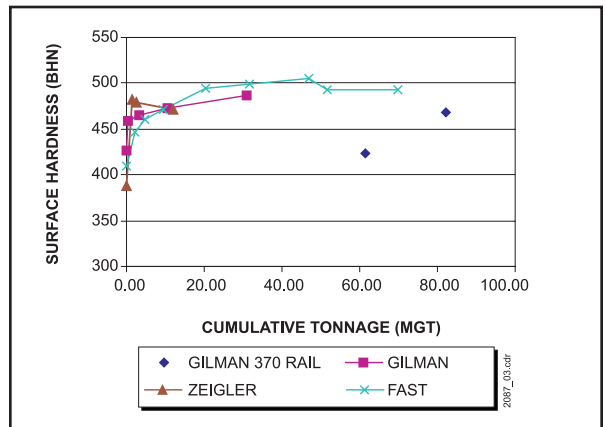
Exhibit 3. Running Surface Hardness of Bainitic Rail Diamonds

Exhibit 3 shows measured running surface hardness for the test diamonds. The running surface hardness for all three test diamonds reached about 470 Bhn

at 10 MGT. Hardening is rapid with traffic, as it is with AMS castings. The hardening rate is linear on a logarithmic scale. By comparison, the premium pearlitic rail, with an initial hardness of 370 Bhn, hardens to about 460 Bhn after 80-100 MGT.

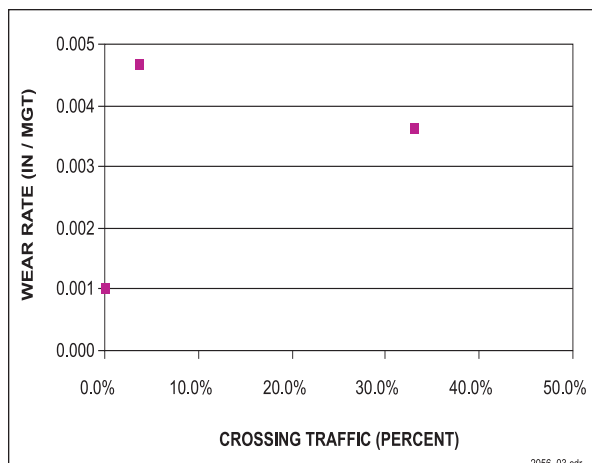
Exhibit 4. Running Surface Wear Rate vs. Percent Crossing Traffic

Comparison of average wear rate versus percent of crossing traffic was made for the three test diamonds. Exhibit 4 shows this comparison. The better performance of the FAST diamond to some extent is attributed to the lack of crossing traffic. Despite the higher wheel loading and with similar speeds, the FAST diamond had a much lower wear rate than has been seen on the revenue service diamonds. It appears that a small amount of crossing traffic is sufficient to cause considerable wear. The running surface of the crossing track presents two problems on three rail diamonds. The first is that it can be difficult to keep the five different pieces of each frog in alignment. The second is the adverse running surface profiles that are encountered. While the mainline track sees only properly oriented running rail, the crossing track sees three rails at each frog that are rotated to the crossing angle. Exhibit 5 shows the cross track running surface. The running surface longitudinal profile is a series of four dips and three humps. This profile results in impacts and high-contact stresses between non-conformal wheel and rail surfaces, resulting in higher wear rates.

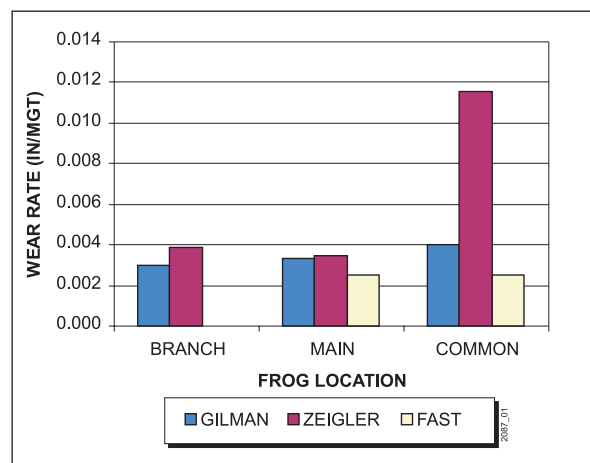
Exhibit 6. Wear Rate vs. Frog Location

The common corners have the most deformation, as they have the most tonnage. The mainline corners have the lowest deformation rates because the rail running surface is best aligned for the main route.

Exhibit 6 shows wear rate versus location for the bainitic three rail diamonds. The revenue service diamonds are showing the highest wear rates on the common corners. The mainline corners are showing lower wear rates than the common corners. The branchline corner rates are about the same as the mainline rates on the two revenue service diamonds (somewhat lower in the case of Gilman and somewhat higher in the case of Zeigler). The relatively small amount of tonnage and wear seen on these corners makes the data uncertain.
