## Tie Conditions Leading to Dynamic Gage Widening Exceptions Under TLV Loads

by Richard Reiff

Work performed by **TTCI**  
Transportation Technology Center, Inc.

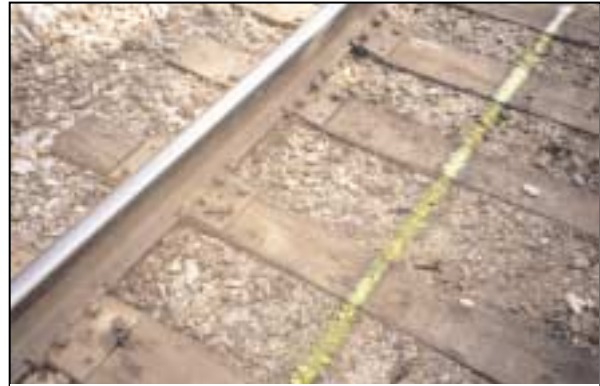
**Exhibit 1. Yellow Paint Mark at Site Exhibiting a Broken Spike and Field Side Cant**

In curve areas, the degradation mode most commonly noted was high rail, negative cant plate cutting (Exhibit 1). In these areas, the field side of the plate could be seen digging into the tie, while for the most part, the low rail did not exhibit such cutting. It was suggested that this high rail cutting was due in part to high lateral loads being generated by the two to three unit helpers operating in full throttle mode that are used by every uphill loaded coal train over this territory.

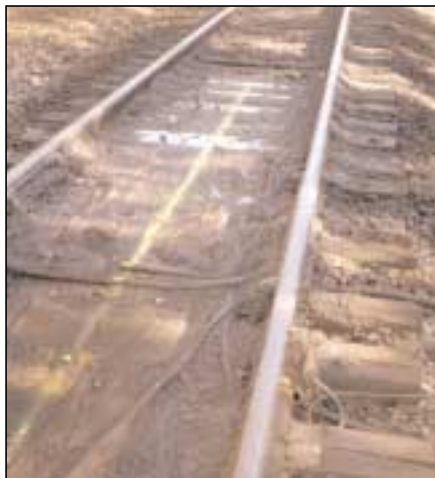
A few isolated areas of dynamic TLV gage widening over 1 inch were discovered in tangents. These were associated with grade crossings and lubricator sites (Exhibit 2). Ties may not have been properly visually inspected at these locations because the roadway or lubricant absorption pads cover them. In the case of wayside lubricators, evidence of recent tie renewals could be seen each side of the lubricator. This suggests that the inconvenience and difficulty of removing the lubricator and its associated equipment may have caused these sites to not be handled by production work gangs.

**Exhibit 2. Yellow Paint Mark on Tangent Track at a Wayside Lubricator Location**

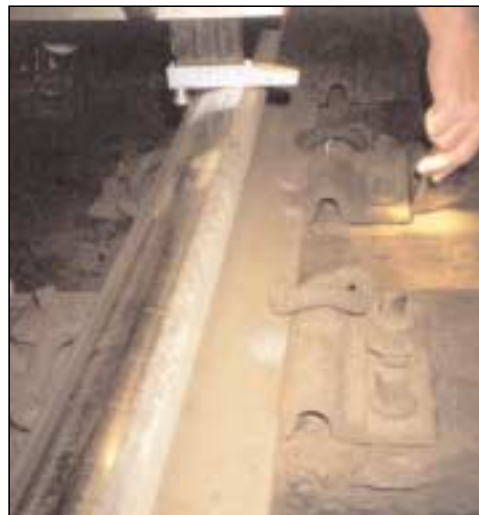
Direct fixation fasteners offered an unusual situation. At first glance at locations identified by the TLV, the ties and plates appeared to be in excellent condition, with no cutting or negative cant. Closer examina-

tion revealed that the ties were cut significantly (Exhibit 3). Plates were actually suspended over a depression in the tie by the action of the clips. A passing train would push the plate into the cavity and often would result in the wide gage. Only close inspection, often including the investigation of unused holes, would reveal this condition.

**Exhibit 3. Elastic Fastener on an Open Deck Bridge Exhibiting Hidden Plate Cutting**
