## Thermite Weld Evaluations at FAST

by Joseph Kristan

**TTCI**  
Transportation  
Technology Center, Inc.

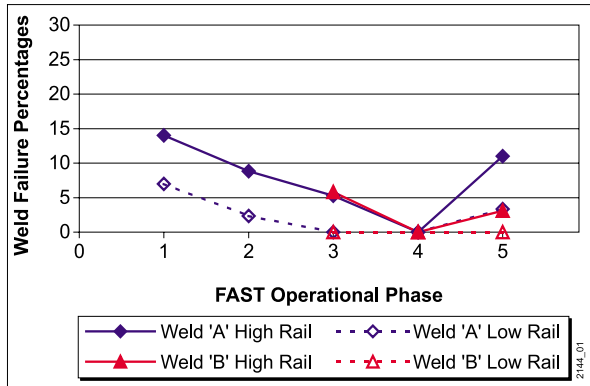
- Twelve of the 15 premature fractures were Type A welds with 10 of 12 of Type A occurring in the high rail.
- Nine of the 10 investigated Type A premature weld fractures were due to fatigue that initiated at the center third of the rail base. The other was due to fatigue at the web to base fillet.
- Each of the base fractures occurred between 1/8 and 1/2 inch away from the weld collar back into the parent rail.
- All of Type A high-rail premature fractures had substantial flashing at the fatigue initiation site due to vertical offset at the base of the opposing rails of between 1/16 to 1/4 inch to allow the use of rail repair plugs.

The analysis of the premature thermite weld fractures (premature fractures were service fractures that occurred with less than 30 MGT of accumulated tonnage on the weld) by both TTCI and the manufacturer of Type A weld showed that the offset of the rail bases contributed to the fracture and was not caused specifically by the Type A weld. Because each of the fractures initiated a distance away from the weld collar in the flashing area, TTCI concludes that the resultant excessive flashing from the offset of the bases was a major contributing factor to the premature fractures. But the manufacturer of Type A weld contends that flashing has no influence on weld performance and did not contribute to the premature fractures of the FAST welds. Therefore, they attribute failure specifically to the vertical geometry mismatch of the rails.

**Exhibit 1. FAST Premature (<30MGT) Thermite Weld Failures per Operational Phase**

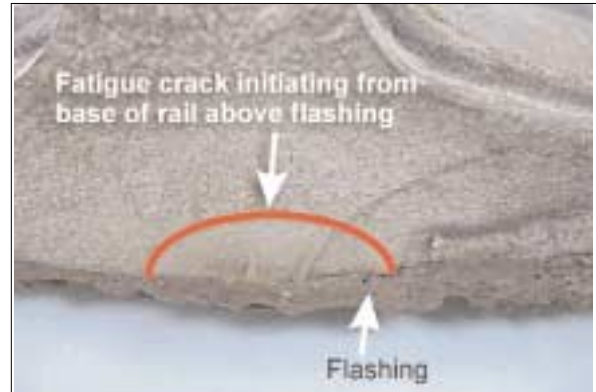
The setup of the test welds is intended to incorporate the two common factors between each of the premature maintenance weld fractures. The 0.188-inch offset of the bases correlates directly with the geometry of the premature fractures investigated. The resultant flashing from the offset of the rail bases (without reduced flashing) will theoretically produce a stress concentration site initiating fracture at the rail base a

**Exhibit 2. Offset Thermite Weld**

The vertical offset test welds had received 14.5 MGT through 2001 with no fractures to date. The test welds will likely require an additional 10 MGT before any fractures occur; the average Type A premature weld fracture occurred at 22.4 MGT. Definitive results will likely be attained after 50 to 60 MGT, which will occur approximately mid-year in 2002.

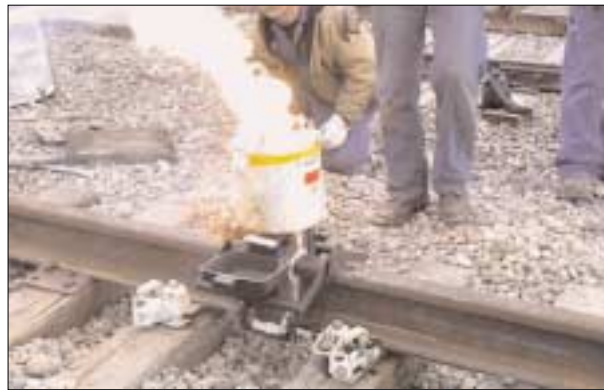
The mechanical testing of the head hardened welds began with rolling load and slow bend tests. The criteria for the rolling load test are a 59,400-pound load applied to the railhead through a minimum of 2-million cycles. The head hardened test weld fractured after 285,800 rolling load cycles; and thus, did not meet

AREMA’s proposed minimum test requirements.

**Exhibit 3. Test Weld being Poured at FAST for Laboratory Evaluation**

This weld manufacturer has taken an aggressive engineering approach to improve the performance of their welds. Because of this effort, TTCI will likely resume laboratory testing of the head hardened thermite weld in 2002. If the weld performs acceptably in the TTCI laboratory evaluation, the weld will be considered for track testing at FAST.
