## Evaluation of Specialized Rail Joints for Moveable Bridges under HAL Traffic

Charity Sasaoka, David Davis,  
Duane Otter, and Brian Doe

**TTCI**  
Transportation  
Technology Center, Inc.

©July 2002

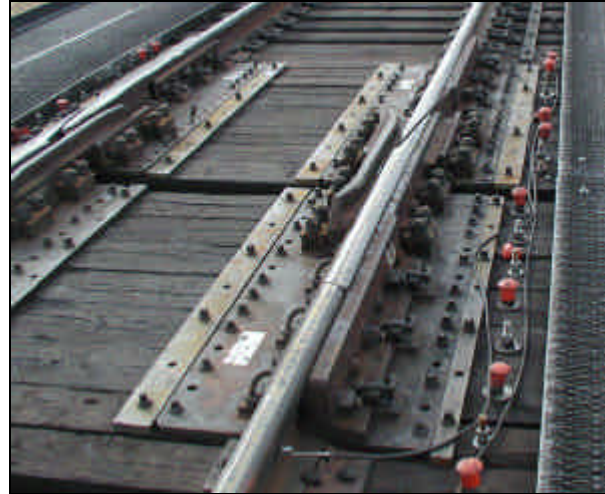
**Exhibit 1. AMS Casting Bridge Joints Installed**

Two-piece AMS casting joints were installed and tested on the High Tonnage Loop at FAST. The joints consist of two separate pieces of explosion-hardened manganese. Each piece was fastened to a base plate with elastic fasteners. The base plate was then fastened to the ties. One side of the joint was fixed (point side), and the other side was the moveable, lift side. AMS casting joints are designed specifically for bascule and vertical lift bridges (see Exhibit 1).

The joints were installed between the two spans on the bridge. The fixed side of the joints was on the large bridge span and the lift side was on the small bridge span. The two-piece AMS casting joints were installed per manufacturer specification of a 4-inch gap at the base plate.

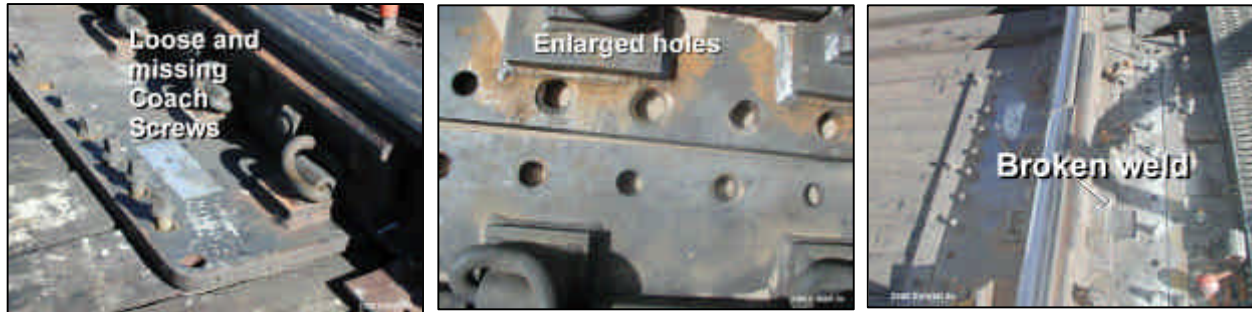
**Exhibit 2. Deformed Bolt Holes and Broken Fasteners**

The AMS casting joints accumulated 54 MGT before being removed for increased maintenance demands. Approximately two-thirds of the coach screws used to fasten the plate to the tie worked loose or broke. Some of the fasteners began to pull through the plate, enlarging and deforming the fastener holes. Once these fasteners began to fail, the joints began to move laterally. Steel "straps" were placed on both sides of the plate restraining the joints laterally. Exhibit 1 shows these straps. The joints were still allowed to move vertically. The elastic fasteners used to hold the casting and rail to the base plates were mounted on base blocks welded to the plates. Some of the welds and elastic fasteners failed due to the vertical movement of the joint. The plate-to-tie fasteners and the casting-to-plate fasteners did not allow for much vertical movement of the joints. Daily maintenance of tightening the coach screws decreased after the joint was restrained laterally by the straps and allowed to move vertically. Exhibit 2 shows the maintenance issues due to fasteners.

The AMS casting joints were installed without damping pads. The use of damping pads may help absorb some of the vertical impacts, decreasing the needed maintenance due to the vertical movement.

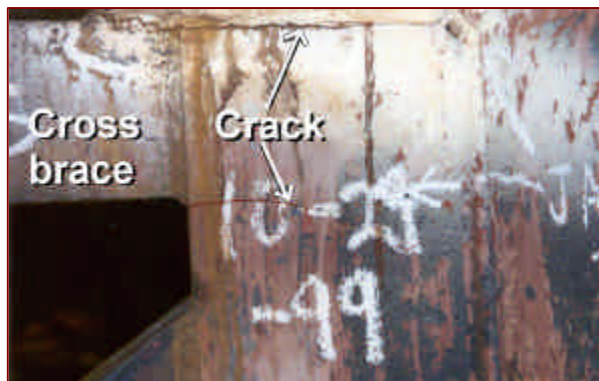
**Exhibit 3. New Cracks on 65-foot Span**

The AMS casting joints also contributed to increased fatigue cracking and maintenance on the bridge, due to impacts. New cracks were discovered in stiffeners in the 65-foot span near the bridge joint. Exhibit 3 shows two cracks, one between the stiffener and the top flange that extends into the weld on the web and one in the weld on the horizontal bracing angle and continuing about 4 inches through the stiffener on the back side. New cracks appeared in similar locations on two other stiffeners. Two new hairline cracks in the welds of the stiffeners to the bottom flange were discovered on the 55-foot, 6-inch span close to the center pier. These cracks were also under the bridge joint location. All of the new cracks in the spans are located under the bridge joints.

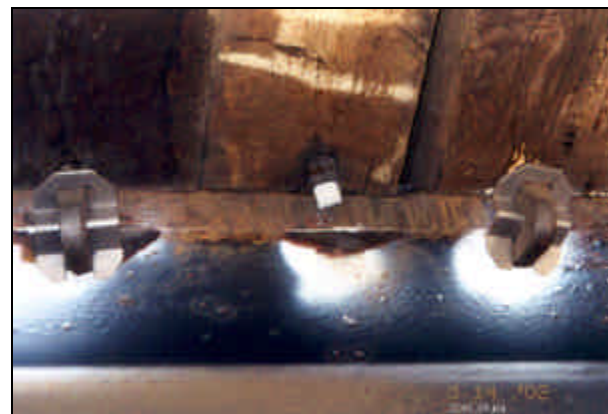
**Exhibit 4. Broken Hook Bolt**

The hook bolts holding the deck ties in place became loose due to the vertical forces and vibrations

caused by the joints. Lock plates were added to keep the hook bolts from turning off of the girder. On some of the hook bolts, the top of the bolt snapped off as shown in Exhibit 4; others snapped off at the bottom of the bolt where it was attached to the flange.

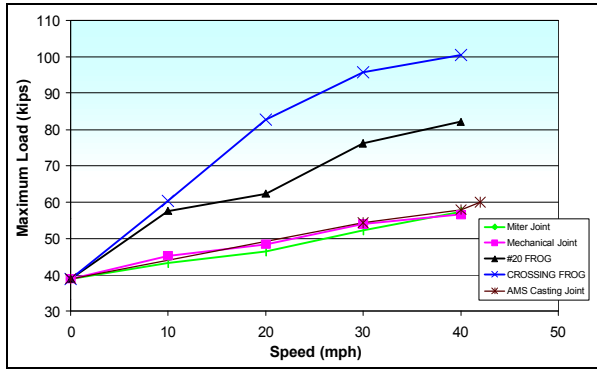
Exhibit 5. Average Maximum Vertical Dynamic Loads

The AMS casting joints had similar vertical dynamic loads to a typical mechanical rail joint in ballasted track. Exhibit 5 shows dynamic vertical loads from instrumented wheelset data for the AMS casting joints, a typical mechanical joint, and various other components in ballasted track for comparison. The AMS casting joints had average maximum vertical dynamic loads approximately 1.5 times static wheel load. In comparison, a No. 20 turnout frog had average maximum vertical dynamic loads 2 times static wheel load, and a crossing diamond frog had average maximum vertical dynamic loads 3 times static wheel load.

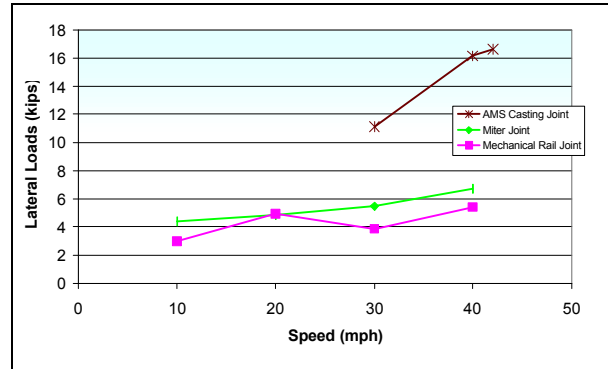
Exhibit 6. Average Maximum Lateral Dynamic Loads on the Outside (High) Rail

The AMS casting joints had higher lateral dynamic loads than a typical mechanical joint. Exhibit 6 shows average maximum lateral dynamic loads (on one rail) for the AMS casting joint and a typical open track mechanical joint. The AMS casting joint shows loads 2.5 times higher than the mechanical joint.

The bridge at FAST is located on a tangent between spirals entering 5-degree curves approximately 200 feet from the bridge joints. The joints are subject to lateral impacts from any trucks that do not straighten out and re-center themselves on the rails in the short tangents before the joints. Based on guardrail wear, a large number of wheelsets are not straight and centered at the joints. While both guards received impacts in both directions, the guard and plate work in one quadrant of the joints appeared to suffer the most damage from guard impacts. This lateral impact problem may not be an issue for tangent track locations. However, it does point to potential design and field application limitations.

The guards on the joints must be short to allow the joint to function as a lift span bridge rail joint. The 46-inch-long guards make the wheel impact angle of attack larger than it would be with turnout frog guardrails. Therefore, it is problematic to improve upon the design. A remedy may be to locate guardrails just before the joints.
