Dynamic Gage Widening Inspection of a Western U.S. Main Line under TLV Loading

by William Larson, David Davis and Randy Thompson

TTCI
Transportation
Technology Center, Inc.

©December 2002

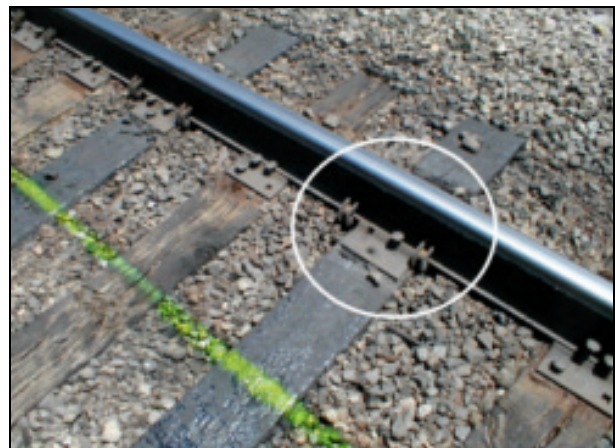
under the TLV equals or exceeds a preset value (exception). Multiple spray sites through a curve were treated as one “location.” Wide gage paint limit (loaded gage) was set at 57.00-58.00 inches and delta gage paint limit (loaded-unloaded) was 1.00-1.50 inches. (See Figure 2 for typical paint marking.)

Figure 2. Yellow Paint Stripe at Curve with a Broken Spike, Tie Plate Cutting, and High Spikes

Other conditions seen in the painted curve areas included spike lifting, tie plate cutting, and evidence of plate-to-tie lateral movement at field side of high rail tie plates (see Figure 2). Broken spikes, as seen in the photo, were found in two locations, but this was not a typical circumstance found during inspection.

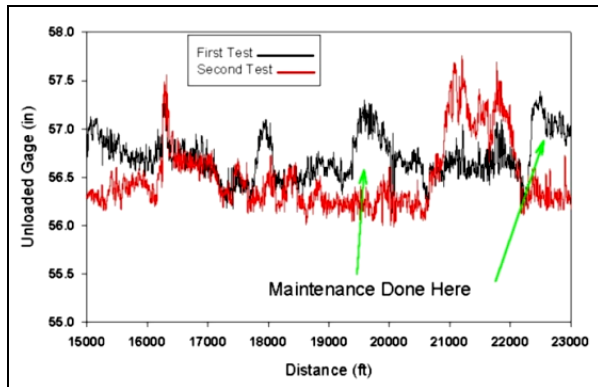
The unloaded gage in painted areas typically measured in a range of 57.13 inches to 57.50 inches. The TLV measured two locations where unloaded gage was more than 57.50 inches. Those areas had nominal gage restored by repositioning the low-side rail.

Figure 4a (unloaded gage) and Figure 4b (loaded gage) support this conclusion. They are overlays of histograms taken from the same section of track in both tests, to make the areas of improved gage strength easily distinguished.

Figure 4a. Histogram showing Unloaded Gage in 2002 vs. 2001 at Same Location

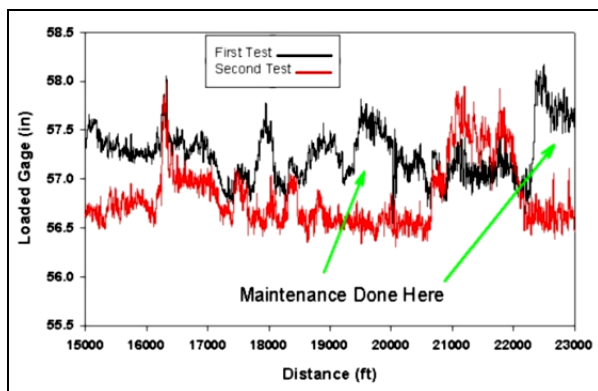
Seven of the 14-milepost sections found in 2002 had TLV wide gage exceptions on the 2001 test as well. In fact, the TLV histograms from both tests of these areas look nearly identical. This lack of change implies that maintenance in these particular sections has been effective in preventing additional deterioration caused by continuing traffic.

Figure 4b. Histogram showing Loaded Gage in 2002 vs. 2001 at Same Location

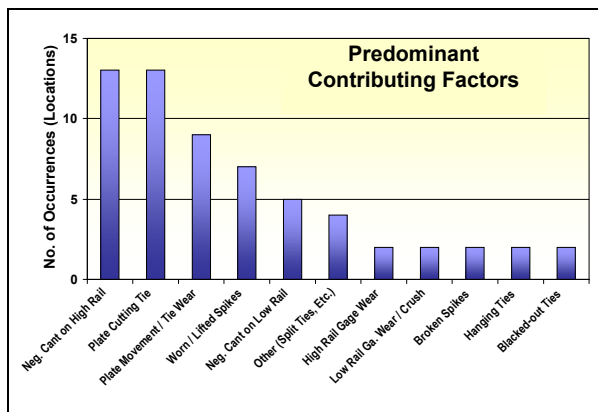
Figure 5 summarizes the number of locations for each of the major conditions determined to cause TLV wide gage found in the 2002 inspection. Note that many sites had combinations of causes, especially plate cutting, spike lifting, and ties splitting.

Figure 5. Number of TLV Exception Occurrences
