Dynamic Gage Widening Inspection of an Eastern U.S. Main Line

by William Larson, Joseph LoPresti, and Randy Thompson

Summary

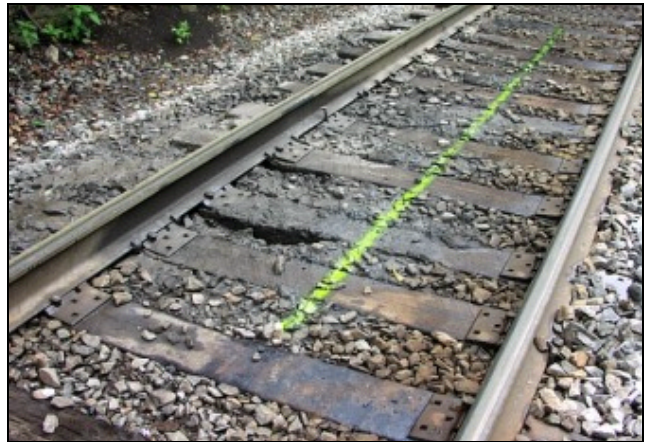
For this test, the TLV was configured to inspect for track gage restraint and in a few locations for vertical track modulus. For loaded gage testing, the TLV applied continuous loads of 33,000 pounds vertically and 18,000 pounds laterally, at track speeds between 15 and 20 mph. In this configuration, an automated paint spray system marks locations where dynamic gage or delta gage under the TLV equals or exceeds a preset value (exception). Multiple spray sites for exceptions through a curve were regarded as one "location." Wide gage paint limit (loaded gage) was set at 57.50 inches, and the delta-gage paint limit (loaded/unloaded) was set at 1.00 inch, the same as for the previous year. (See Figure 1 for typical paint marking.)

Figure 1. Wide Gage Paint Location at Previous Wash-Out Area in Tangent Track

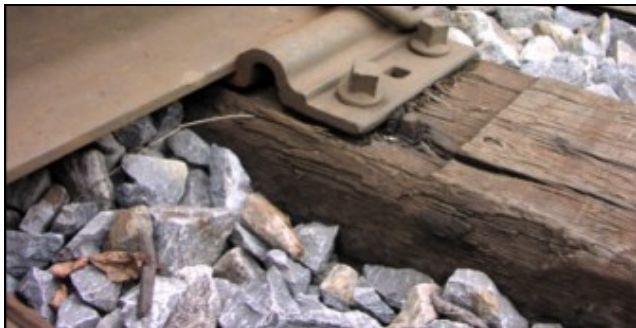
Two locations at bridge approaches had elastic fasteners retro-fitted onto older wood ties. There were visual indications of gage strength problems, probably caused by older wood ties that were not in prime condition when retrofitted with the elastic fasteners (see Figure 2). One 4-mile section of track, at the beginning of the inspection, had concrete ties and was referred to as the “concrete test section” by the host railroad. It was not tested during the 2001 investigation so no comparisons can be made. However, in this test, there were four locations where the TLV identified and marked for wide gage conditions. The wide gage exceptions were in both tangent and curve track. One of the track inspectors reported that the elastic fasteners and concrete ties were periodically being replaced with hardwood ties, 18-inch tie plates, and cut spikes as part of recent T&S programs. Apparently the concrete system has not worked out well for this line because of insulator wear, rail seat abrasion, and tie pad wear problems (see Figure 3).

Figure 2. Elastic Fastening System Installed on Old Ties

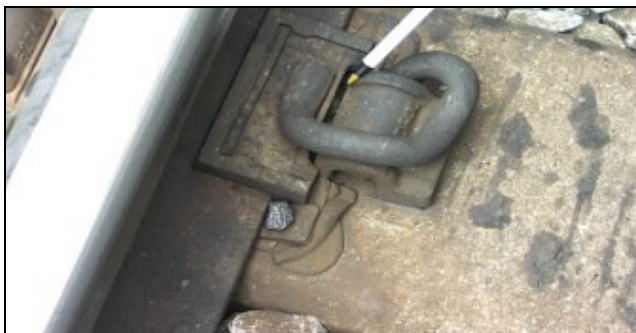
Figure 3. Pencil Points to Worn Insulator at Concrete Tie

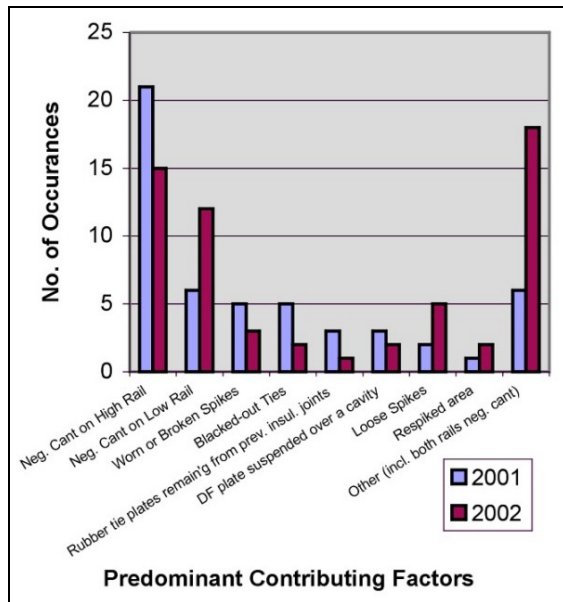
Figure 4 summarizes the number of locations, over the first 50 miles of the first main line, for each of the major conditions determined to cause widened gage. It compares results from the 2002 investigation with those from the previous year.

Figure 4. Number of Defect Occurrences
