Effects of Flashing and Alignment on Thermite Weld Performance

by **Joseph Kristan**

Summary

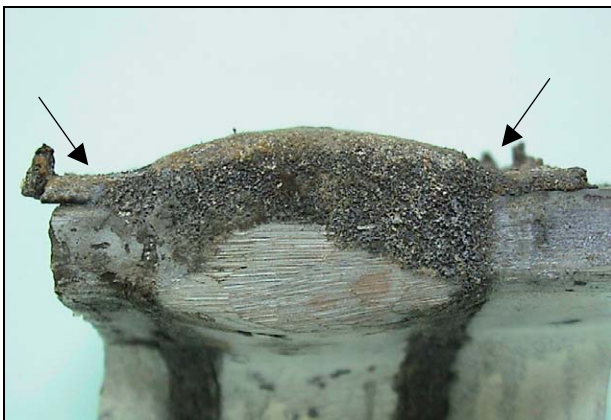
The flashing is the result of the molten thermite portion flowing into spaces that are not completely filled by the mold and/or the sealing sand or paste. Figure 1 shows the result of the formation of flashing.

Figure 1: Flashing is present below the rail base on both sides of the weld because the molten thermite portion flowed into spaces that were not completely filled by the mold and/or the sealing sand or paste.

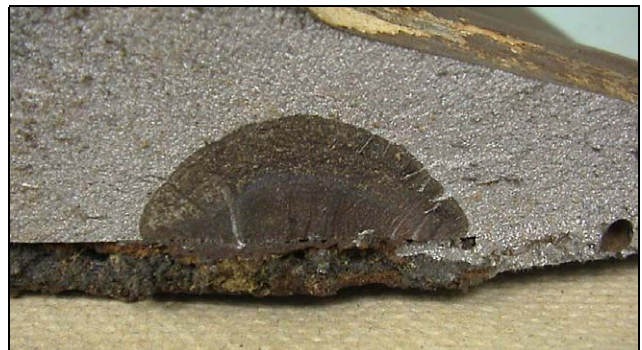
The overall failure rate of all 3/16-inch offset test welds was 60 percent for both the base flashing and reduced base flashing weld types. Five of the six test weld fractures with flashing failed by fatigue directly above the flashing on the bottom of the rail base (Figure 2); only one occurred at a discontinuity at the head/web fillet. Figure 3 shows a different view of the fracture shown in Figure 2, indicating fracture distance from the edge of the weld collar, which is inherently a stress raiser. The average failure tonnage accumulation of the five base failures of the test welds containing flashing was 74.3 MGT. One of the reduced

Figure 2: Fatigue fracture of 3/16-inch vertically offset thermite test weld, which initiated at the base of the rail immediately above the flashing intentionally produced for the test (run-out).

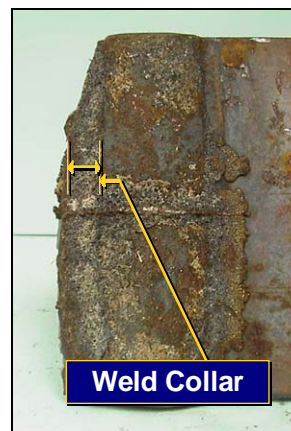
Figure 3: Bottom view of weld fracture shown in Figure 2 illustrating the location of the fracture relative to the weld collar.

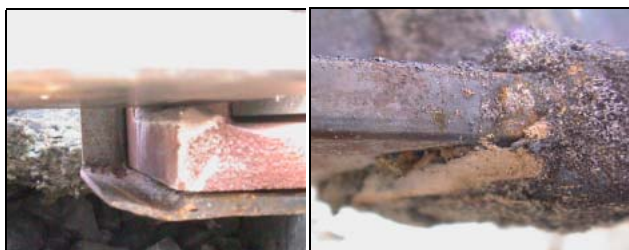
Figure 4a: Rail bottom and weld mold with refractory paste.

Figure 4b: Refractory paste reduced flashing formation at bottom of base.

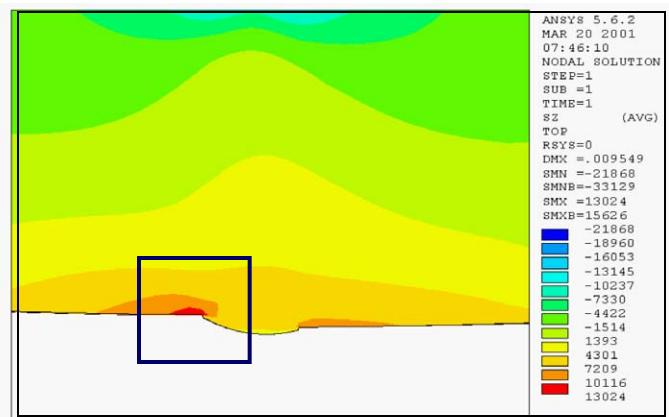
The influence of weld geometry in the absence of flashing (run-out) was estimated using a finite element model with the approximate weld geometry of an Orgo-Thermit, Inc. 1-inch-gap weld. (A pre-existing rail model, with UIC60 section, was used to shorten the required time to complete the analysis.) The approximate weld geometry at the base of the rail for both no vertical offset and 0.25-inch vertical base offset was analyzed. The maximum localized stress for the aligned base model was 10.7 ksi symmetric on either side of the weld collar at the base of the rail. However, with a 0.25-inch vertical offset introduced and optimized base collar geometry, as with an offset base mold, the maximum stress increased to 13.0 ksi at the uplifted collar edge, as Figure 5 shows. This is an increase of more than 21 percent due strictly to the resultant weld geometry though optimized for the conditions of vertical offset. Orgo-Thermit, Inc. has modified the weld collar radius since this analysis was performed. Thus, the localized stress has likely been reduced though the magnitude in the difference between the aligned and vertically mismatched welds would likely be similar.

Figure 5: Finite element analysis of thermite weld base geometry influence on localized stress. Comparison between zero and 1/4-inch base offsets determined a 21-percent stress increase at the uplifted base (influence of flashing [run-out] not included).
