Bainitic Steel Test Results: Diamond Crossings in Revenue Service and at FAST

by Don G. Guillen, David D. Davis, and Charity D. Sasaoka

Summary

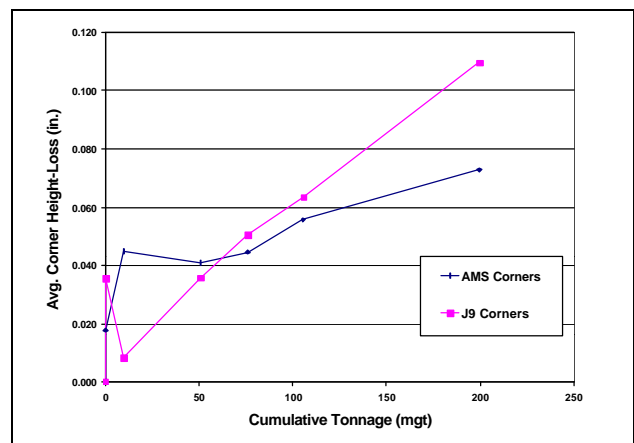
Figure 2. Diamond Crossing Height-Loss, Salem, IL

The diamond crossing located in Salem, Illinois, has two corners with J9 bainitic steel and two corners with AMS. The J9 castings are setting cater-corner from each other with the AMS casting corners in the other two slots. Each corner bears similar traffic conditions from both the branch and main lines. The initial average deformation rates of the J9 castings are similar to the AMS castings. But, after 200 MGT, the AMS casting corners height-loss is performing better than the J9 casting corners.

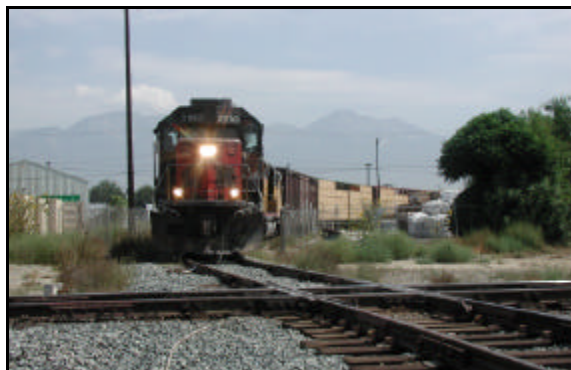
Figure 3. AAR Advanced Diamond Crossing, Ontario, CA

The advanced design crossing diamond located in Ontario, California, was developed for improved dynamic performance and durability (Figure 3). Improved dynamic performance was measured on the diamond, using load-measuring wheelsets. After 60 MGT of operation, the diamond had no major component failures and low running surface height loss rates. The features intended to improve performance include:

- Running surface ramps: the first one designed for a 3-rail design diamond crossing
- Herringbone corner design: eliminates one rail joint from the crossing track running surface
- Modified flangeway corner radii: smaller flangeway radii on inside corners
- Milled base plates for rail base seats
- Self-centering washer and bolts

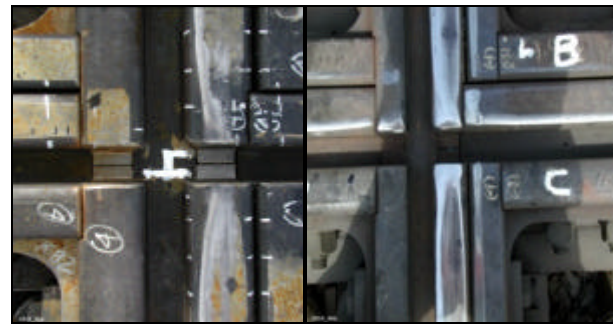
Surface ramps were milled into the top of the railhead of the J6 material for 40-mph traffic. The surface ramps have been successful with little deformation at 81 MGT (Figure 4).

Corner 4 Ramp at 5 MGT Corner 4 ramp at 81 MGT
Figure 4: Ramping System –Diamond Crossing Minimal Deformation after 81 MGT at the Ontario Site

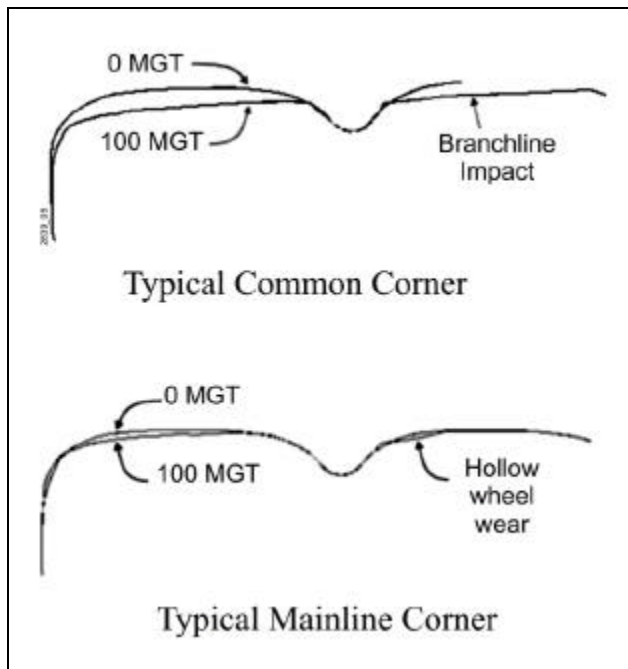
Figure 5. Typical Worn Profiles

Running surface profiles are similar for all of the diamond crossings in test. Common corners show the most deformation because they receive impacts in two directions. The effect of branch-line traffic is most significant due to the running surface discontinuities created by the main-line guard, running, and easer rails. The height loss on the easer rail is from wheel impacts on the branch-line side. The typical worn profile of the corner that only has main-line traffic has less height loss. The wear from hollow tread profile wheels is seen on the easer rail. Common corners have the most height loss due to the impact from both main-line and branch-line traffic (Figure 5).

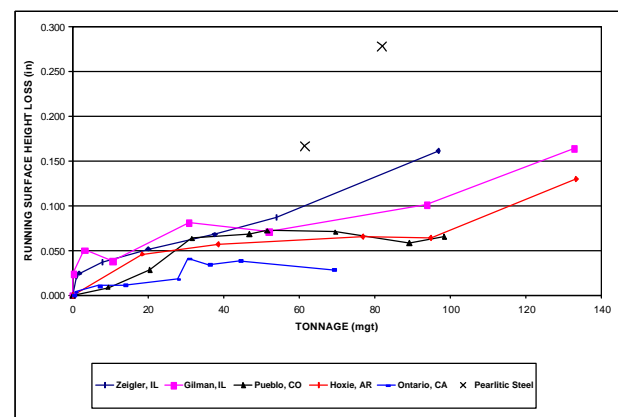
Figure 6: Five Diamond Crossing Tests

tests show that using J6 bainitic rails in high angle diamond crossings extends their life or prolongs the maintenance of its replacement parts. Premium pearlitic rails have two-times the height-loss than J6 bainitic rail in high angle diamond crossings (Figure 7). However, wide-scale application of J6 will require development of suitable repair methods and a reliable supply of rail.
