Update: Cracks in the Welded Girders of the Steel Bridge at FAST

by Muhammad N. Akhtar, Duane Otter, and Brian Doe

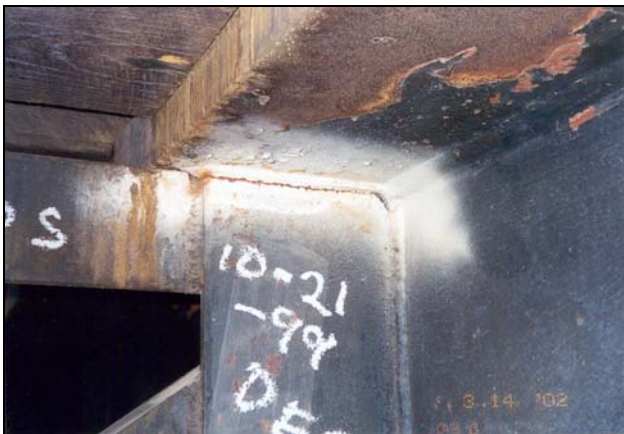
Figure 3. Crack in Diaphragm Connection

On the north girder of the 65-foot span, all angles at the top of the diaphragms are welded to one side of the intermediate stiffeners at some locations. When the bridge was subjected to lateral loads or uneven vertical loads, out-of-plane bending may have caused an eccentric resultant force on the stiffeners. Three out of five diaphragms with these connection details initiated cracks that have propagated into the stiffeners (Figure 3). On the south girder, diaphragm angles tend to be welded on both sides of the stiffener at the top of the girder. The applied diaphragm forces are more balanced. No crack has been observed in the south girder diaphragm connections.

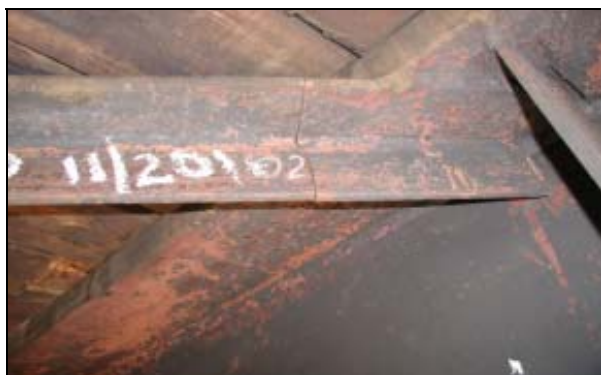
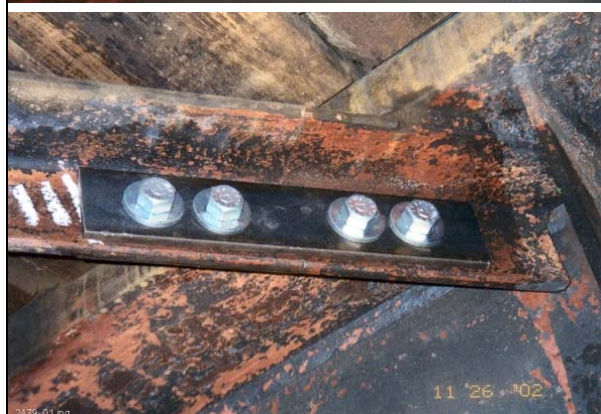
Figure 5. Lateral Bracing
(Top) Fractured (Bottom) Repaired with Bolted Splice

To date, the 65-foot span has experienced three cracked lateral braces between top flanges. In two of the braces, the entire cross section cracked. They have been repaired with bolted splices. In one of these braces, the crack was not completely through the cross section until after the splice

was installed. It appears that these cracks initiated in welds, under higher dynamic loads from the bolted rail joints. Each cracked brace is in the vicinity of a bolted rail joint. No cracks were observed on these braces before joint installation.

One brace with a crack has not yet been repaired. The crack is only partially through the cross section. It is being monitored, as the rail joints were recently removed from the bridge deck near that location. Figure 5 shows a brace repaired with a bolted splice.

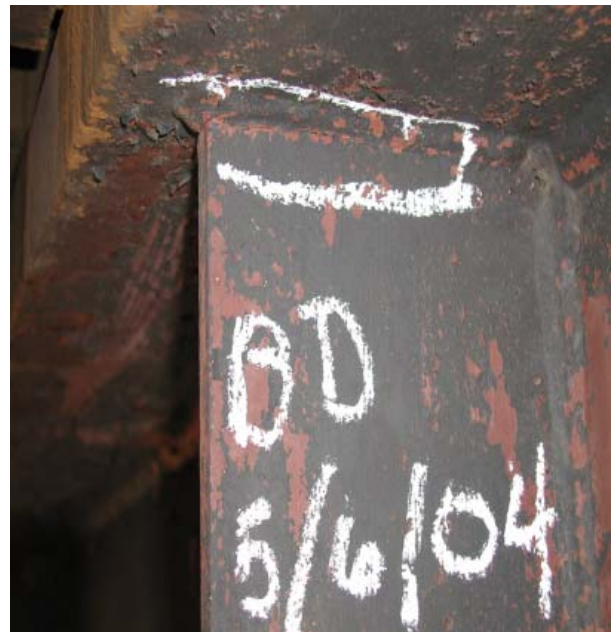
Figure 6. Crack in the Weld of Stiffener and Compression Flange

Figure 6 shows a crack that initiated recently. There is no diaphragm or lateral bracing attached to this stiffener. Rotation of the compression flange or out-of-plane bending of the web may have played a part in initiating this crack.

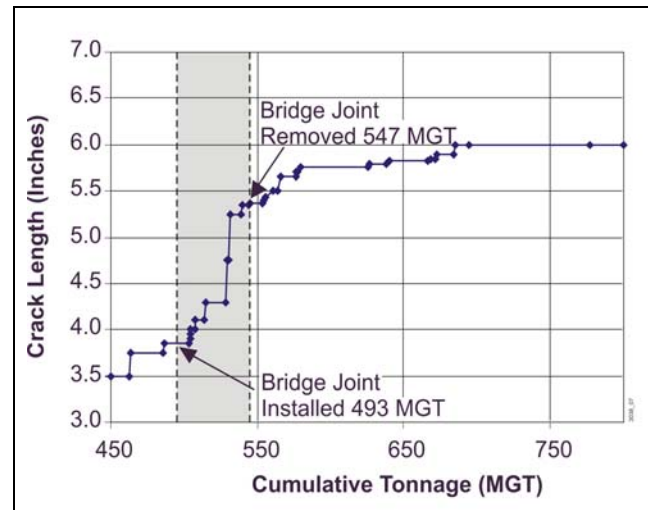
Figure 7. Crack Growth during Time the Mechanical Rail Joint was Installed

Two web cracks in the 55.5-foot span remain active. These cracks are under the first intermediate stiffeners of each girder near the bearings at the center pier. This location is below the area where the moveable bridge joints have been installed. Figure 7 shows that this crack became more active while the moveable bridge rail joint was installed. The length of cracks in the north and south girders increased from 10 to 15 inches and 2 to 5 inches, respectively. Only minimal crack activity has been observed since the rail joint was removed.
