## Performance of an Advanced Design Diamond Crossing in Revenue Service

by David D. Davis, Don G. Guillen and Charity D. Sasaoka

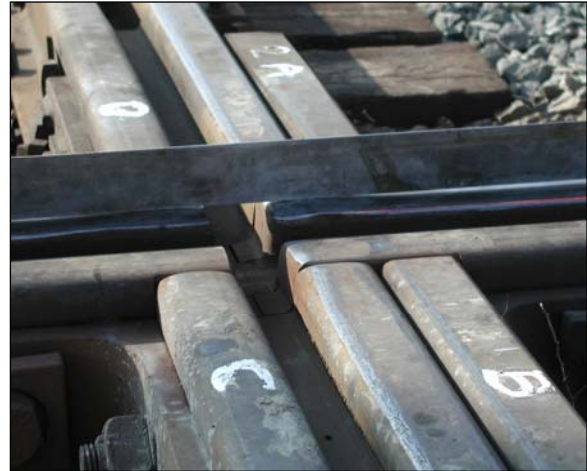
- The ramps are durable. The mainline ramps are still in existence after 125 MGT of traffic. The branchline ramps have been "cut" by false flanges from mainline traffic.

- Ramped running surface corners — made to Association of American Railroad design to minimize vertical forces for 40 mph traffic.<sup>1,2,3</sup> The ramps were 6 inches long with a 1:48 slope upward toward the flangeways. Figure 1 shows the ramps after 100 MGT of service

Figure 1. Ramped Running Surfaces after 100 MGT of Traffic

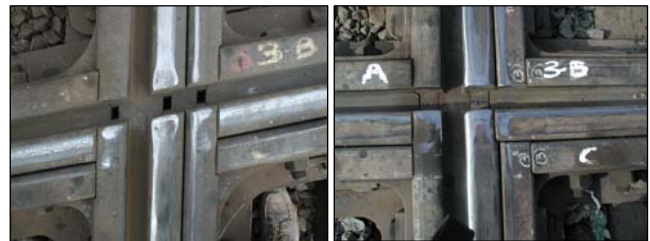
- Herringbone corners – arrangement of the supporting rails was changed at the frogs to eliminate the easer rails from the branchline running surface. This should make the crossing route smoother. The crossing base plate was made thicker to compensate for the loss of mainline bending strength. Figure 2 shows a conventional diamond frog and the Herringbone arrangement. Note that the branchline running rail butts against the mainline running rail, removing the mainline easer rail from the branchline running surface.

Figure 2. Conventional and Herringbone Rail Arrangements at Diamond Frog

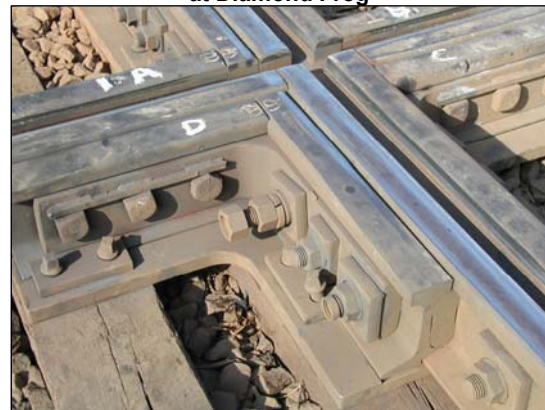
- Milled plates have worked well. The 1 1/4-inch thick plates with 1/4-inch milled seats have performed well. To date, there is no plate cracking. The diamond has remained in the plate seats.

- Milled plates – base plate has milled seats to assist in holding the diamond crossing in alignment. Typical designs rely on welded stops to hold the diamond in alignment. The stop welds often fail, cracking the plate or the stop. Figure 3 shows the diamond’s milled seat plate work.

Figure 3. Milled Rail Seat Base Plate (note ¼ inch milled seat at end of easer rail)

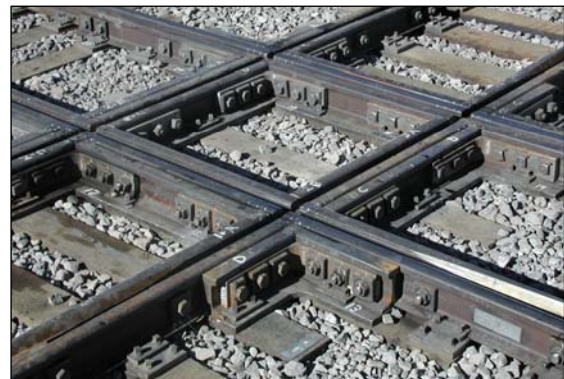
- A comparison of fastener performance shows that conventional bolts, nuts, and flat washers and self-centering bolts, nuts, and washers work well with higher torque applied. At 1,700 ft-lbs, both types of fasteners failed at about twice the rate seen at 2,300 ft-lbs.

- Self-centering bolts – Union Pacific standard self-centering bolts and washers were installed on half of the diamond. These components are designed to minimize bolt breakage due to shear or bending forces. Figure 4 shows self-centering and conventional bolts.

Figure 4. Self-Centering and Conventional Fasteners

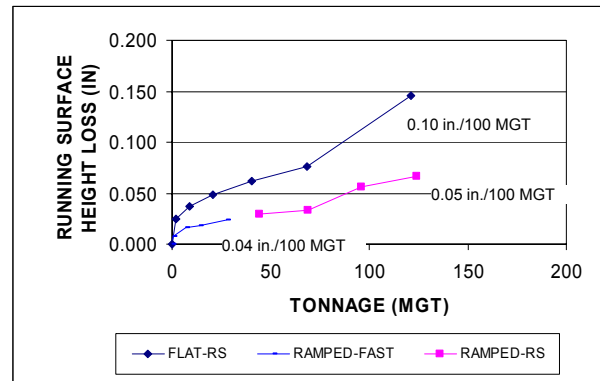
Measurements of running surface height loss were made on the diamond when in service at FAST and at Ontario, CA. Height loss encompasses both metal flow and wear of the running surface. At high impact locations, such as flangeway gaps, metal flow can be the dominant factor in running surface height loss. In conventional track, wear and rolling contact fatigue are more important. Figure 6 shows average running surface height loss for the mainline route of bainitic rail diamonds tested. Note that the running surface height loss rate is lower for the ramped diamond than for conventional flat (i.e., no ramps) running surface bainitic rail diamonds. The plot shows average height loss rates of 0.10 in./100 MGT for three flat running surface bainitic rail diamonds in revenue service, 0.05 in./100 MGT for the ramped diamond in revenue service and 0.04 in./100 MGT for the same ramped diamond in FAST. The gap in the ramped diamond data is from the period when FAST operations occurred on the branchline route and when the diamond was relocated to revenue service. Also note that the average

running surface height loss rate did not decrease in revenue service, despite lower static wheel loads. It may have increased slightly as the rates measured are about 20 percent higher. In addition, the wear patterns at FAST and revenue service differ. Figure 7 shows the same corner of the diamond after 30 MGT in FAST and after 90 additional MGT in revenue service. The FAST wear band is narrower, with few wheels bearing on the easer rail. The revenue service wear band extends across the entire running rail and has a significant groove worn in the easer rail. Thus, while the running surface height loss rates are similar, the total rail cross sectional area change is higher in revenue service.

**Figure 6. Test Diamond Crossing Running Surface Height Loss vs. Tonnage**

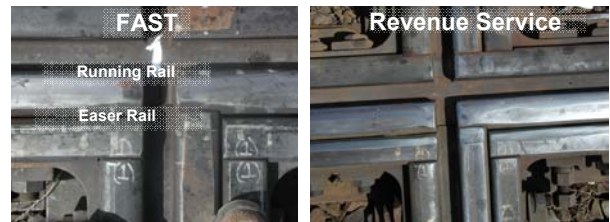
**Figure 7. Comparison of Ramped Running Surface Wear Patterns at FAST and in Revenue Service**

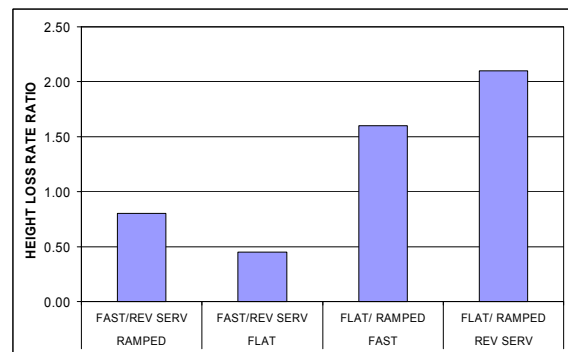
Analysis of the effects of load environment and running surface longitudinal profile was conducted using the running surface height loss data. Figure 8 shows a comparison of running surface height loss rate for ramped and flat diamonds at FAST and in revenue service.

**Figure 8. Effects of Load Environment and Running Surface Design on Diamond Performance**

Comparison of flat and ramped running surfaces at FAST suggests that the flat surfaces “wear” at flangeway corners about 50 percent more per MGT. Revenue service shows the same trends in a more tenuous comparison of performance at different sites. The ramped running surface should reduce dynamic loading for trains operating at track speed, and thus reduce running surface flow.

The data also suggests that the FAST dynamic load environment, despite the higher static wheel loads, is no more severe than revenue service (see the FAST/UP comparisons). The same ramped diamond crossing has similar running surface height loss rates in revenue service. The comparison of flat running surface diamonds has more uncontrolled variables, but shows the same trend. Potential explanations for the higher height loss rates despite lower average wheel loads in revenue service include:

- Ramp wear. As the ramps wear their effectiveness will diminish.
- Variations in train speeds. The running surface ramps were designed for 40 mph operations and will perform best for trains near this speed.
- Wheel profiles. FAST has profiles that are conformal to the rails, with little tread hollowing. Revenue service has a wide range of wheel profiles. These wheels produce adverse steering and higher contact stresses.
- Vehicle and truck maintenance. Car performance monitoring allows FAST to control dynamic loads more closely than can be done in revenue service. As a result, vehicle conditions that can cause high dynamic loads are remedied sooner. The result is a lower vehicle caused dynamic load environment.
