Hook-Bolt Fastener Performance on the FAST Steel Bridge

by Brian Doe and Duane Otter

Summary

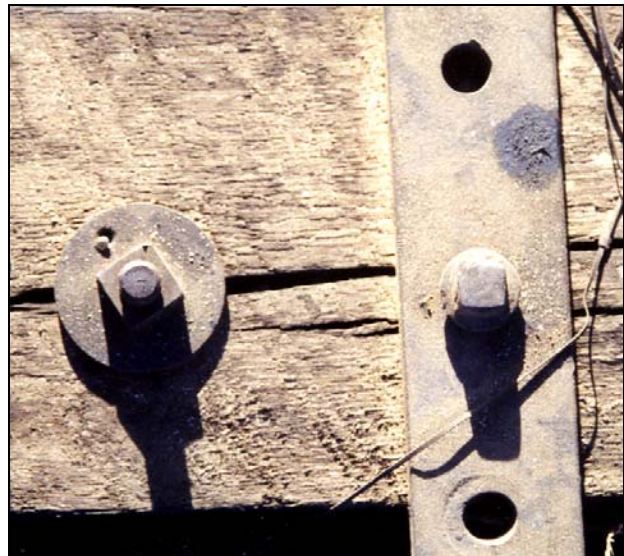
The original hook bolt configuration, when the deck was installed, consisted of a 14-inch hook bolt with a washer nut. There is a hole in the washer-nut for a nail to be driven in to prevent the washer-nut from turning (see Figure 1). The lower portion of the hook bolt neck is fluted, intended to engage into the tie to prevent turning. This system withstood about 275 MGT of HAL traffic until the hook bolts had to be straightened and the nuts tightened. At the time of the first tightening, there was one broken hook bolt and 22 spun hook bolts out of a total of 56 on the bridge at that time (Figure 2). Due to the relatively thick girder flanges, the fluting of the hook bolts was only minimally engaged in the ties. In many cases, the hook bolts turned loose over time. In the process, they rounded the holes in the deck ties so the fluting could no longer engage the ties. In some cases, the nail worked out of the washer-nut, allowing rotation.

Figure 1: Original Conrail System using a Hook Bolt and a Washer Nut with a Nail through the Washer Nut to Prevent Rotation

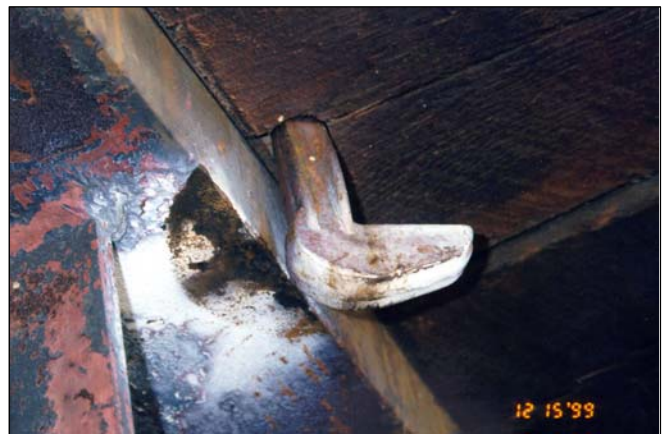
Figure 2: Turned Hook Bolt

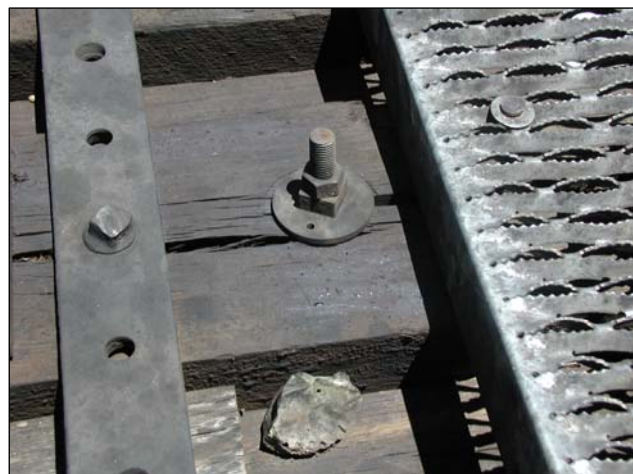
After establishing the performance of the original system in both new and worn ties, a common field retrofit was applied. The hook bolts were again aligned and tightened, with double nuts and a thread locking material (Loctite) applied to keep the nuts from loosening (Figure 3). This system has been in service for more than 460 MGT on a portion of the bridge, requiring no maintenance to date. This system is performing very well. On a portion of the bridge where this system was removed (for other test purposes), considerable effort was required to loosen the hook bolts even after more than 300 MGT of HAL traffic.

Figure 3: Double Nut and Washer Nut with Nail Hole

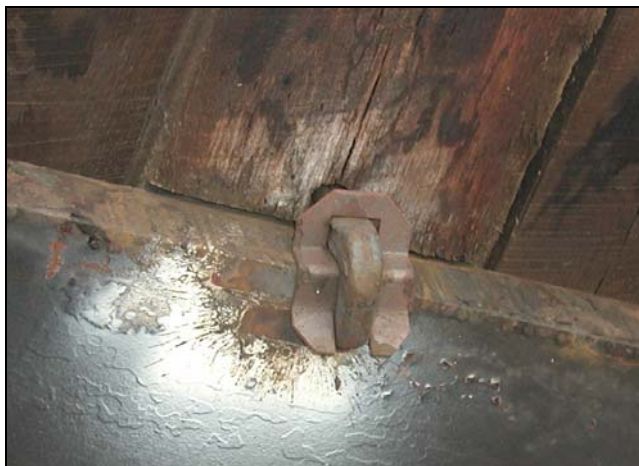
Figure 4: Hook Bolt with Locking Clip

At the same time as the above installation, the second girder was equipped with a similar system of hook bolts with spring lock washers and locking nuts. On the second girder, however, locking clips were used as well (Figure 4). This system has performed satisfactorily, accumulating over 100 MGT of HAL traffic with no maintenance required.

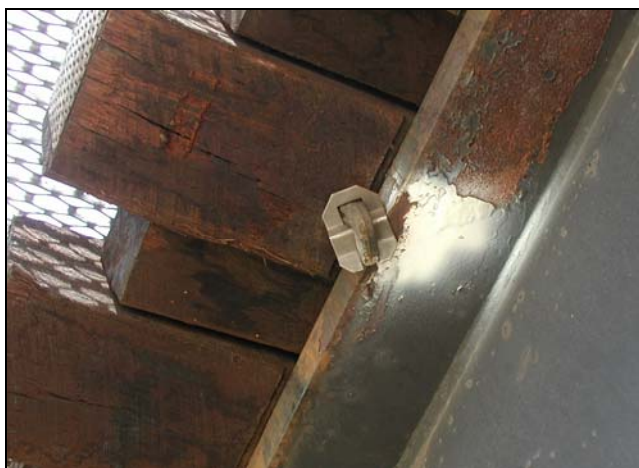
Figure 5: Turned Hook Bolt with Locking Clip

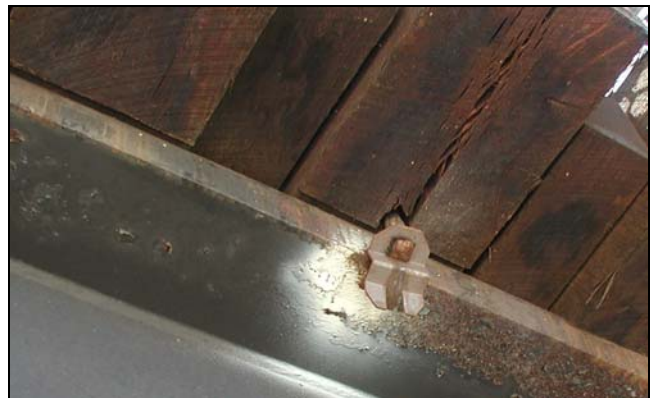
Figure 6: Broken Hook Bolt with Locking Clip

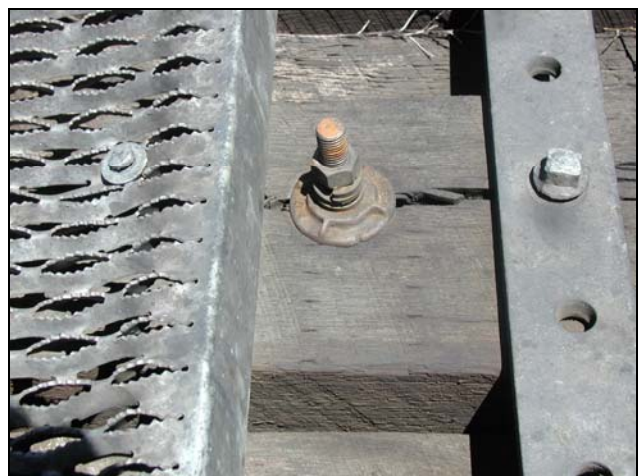
In conjunction with installation of a thick-web rail moveable bridge joint, the deck fasteners on two girders were changed. On one girder, hook bolts with spring lock washers and locking nuts were used (Figure 7). On the worn ties at FAST, this system required maintenance after about 30 MGT of HAL traffic. Failure modes for individual fasteners included turning of the hook bolts, breaking of hook bolts, and breaking of the springs. A concern is that there is no recommendation for the tightening of the spring lock. If too loose, the hook bolt is likely to turn. If too tight, either the spring or the hook bolt is likely to break (Figure 8). Each of these problems was experienced on this particular girder at FAST.

Figure 7: Locking Nut, Spring Lock and Washer

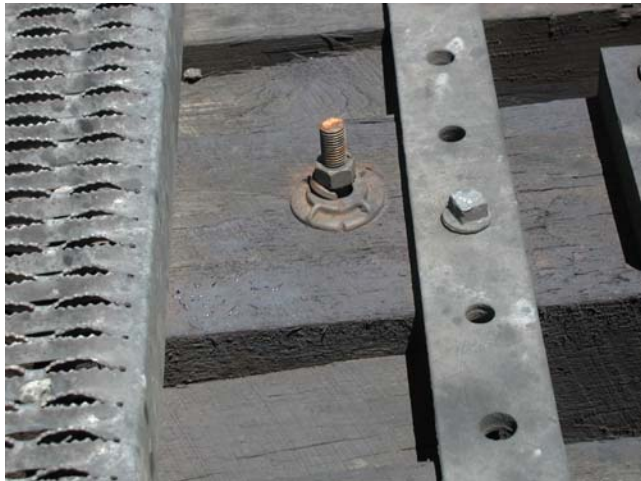
Figure 8: Broken Lock Spring on Hook Bolt

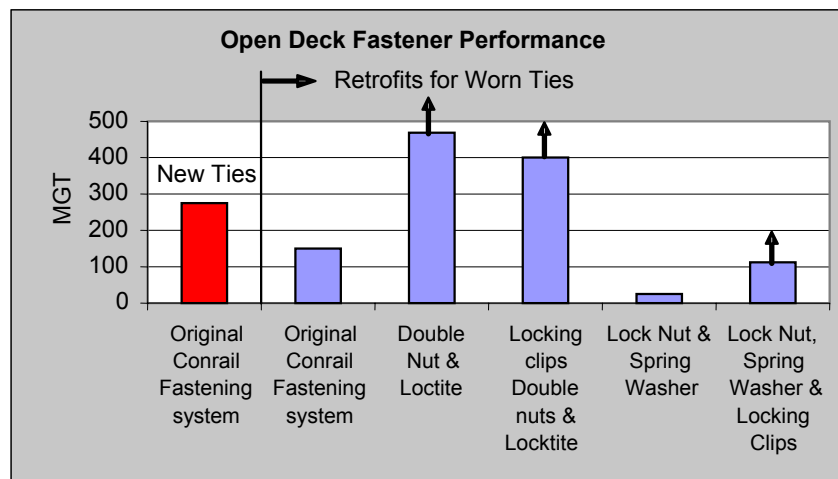
Figure 9 provides a summary of the performance of the various systems thus far.

Figure 9: Comparison of Hook Bolt Fastener Performance
