## Long-Term Performance of Hot-Mix Asphalt over Soft Subgrade at FAST

Joseph LoPresti and Dingqing Li

### Summary

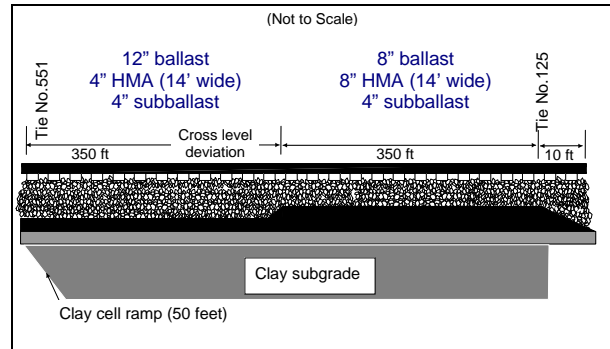
Following installation, there was some settlement of the track as measured by taking top-of-rail elevations. The initial settlement rate was higher, with about one inch in the first 10 MGT. After that, settlement was gradual and uniform through 342 MGT, when a slight cross level deviation was noted in the 4-inch HMA segment. No maintenance was needed at that time. Figure 1 shows the general test section layout and location of the geometry deviation.

**Figure 1. HMA Test Segments and Location of Geometry Problem**

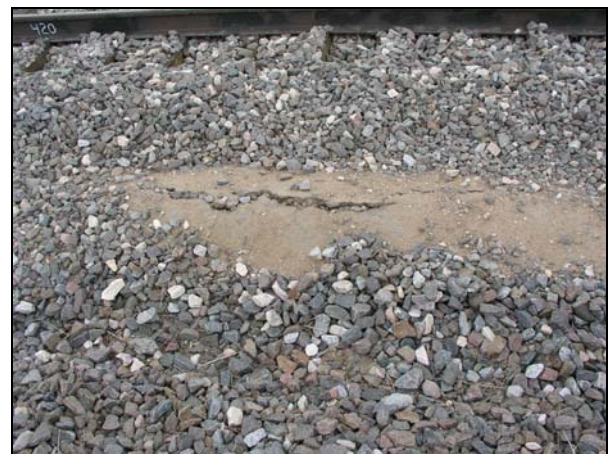
Little change in geometry was noted in an additional 17 MGT; however, the left rail then began to settle more rapidly. The first surfacing was needed in February 2005 with 371 MGT on the HMA track when cross level exceeded 1.75 inches. Sixty five feet of track were surfaced. Similar maintenance was needed seven more times in the next 35 MGT. The interval between the first and second tamping was 16 MGT. Between the seventh and eighth, it was 2 MGT. As the rate of degradation increased, it became evident that the asphalt had been damaged. Figure 2 shows early evidence of the asphalt pushed up and outward from the ends of the ties.

**Figure 2. Early Indication of Asphalt Damage**

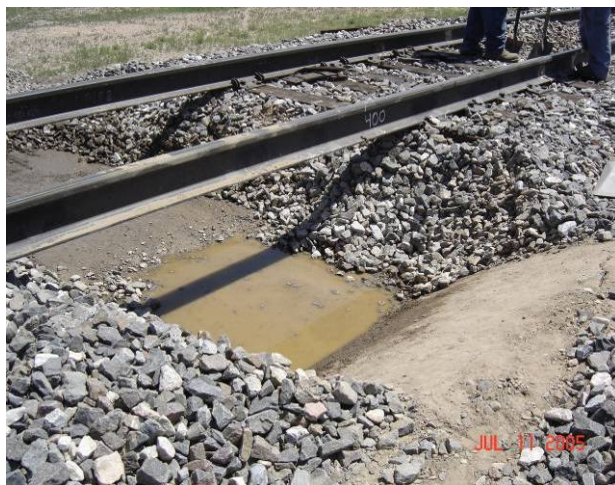
- Approximately 80 feet of asphalt cracked longitudinally near the inside rail, and was pushed upward and outward. The asphalt that had been pushed up was about two feet higher than the asphalt that had not.

- There was water under and along the asphalt that failed. This was at a low spot in the track, and where geometry problems had occurred earlier in the LTM test. This low spot has historically collected water from rain and snow fall in the surrounding area.

- The permeable subballast provided an entry path for the water to get under the asphalt.
- The water contributed to the start of the failure by weakening the subballast and clay and accelerated the degradation following failure initiation.

- The underlying cause of the asphalt failure was progressive shear failure of the clay. The clay also pushed upward and outward. This is consistent with previous subgrade failures in the LTM section.

Figure 3 shows the HMA where the cross level deviation was the greatest. For comparison, Figure 4 shows undamaged asphalt approximately 210 feet away.

**Figure 3. Asphalt Damage and Standing Water**

The damaged and displaced asphalt and the subballast were removed. Ten to 12 inches of asphalt was then placed directly on the clay. The placement of the asphalt directly on the clay differed from the original installation and was thoroughly discussed at TTC. The primary reason for placing the asphalt on the clay was to better seal surface water from the clay and remaining subballast by removing the permeable entry path. A subballast layer may be preferable in other situations. The clay may be too soft to support paving operations, and the subballast can

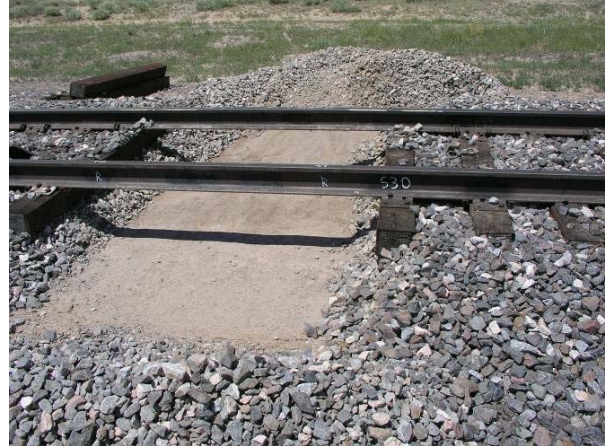
**Figure 4. Undamaged Asphalt 210 Feet from the Damaged Asphalt shown in Figure 3**

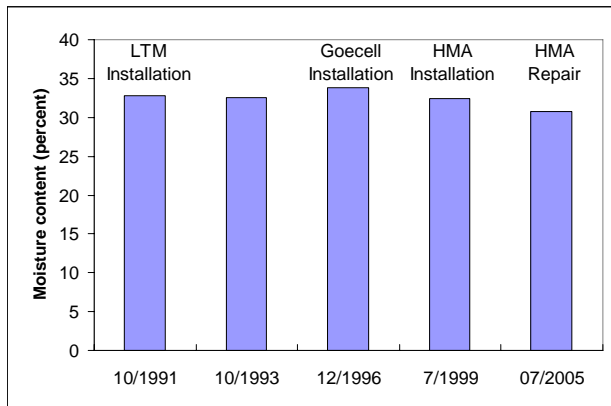
Clay samples were taken for moisture content at two locations along the track as well as at the left, center, and right across the clay trench at each of those locations. Samples were taken from 1, 2, and 3 feet below the top of the clay. Average moisture content for the 18 measurements was 31 percent, slightly lower than the 33 percent at the time of installation. Figure 5 shows average moisture content since installation. There were variations among the recent samples with the averages from a site 210 feet from the failure being drier than from the failure site (27 versus 34 percent), and the averages from 1 foot drier than those from three feet (28 versus 34 percent).

Figure 5. Moisture Content of Clay

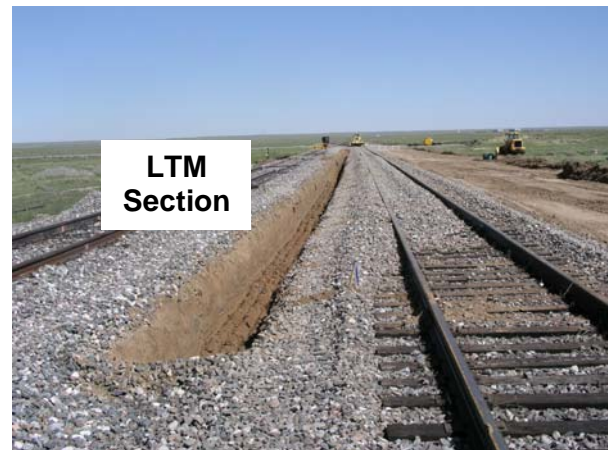
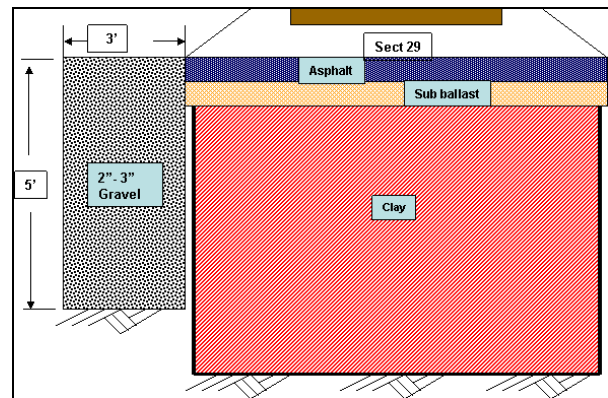
Figure 6. Drainage Trench along the LTM Section

Figure 7. Drainage Trench Illustration along the LTM Section

Drainage in the area was improved with the installation of a trench to intercept and divert surface water from the clay (Figure 6 and 7). The trench was filled with coarse gravel. The need for improved drainage indicates that, while asphalt can divert water from problem subgrades, other aspects of proper drainage need to be considered. The repair effectively strengthened the damaged track and no surfacing has been required in 14 MGT.
