Evaluation of a Thick-Web Miter Rail Joint and Signal System Interface under HAL Traffic

Summary

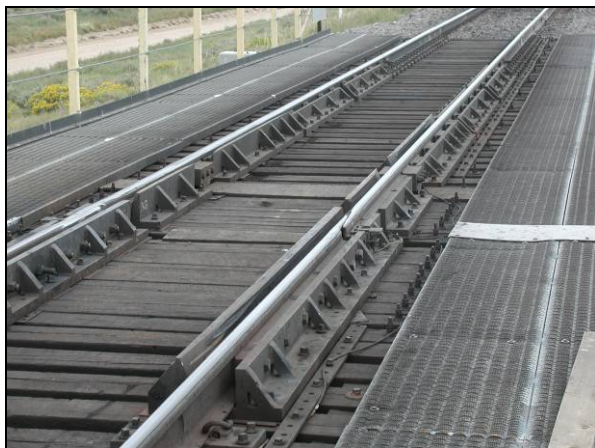
Figure 1: Amtrak Long-Point, Thick-Web Bridge Joints Installed on the Steel Bridge at FAST

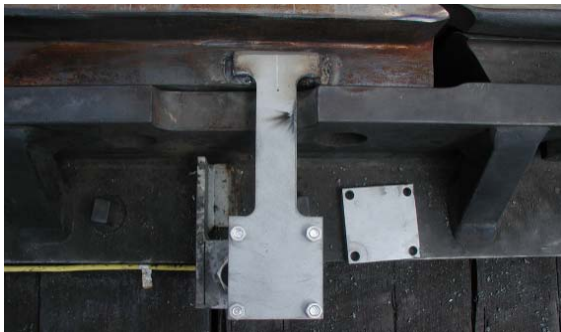
Proximity sensors and their targets were installed on the points and were monitored for their performance. The initial targets were steel and were donated by Amtrak. They were welded onto the points, following Amtrak’s standard installation procedure. The initial design failed in one day due to inadequate allowance for temperature-induced movement. Two sets of modified targets were installed but each failed within 5 MGT of traffic. These are shown in Figures 2 and 3. Failure mode each time was fatigue leading to fracture. The welds on the target brackets did not fail. The length and weight of the brackets combined with the severe vertical force environment contributed to the fractures, which occurred about an inch away from the welds and the points.

Figure 2: Steel Target and Proximity Sensor, Welded to Miter Joint

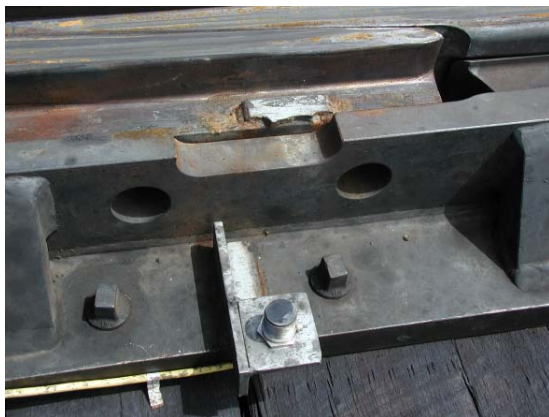
Figure 3: Broken Steel Target and Proximity Sensor, Welded to Miter Joint

After the rapid failures of the steel targets, TTCI staff designed and fabricated Delrin plastic targets with a thin sheet metal plate held in place with four screws. These targets were bolted to the points. The mounting for the proximity sensor was also changed to allow a shorter target arm, which was also bolted rather than welded. The proximity switch brackets were moved from the bottom plate to the vertical wall of the fixed end guide plate and bolted instead of welded. Compared to the steel targets, the Delrin plastic targets (shown in Figure 4) were shorter and much lighter in weight. These targets were still performing well until the removal of the bridge joints. The targets accumulated about 41 MGT with no failures.

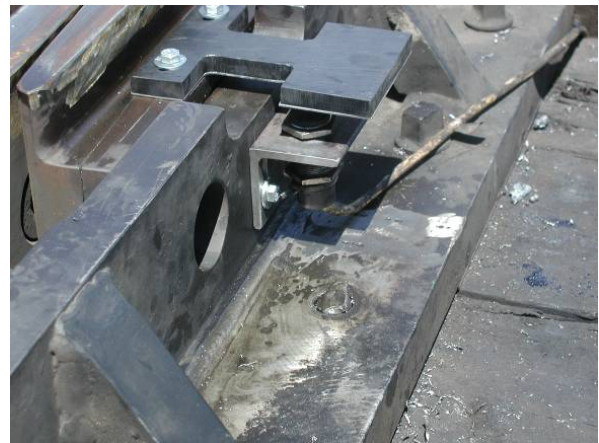
Figure 4: New Delrin Plastic Target and Proximity Switch Bracket Bolted Instead of Welded

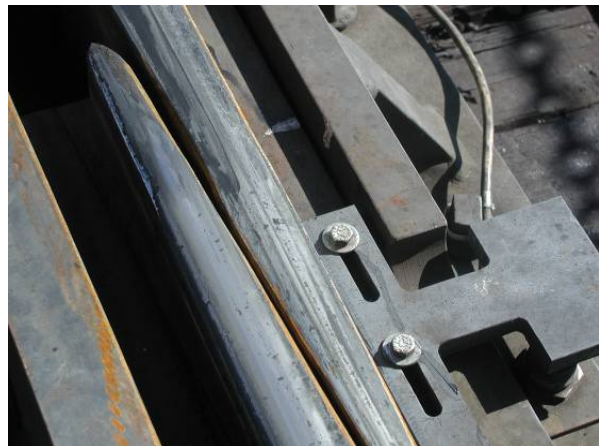
Once the target bracket problem was solved, a second problem was found. Rail longitudinal movement, due to the expansion and contraction of the points and train traffic, pulled the target completely off of the proximity sensor. Lengthening the base of the plastic Delrin target and slotting it to slide back to the proximity switch solved this problem. By using slots, as shown in Figure 5, adjustments can be made quickly if necessary due to a change of season or rail changes nearby.

Figure 5: Slotted Target with Adjustment for Rail Longitudinal Movement

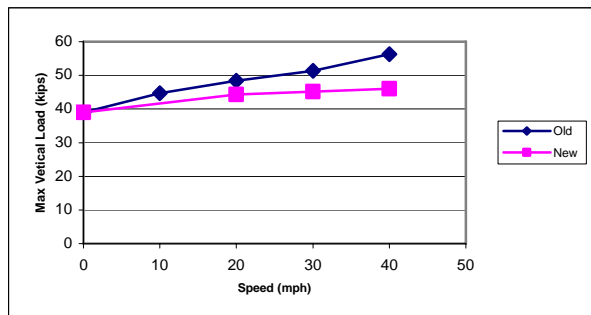
When new, the Amtrak joints had lower vertical dynamic loads than typical mechanical rail joints. Figure 6 shows dynamic vertical wheel loads from instrumented wheel set (IWS) data for the Amtrak joints. This data was taken when the bridge joints were fairly new and again when the joints were approaching the end of its service life at FAST. The Amtrak joints had average maximum vertical dynamic loads, approximately 1.1 times the static wheel load when new. In comparison, the data from the worn bridge joints had increased to 1.44 times the static wheel load at 40 mph. Even in the worn state, the Amtrak joints had lower vertical loads than the previous bridge joints tested, as well as other special trackwork components. The previously tested joints had dynamic vertical wheel loads averaging about 1.5 times the static wheel load.

Figure 6: Average Maximum Vertical Dynamic Wheel Loads

During the life of the joints, the maximum dynamic vertical wheel loads increased from 1.1 times to 1.44 times static wheel load at 40 mph. The maximum lateral wheel forces increased from 7.3 kips to 12.7 kips or 1.7 times more.

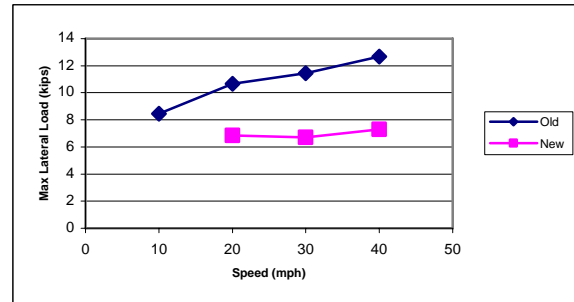
The Amtrak joints had slightly higher lateral dynamic loads of about 1 to 2 kips more than a typical mechanical joints. Figure 7 shows average maximum lateral dynamic loads for Amtrak bridge joints in the new and worn state.

The lateral loads did not seem to increase with speed but stayed steady at about 7 kips in the new state. In the worn state at 40 mph the loads increased to 1.7 times more than the new state.

Figure 7: Average Maximum Lateral Dynamic Wheel Loads
