Preliminary Placement Guidelines Top of Rail Friction Control Application Systems

Richard Reiff (TTCI) and David Lilley (CN)

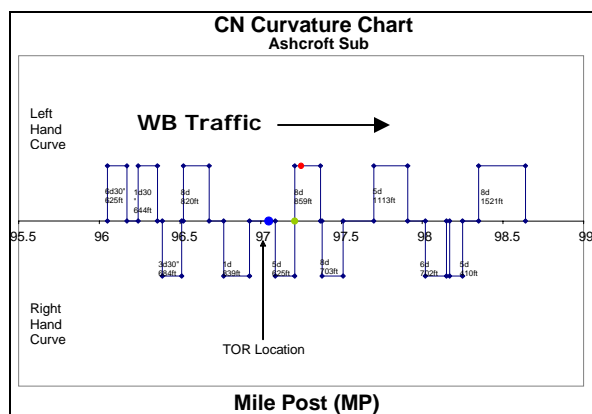
Figure 1. Location of TOR System on Ashcroft Subdivision Showing Initial, then Relocated Site

Spalling was observed and attributed to hydro-pressurization of KELTRACK® Trackside Freight FM in liquid form. The single Portec Protector IV unit was moved to a location on tangent track, 250 feet upstream of a 5 degree curve. A gage face lubricator is located at Mile Post (MP) 93, 4 miles east of the TOR installation site. Figure 1 provides the test site schematic.

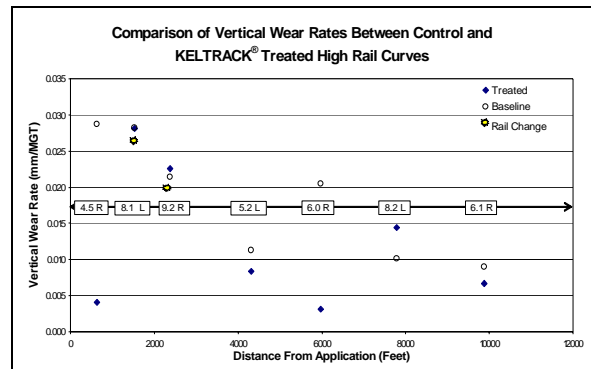
Figure 2. High Rail Vertical Wear Rates for Curves within 10,000 feet Downstream of TOR Applicator

The rail wear analysis utilized 26 different curves. Baseline (non-TOR treated) curve wear was compared to comparable curves treated with TOR FM material. High rail vertical wear rates are summarized in Figure 2. Examination of results shows that at most locations the wear rate of the TOR treated curves were less than that of non-treated curves; however, the data scatter is high.

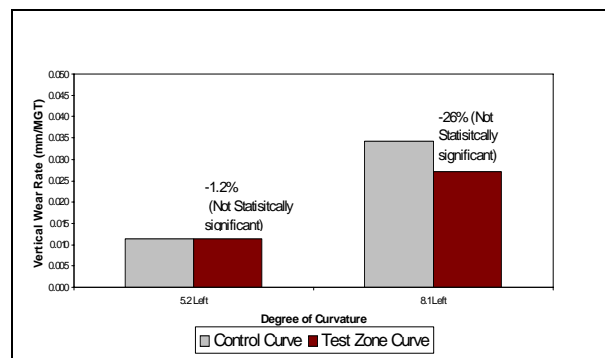
Figure 3. Control Zone and TOR Zone Curve Wear Rates Prior to TOR Activation

Referencing Figure 2, specific results for a pair of 5-degree and a pair of 8-degree curves were selected for comparison based on similar curvature and rail wear rate during no FM application, shown in Figures 3 and 4. Figure 3 illustrates the similarity inherent in each set of curves, indicating a valid comparability. For each set, one curve was then treated with FM and re-compared (Figure 4).

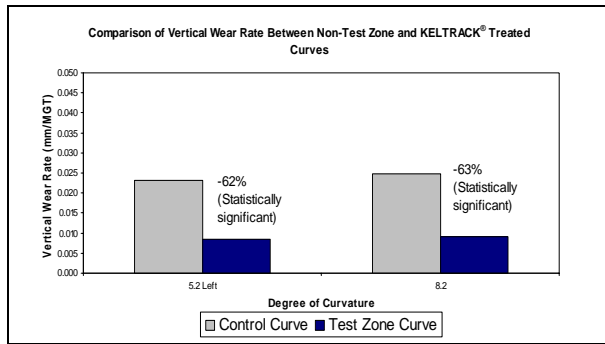
Figure 4. Control Zone and TOR Zone Curve Wear Rate after TOR Activation

The curves treated with FM demonstrated lower rail wear rates by 62 to 63 percent, where the reduction passed as statistically significant.

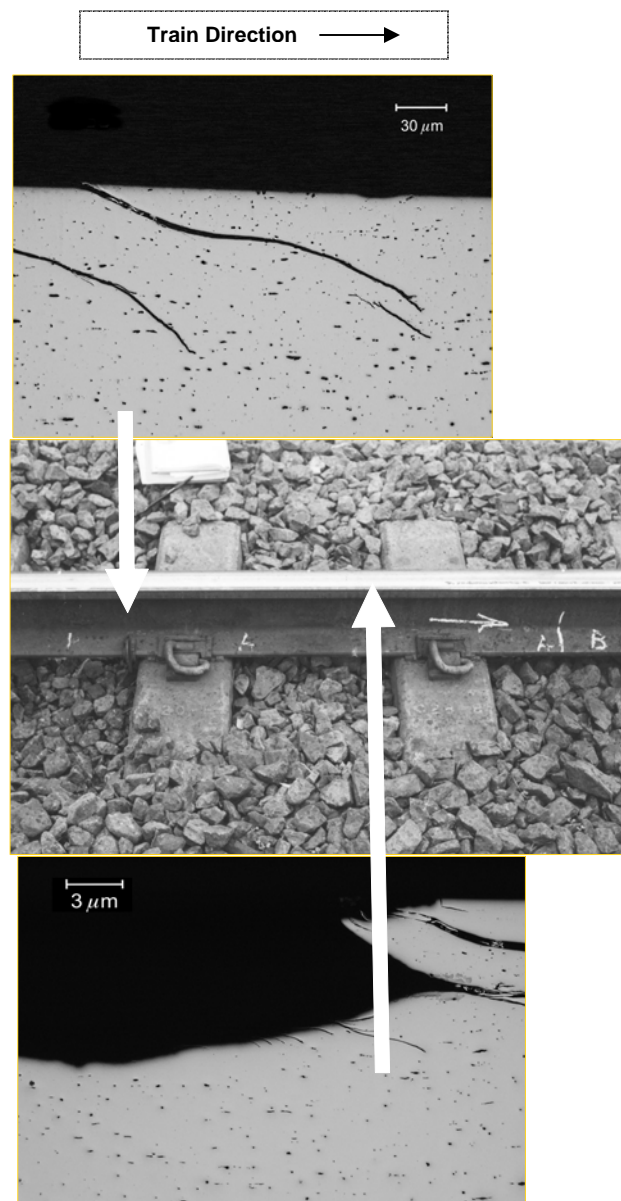
Figure 5. TOR Running Surface Showing Spalling Starting at Center (middle photo). Cross-Section of Rail before Spalled Site (top detail), in the Spalled Area (bottom detail)

Between July 17, 2002 and August 2, 2002, the TOR applicator was originally located in the entrance spiral of the 8-degree curve just west of a bridge. The initial installation site location was selected, in part, to be near commercial power to avoid the use of solar power. Within 19 days of TOR applicator commissioning, spalling developed at the applicator bars and was noted for 40 feet downstream of the TOR system on the low rail and about 19 feet on the high rail.

Severe spalling occurred primarily on the low rail near the gage corner with minor spalling on the high rail near the gage corner. Through discussions with Dr. Joe Kalousek of the National Research Council of Canada Centre for Surface Transportation, it was suggested that the FM material, which is water based, remained in a liquid phase for up to 50 feet downstream of the TOR system. This created a situation where FM material (still in its liquid phase) could seep into existing cracks in the rail head, which is characteristic of curves in this area, allowing hydraulic dynamics to propagate crack growth, resulting in top of rail spalls. No spalling was found beyond 40 feet, which suggests that the FM material in a dry phase does not cause spalling.

Subsequent investigation of other curves in the area indicated that rail surface cracks (virtually invisible to the eye) were likely present on the top running surface of the rail prior to installation of the TOR system. A section of rail at the applicator site was removed for examination in the laboratory. The evaluation verified that cracks existed ahead of, at the location of the TOR applicator bars, and downstream from the applicator site.

Figure 5 shows details of the rail and cross section analyses. These samples are representative of the rail just ahead of the spalling and at the spalling site. The evaluation agrees with the theory that a water-based FM entered the cracks and acted as a hydraulic ram, accelerating the development of spalls.

This situation was addressed by relocating the TOR system approximately 1,200 feet eastward, on tangent track, west of the 5-degree right hand curve. Dye penetrant inspection of the tangent section at the new location confirmed that the rail, at and near the relocated applicator site, did not contain surface cracks. After more than 1 year of operation, no spalling was noted at or near the relocated applicator. This also includes nearby curves that contained pre-existing rail surface cracking similar in nature to the original site.

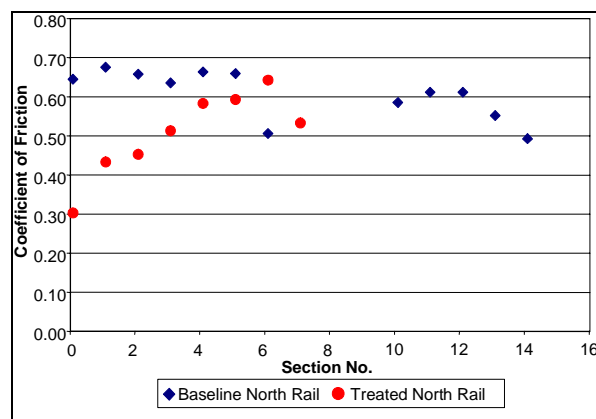
Figure 6. Friction Measurements for North Rail

Tribometer readings were taken up to 1,600 feet west of the unit encompassing the 5-degree and the following 8-degree curves. The top of the north rail friction measurements (Figure 6, red series) during the FM treated phase indicated a reduction in friction from 0.6 μ dry to about 0.3 μ at the applicator site and a return to dry COF about 600 feet from the applicator. The south rail did not exhibit this change in friction.
