Investigation of Open Deck Bridge Transition Issues at the Eastern Mega Site

Dingqing Li, Charity Duran, and Russell McDaniel

Summary

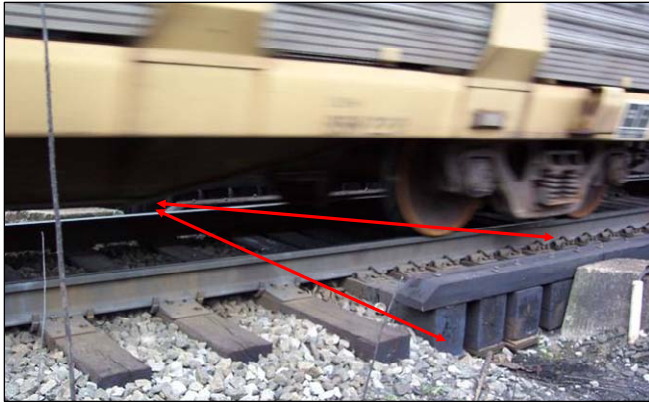
One of the major factors contributing to the bridge transition issues at the eastern mega site are skewed bridge back walls. Skewed back walls are used because these bridges cross rivers or roads not perpendicular to the railroad tracks. In general, a skewed back wall requires that approximately five ties at the transition area span both the bridge structure and the approach track.

This creates a differential support between left and right rails, i.e., the side supported on the abutment is much stiffer than the side supported on the ballast. Exemplifying this problem are the ties on the weaker side that are often supported directly on the ground without ballast, as Figure 1 shows. Shimming is often required to compensate for the track settlement on the weaker side.

Figure 1. Ties Shimmed and Supported without Ballast, due to Skewed Abutment

- Change of open deck to ballast deck should help address the lateral track stiffness issue, and to a secondary degree should help address the vertical track stiffness issue. Consistent ballast support, tie type, tie spacing, and fastening between bridge and approach will make track conditions more consistent in the transition.
- Approach slab, or HMA (hot mixed asphalt), should help address differential track support between the two rails as well as vertical track stiffness issue.

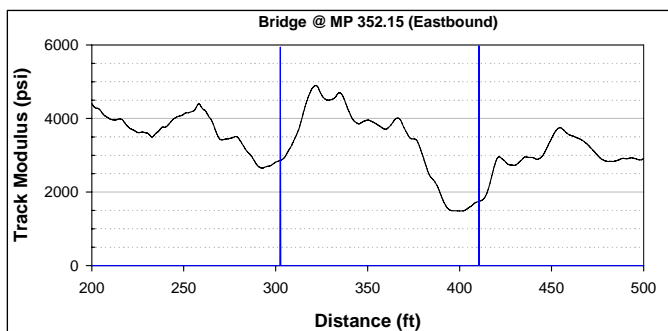
Figure 2 shows an example of track modulus test results obtained using TTCI's Track Loading Vehicle (TLV). It shows significant modulus variation between the approaches and the bridge. That is, track modulus results measured on the bridges were higher than those measured on the approach tracks. For this bridge at MP 352.15, the change is even more pronounced for the east approach. As found from past research (TD 03-013 and TD 05-001), large changes of track moduli in track transition areas can contribute to the problems in these areas. Furthermore, this approach track has track moduli measured lower than 2,000 psi, indicating weak track support.

Figure 2. Track Modulus Test Result at MP 352.15

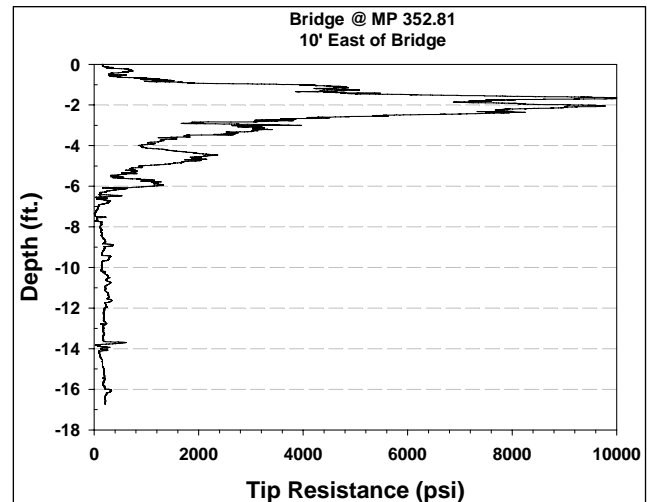
Figure 3 shows an example of CPT test results, which indicate layer thicknesses and subgrade soil strength. As

shown, the ballast layer thickness (as indicated by large tip resistance) is large (6 feet), obviously as a result of past ballast surfacing and tamping operations. For this bridge, the subgrade at the east approach is weak, as indicated by very low tip resistance (i.e., low soil strength), obviously having contributed to the surface problems requiring frequent tamping in this approach track.

Figure 3. CPT Test Result 10 Feet East of Bridge at MP 352.81

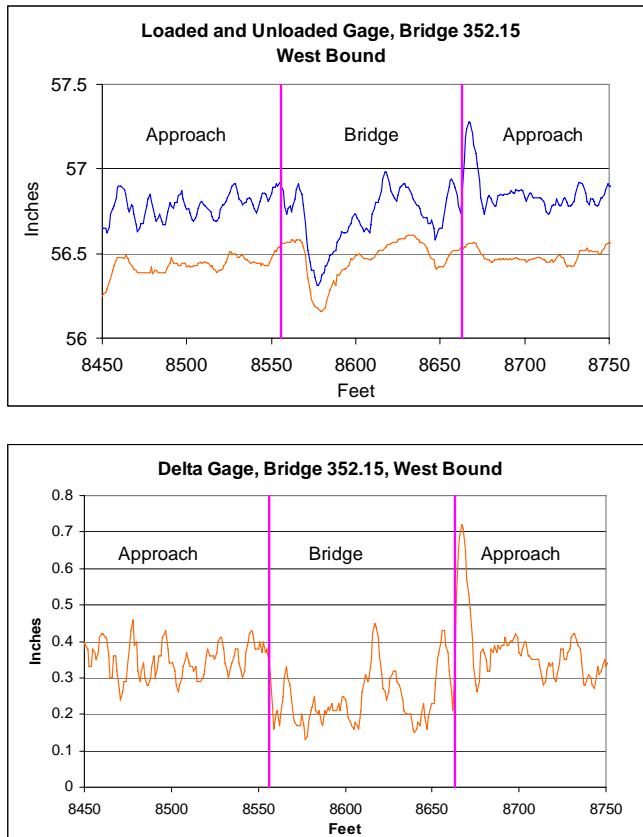
Figure 4 shows the GRMS test results for the location at MP 352.15. As illustrated, the test results showed a large variation between the bridge and the approaches, with a lot stiffer track on the bridge (in terms of delta gage, i.e., lower delta gage and higher lateral stiffness) than the approach tracks.

What this means is that the track in the approaches can move laterally much more easily than the track on the bridge, leading to a misalignment condition. The track in the approaches could move inches laterally due to temperature change and sharp curvature, while the track on the bridge could move much less because of higher lateral track stiffness on the bridge.

Figure 4. Gage Strength Test Results at MP 352.15
