# Evaluation of Rotational Resistance between Truck and Carbody

Harry Tournay, Ron Lang, and Sam Chapman

*This Technology Digest (TD) supports TD-07-006, which describes inspection and maintenance procedures for poorly performing cars identified by truck performance detectors (TPDs). It details conditions of the truck/carbody interface that might give rise to high truck/carbody rotational resistance — an identified cause of poor curving performance. It also refers to TD-07-007, which details inspection and maintenance procedures for carbody twist. Excessive carbody twist is one reason for high truck/carbody rotational resistance.*

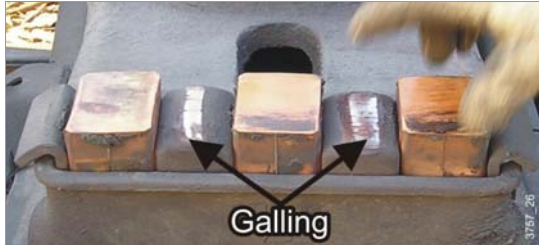
- Galling of side bearing surfaces (Figure 1)

Figure 1. Galling of Side Bearing Surfaces

Galling is evidence of continuous solid contact across the side bearing as a consequence of tight side bearing clearances or incorrect setup heights that may be a consequence of carbody twist<sup>7</sup> or material flow of nonmetallic center plate liners. By their nature, short-travel constant-contact side bearings (CCSBs) are more susceptible to solid contact and hence galling.

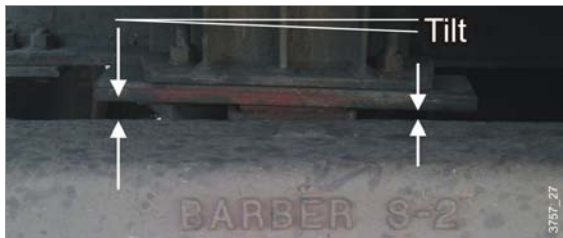
- Tilted body side bearing wear plates (Figure 2) or worn wear plates (Figure 3) in cars fitted with CCSBs. These can cause rotational resistance to be higher in one rotational sense than the other because the side bearings have to lift or drop the carbody as the truck rotates underneath.

Figure 2. Tilted Body Side Bearing Wear Plate

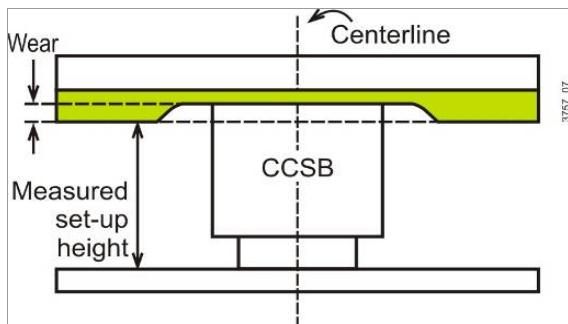
Figure 3. Worn Body Side Bearing Wear Plate

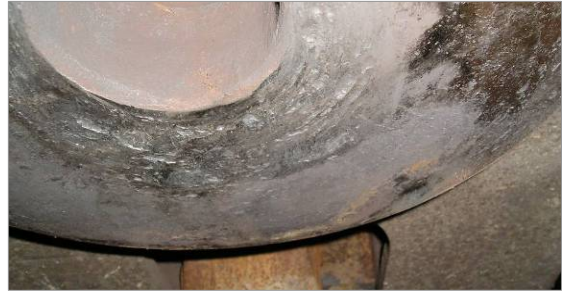
- Heavy galling of the center plate (Figure 4)

Figure 4. Galling of Center Plate

Center plate galling, side wall chatter, line contact on the center plate liner, and extruded polymer center plate liners may all be indications of tight side bearing clearances or incorrect setup heights, poor center plate geometry, or carbody twist.<sup>7</sup>

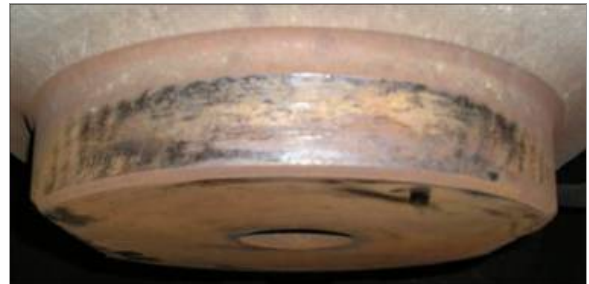
- Chatter on the side wall of the center plate (Figure 5). This is a sign of intermittent eccentric rotation of the center plate in the center bowl, a consequence of relative longitudinal motion and binding of the center plate against the wall of the center bowl.

Figure 5. Chatter on Side Wall of Center Plate

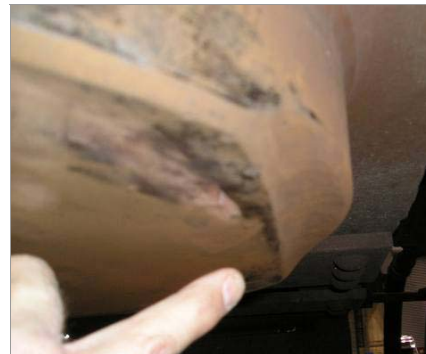
- Line contact between the chamfered edge of the center plate and the center plate liner. This is further evidenced by material flow on the chamfered edge of the center plate (Figure 6), which should have a 3/8-inch radius.<sup>11</sup>

Figure 6. Material Flow on Chamfered Edge of Center Plate

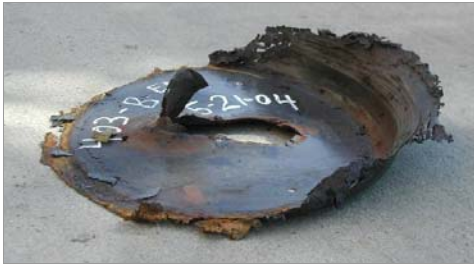
- Material flow or extrusion of polymer center plate liners (Figure 7)

Figure 7. Flow or Extrusion of Polymer Center Plate Liner

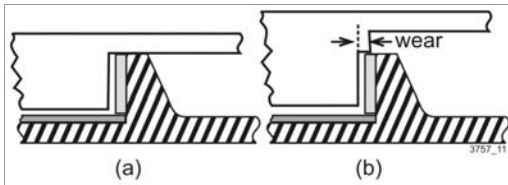
- Vertical contact between the side wall of the center bowl and the center plate.<sup>5</sup> This may occur as a result of incorrect setup (Figure 8a) or excessive center plate side wall or liner wear or deformation (Figure 8b).

Figure 8. Vertical Contact Between Side Wall of Center Bowl and Center Plate

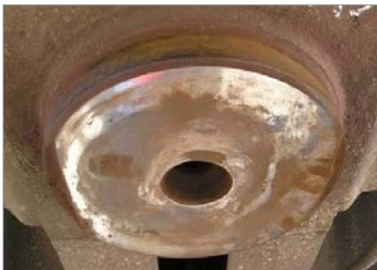
- Concave center plates and bowls. These are evidenced by shiny perimeters of both center plate and bowl (Figure 9) and can be measured using a straight edge.

Figure 9. Concave Center Plate Showing Edge Contact and Rust in Center

A correlation between concave center plates/bowls and higher rotational resistance has not been definitively made. Engineering judgment, however, does suggest that higher rotational resistance might occur as a result of a higher resistive moment arm and eccentric rotation as carbody roll occurs and the center plate load is transferred to the edges of the plate and bowl assembly. Concave surfaces could also result in higher sensitivity of the truck/carbody interface to tolerances in carbody twist.<sup>7</sup>
