Revenue Service Implementation of a Flange Bearing Crossing Diamond at Shelby, Ohio

by David D. Davis, Rafael Jimenez (TTCI), Jim Beyerl and David Clark (CSX)

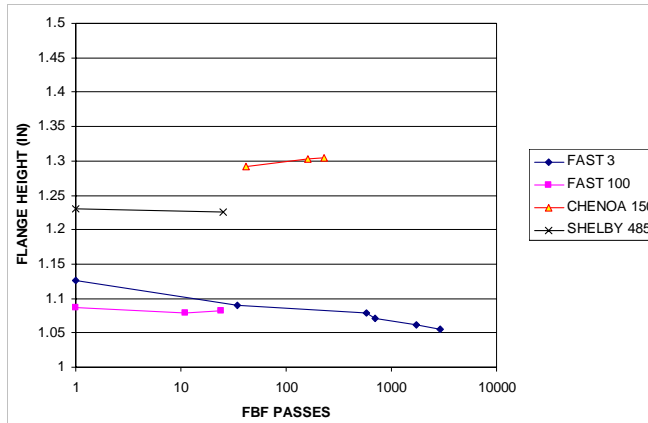
Figure 3. Flange Height vs. Flange Bearing Diamond Passes for Various Operations

Figure 3 shows the measured average flange heights versus FBF diamond passes for the 12 cars in the FBF test fleet. The measurements of the Shelby fleet show that flange heights have decreased slightly in the first 25 passes. This is not unexpected as the initial deformation on the flange tips is relatively large. The average flange height changed from 1.23 to 1.22 inches (statistically the same for each measurement).

For comparison, Figure 3 also shows flange height versus FBF passes for other freight operations. The effect of miles to passes can be seen in this plot. The original tests at FAST, with cars going over a diamond every 3 miles, reduced flange heights over time. The rate of flange deformation exceeded the amount of wheel tread wear. For operations more representative of revenue service, such as the OWLS diamond at Chenoa, Illinois, the flange heights have increased with time.

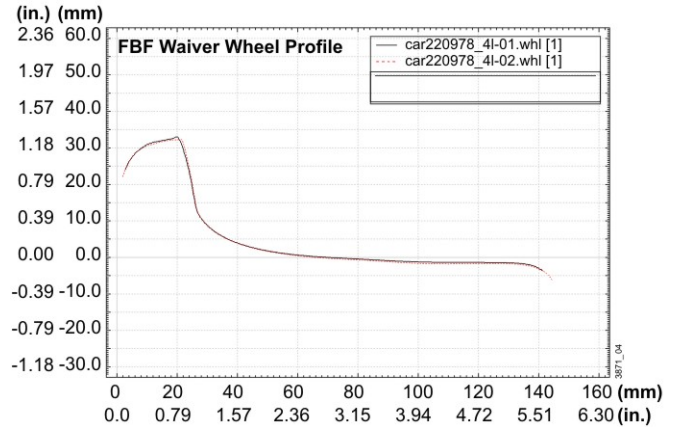
Figure 4. Time Series of Wheel Profiles from Loaded Car Operating Over FBF Diamond

Figure 4 shows a time series of profiles for one wheel being monitored. It is typical of the group. Note that the flange height decreased in this initial interval of flange bearing. From the shape change it is clear that flowed metal on the tip flattened and accounts for much of the height loss. In future intervals, we expect the flange heights to grow, indicating that tread wear is exceeding flange height loss. As was measured at FAST and in OWLS revenue service tests, the flange tip flattens rapidly to become conformal to the diamond running surface.² The gage side corner of the flange tip may also sharpen (i.e. decrease in radius).

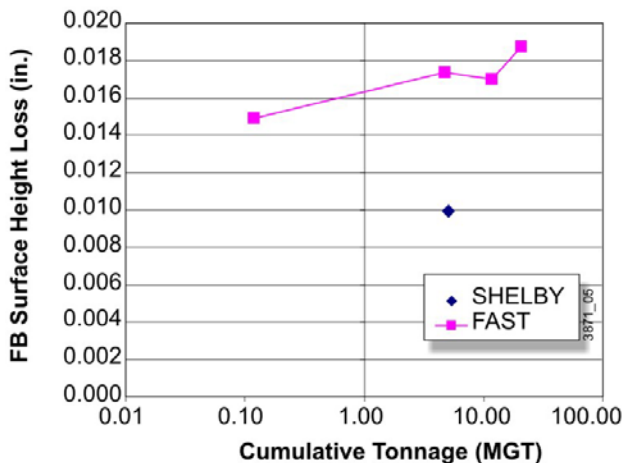
Figure 5. Flange Bearing Running Surface Height Loss vs. Tonnage

Figure 5 shows average flange bearing running surface height loss versus mainline tonnage. For comparison, running surface height loss measured under 315,000 pound, 40 mph traffic at FAST is also shown. The two tests show similar trends, with the higher wheel load test at FAST having higher wear rates. In both tests, the running surface hardness increased from under 400 BHN when installed to about 600 BHN (582 at Shelby and 610 at FAST) after about 20 MGT of traffic.

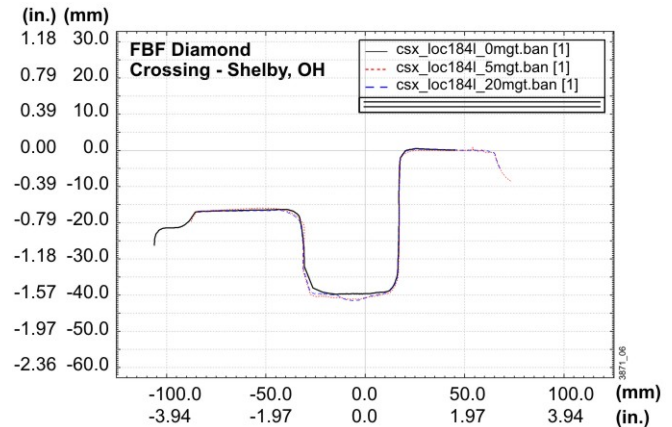
Figure 6. Frog Cross Section Profile Time Series Showing Cross Groove Development

Wear on the flange bearing surfaces of the crossing track have been minimal compared to the CSX track due to lower speeds and tonnage rates. Thus, the cross groove depth is nearly equal to the running surface height loss on the CSX track. Figure 6 shows the cross groove developing in a time series of cross section profiles on the CSX route during 20 MGT of service.

The depth of the groove is relatively unimportant, compared to the width. The width is the length a crossing route flange must “jump.” To provide good ride quality in the crossing track, the cross groove edges must be blended into the rest of the running surface. Measurements at the Shelby diamond will be used to formulate cross groove maintenance policy.
