Thermite Maintenance Weld Performance at FAST

Daniel Gutscher

SUMMARY

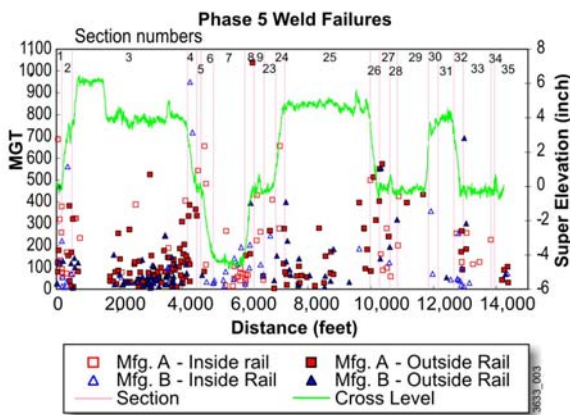
Figure 2. Location and Tonnage of all Field Weld Failures that Occurred during Phase 5

Thermite weld failure data for the HTL was compiled and plotted to investigate trends related to weld type, location, tonnage, and superelevation. Figure 1 shows the layout of the HTL. Figure 2 shows the distribution of failures in the HTL and the accumulated tonnage of all the welds that failed during Phase 5 operations. This data indicated that 66.4 percent of all weld failures occurred in the high rail of curves, while only 4.9 percent of all weld failures occurred in the low rail of curves. The remaining 28.7 percent of all weld failures occurred in spiral or tangent track.

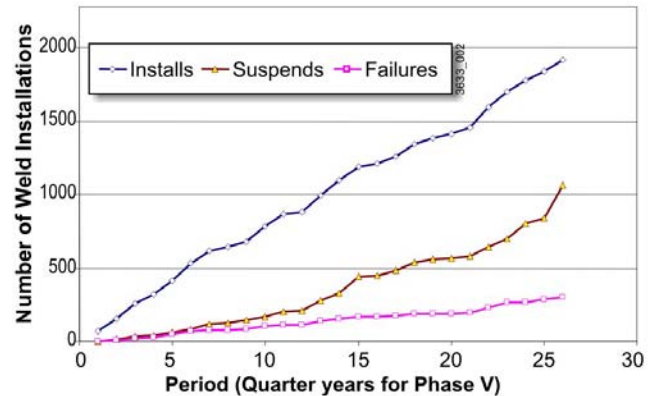
Figure 3. Cumulative Number of Weld Installations, Non-Failure Removal, and Failures for Phase 5 Thermite Field Welds

Since the beginning of Phase 5, over 1,750 welds have been installed. Approximately 1,050 of which have been removed for maintenance and 300 removed due to failure. Figure 3 shows the cumulative number of weld installations, weld failures, and welds that were removed for other causes for each quarter year of operation throughout Phase 5. Both the weld installation and the weld failure rates remained essentially constant throughout Phase 5, whereas the rate of welds removal for reasons other than failure tended to increase.

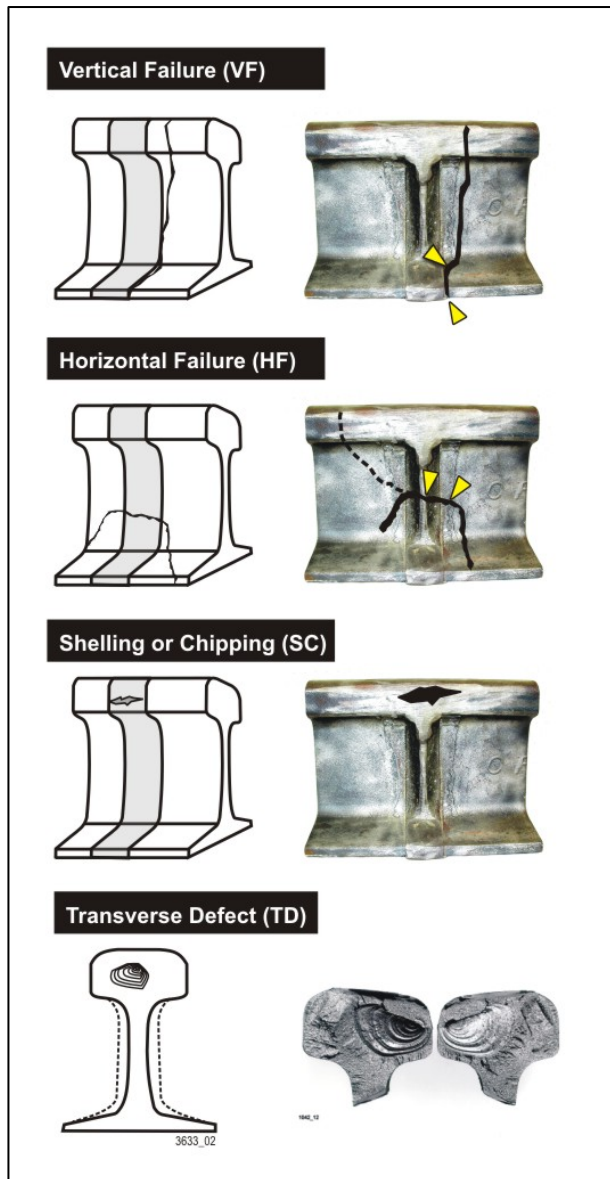
Figure 4. Examples of Thermite Weld Failure Types (yellow markers show typical locations of failure initiation)

Figure 4 illustrates several thermite weld failure types. The distinction between vertical and horizontal failures is discussed in the following paragraphs.

VFs typically originate at or near the fusion line of a thermite weld either along the base or at the flange web radius. The failure then progresses under fatigue (oriented vertical transverse to the weld) until the remaining cross-section is unable to support the load, at which point, the weldment then fractures. VFs often originate at or are associated with stress risers caused by flashing remnants from improper weld mold fit-up or with porosity at or near the weld fusion line.

HF typically initiate at or near the web portion of the weldment and progress horizontally under fatigue through the weldment. The resulting fractures can then turn up, down, or both as they progress into the rail body. HF often start at inclusions, porosity, surface defects, or surface damage such as grinding marks.

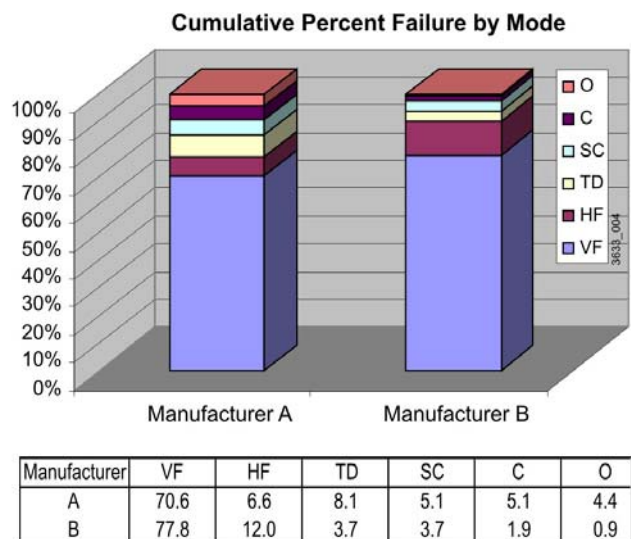
Figure 5. Phase 5 Average Failure Type Percentages for each Manufacturer Welds

The predominant field weld failure type in Phase 5 has been VFs typically originating at the base or flange web radius. Over 70 percent of all field weld failures during Phase 5 were VF. Figure 5 shows the Phase 5 overall thermite weld failure type, percentage breakdown for the two major thermite weld manufacturer welds used at FAST.

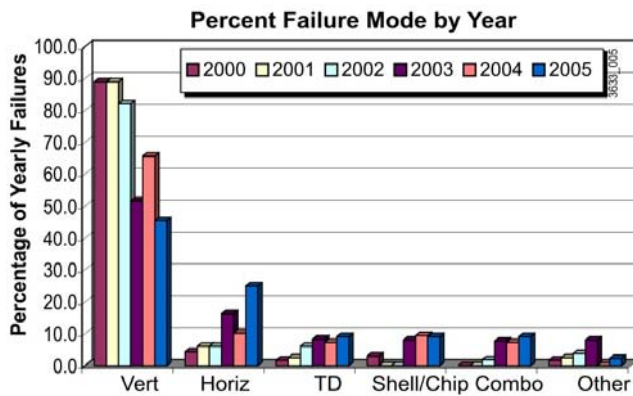
Figure 6. Phase 5 Failure Mode Trends

Close examination of weld failures during Phase 5 operations reveals that the failure type percentages have been changing. Figure 6 shows the weld failure type percentages from 2000 through 2005 at FAST. At the beginning of Phase 5, VFs constituted 88.9 percent of all thermite weld failures. By 2005, this percentage had dropped to 45.5 percent. Simultaneously, the percentages of all the other weld failure types have increased, HF with the largest weld failure increase (approximately 20 percent). This shift away from VF is likely due to a strong emphasis in recent research and testing efforts by TTCI, the University of Illinois at Urbana Champaign, and Orgo-Thermit, Inc.^{3,4,5,6} These efforts focused on issues such as weld procedures as well as the effects of weld profile, flashing, and alignment on weld performance, all of which may contribute to VFs. The greatest contributing factor is likely due to procedural changes implemented at FAST, since both manufacturers' welds showed a similar and simultaneous shift away from VFs.
