Update: New Crosstie and Fastening System Test at FAST

Rafael Jimenez and David Davis

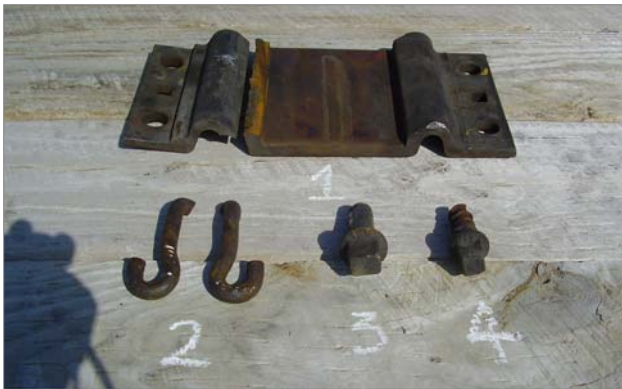
Broken screw spikes and broken tie plates, as shown in Figure 1, were a significant problem in Control Zone 1, where 44 percent of the tie plates had two or more broken LB&N high strength screw spikes and 14 percent of the Pandrol rolled steel tie plates fractured. It appears a failure cycle may have been at work in this zone, where broken screw spikes contributed to the broken tie plates, which in turn led to more broken screw spikes. This type of tie plate, with its diagonally opposed e-clips, has a tendency to skew relative to the tie. The skewing causes point loadings, which continue to result in increased plate fracture rates under heavy axle load (HAL) traffic at FAST. Given that, when two of the four screw spikes break, the screw spike holes in the plate and in the tie become oblong, the plate is freer to skew, it is subjected to point loading, and it ultimately breaks. The remaining screw spikes are then left to react against higher, per screw spike loads that are introduced by lateral translation of the plates.

LB&N submitted the result of a test conducted by an independent laboratory to TTCI on a single broken screw spike sample. The lab's report suggested problems related to rolling laps from the threading process and decarburization. LB&N indicated these issues are continually addressed and improved in their manufacturing process.

Figure 1. Component Failure under HAL Traffic
(1) Pandrol 16-in. rolled steel tie plate (2) NorFast rail clip (3) LB&N High Strength Screw Spike (4) No. 5760 Screw Spike

None of the Pandrol rolled steel tie plates in Control Zone 2 has fractured. By comparison 14 percent of the same type of tie plates used in Control Zone 1 fractured during the same period. This may have been due to the high number of broken screw spikes in Control Zone 1. None of the cast steel tie plates has fractured in the NorFast Zone.

TTCI's current maintenance procedure is to cut spike those tie plates where two or more screw spikes have fractured inside the tie. This is done as a preliminary remedial action. After a number of plates have been cut spiked due to broken screw spikes, those plates are replaced with ones of a different screw spike pattern. To avoid the track component failure cycle, the tie plate cutting, and the track gage degradation that was seen under HAL traffic in Control Zone 1, it is likely best to eliminate the preliminary remedial action step (cut spiking the plates) and to proceed directly to replacing the plates using four new screw spikes.

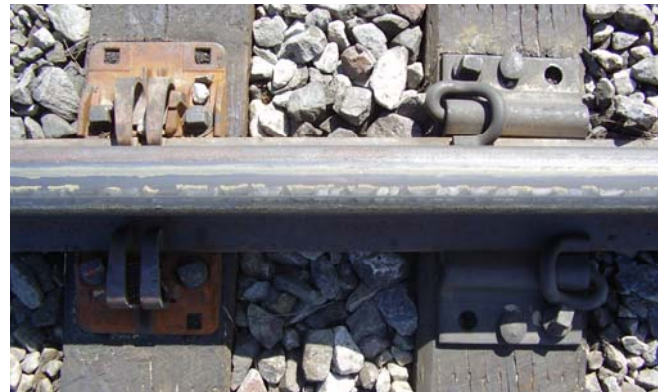
The right tie in Figure 2 shows a tie plate that was cut spiked after two screw spikes broke off inside the tie. The left tie is providing higher track strength. The tie was refitted with

a plate of different screw spike pattern where all four screw spikes can be used again.

Figure 2. Right Tie: Cut Spiked after Two Screw Spikes Broke Off Inside the Tie. Left Tie: Providing Higher Track Strength with All Four Screw Spikes in New Holes

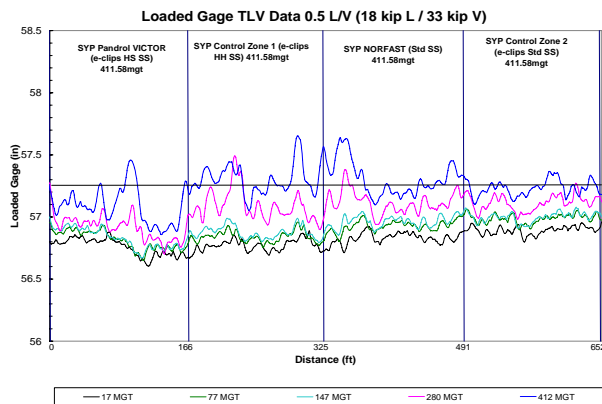
Figure 3. Loaded Gage Measured in the Fastening System Test Zones under the 0.55 L/V TLV Gage Spreading Load at 12 mph

The initial average loaded gage measured in Control Zone 1 and in the NorFast test zone, after 17 MGT, was 56.77 inches and 56.83 inches, respectively. After 412 MGT of HAL traffic, however, the track gage exceeded 57 1/4 inches in more than 50 percent of each of these test zones under the dynamic gage spreading load of the TLV. This gage widening was likely a result of the high number of broken screw spikes in Control Zone 1 and the high number of screw spike uplift in the NorFast test zone.

Less than 10 percent of the Pandrol Victor test zone widened more than 57 1/4 inches compared to almost 20 percent of Control Zone 2. The portion of the Pandrol Victor test zone that exceeded 57 1/4 inches, however, widened more (about 57 1/2 inches) than the widest portion of the control zone. This may have been due to the higher number of tie plates with more than two broken screw spikes in the Victor Zone (11%) as compared to Control Zone 2 (1%).

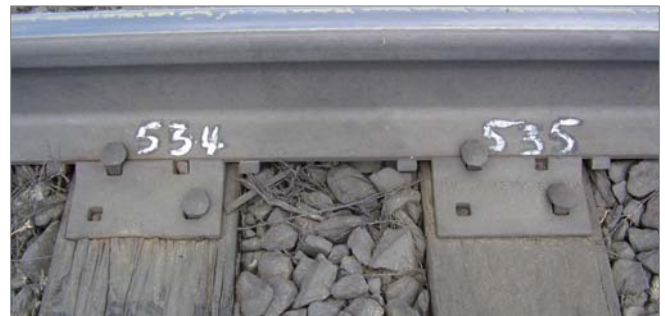
Two types of solvents were used in the copper naphthenate treatment of the parallel strand lumber species ties and the solid southern yellow pine ties. The two solvents are designated CPT-2 (No. 2 oil) and BWR-5 (No. 5 oil). Although some tie plate cutting is evident in all of these alternative treatment test zones, the ties treated with the BWR-5 solvent appear to have a thicker and perhaps more durable protective surface layer than the ties treated with the CPT-2 solvent. The BWR-5 ties also appear to be experiencing less tie plate cutting, as Figure 4 shows.

Figure 4. Two Southern Yellow Pine Parallel Strand Lumber Ties Treated with Copper Naphthenate. Tie No. 534 Treated with CPT-2 Solvent. Tie No. 535 Treated with BWR-5 Solvent Appears to have a Thicker Protective Layer and Experiencing Less Tie Plate Cutting
