## Dynamic Load and Track Response: Bridge Approach Test at the Western Mega Site

Dingqing Li, Abe Meddah, Bill GeMeiner,\* and Steve Mattson\*\*

### Summary

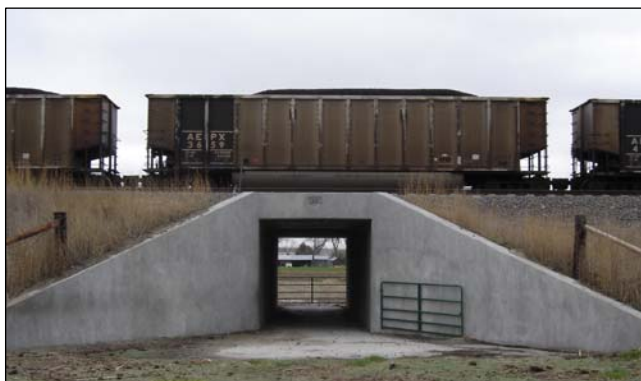
Figure 1. Bridge Approach Test Site

One of the bridges and its approach track was instrumented in September 2005. The bridge is a 10-foot short span on tangent track. Prior to instrumentation, existing concrete ties with cracks were replaced with new ties and dirty ballast was undercut and replaced. Figure 1 shows the test site.

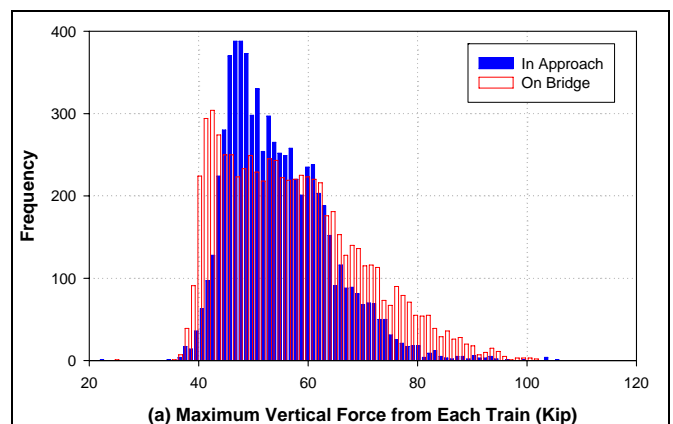
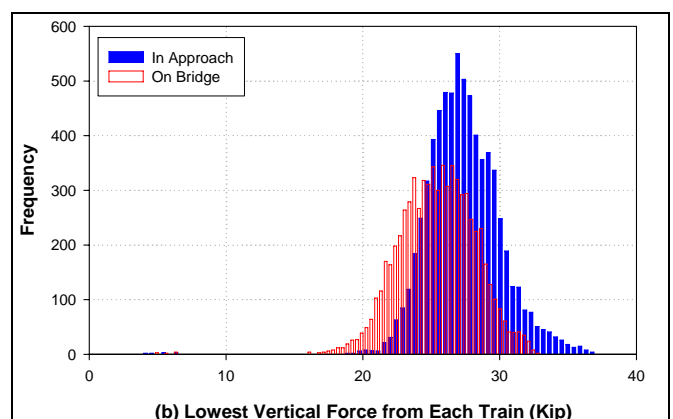
Figures 2a and 2b. Maximum and Minimum Wheel Loads Generated on the Approach and Bridge

Wheel loads were recorded under each passing train for both the track on the bridge and the track in the approach. Figures 2a and 2b show the load environment results recorded. These two plots provide a summary of dynamic vertical wheel loads from about 8,000 trains that have passed through the test site. Figure 2a illustrates that a large number of high-impact wheel loads, at least twice as high in magnitude as the static wheel loads of 36,000 pounds, were measured on one approach track as well as on the bridge. Furthermore, the number of high-impact wheel loads measured on the bridge was greater than that in the approach, because the track on the bridge is a lot stiffer and has less damping than the track in the approaches.

Figure 2b shows the minimum wheel loads recorded from each train. Again, the track on the bridge recorded lower minimum wheel loads than the track in the approach, also indicating greater dynamic vehicle/track interaction on the bridge. Nevertheless, as Figures 2a and 2b show, the load environment for both the approach track and the track on the bridge is severe for the as-is track condition. This load environment data will also be used as the baseline results for comparison with those to be measured under Phase 2 conditions.

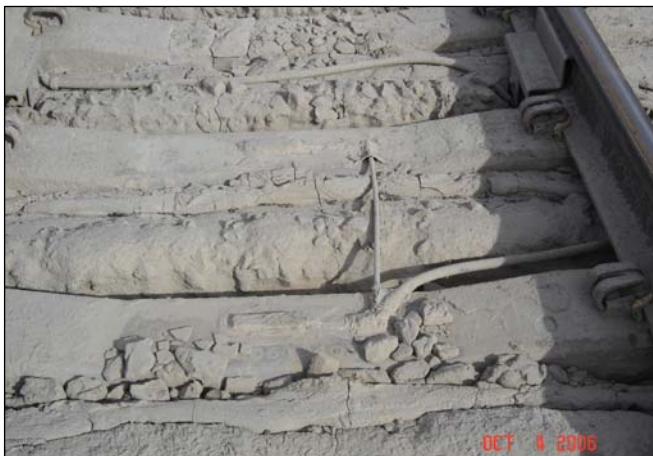
As a result of the large number of impact wheel loads, 1 year after the start of this experiment, the concrete ties on the bridge started to crack and mud pumping from ballast breakdown under impact wheel loads appeared in the approaches as well as on the bridge. Figure 3 shows mud pumping holes present in one of the approaches.

Figure 3. Mud Pumping Holes in the Approach

At mud pumping holes, the track becomes weak when saturated with water, and large cyclic deflections often occur under HAL train operations. When dry, the track becomes stiff (particularly concrete tie track), generating larger impact wheel forces due to rough track geometry. Either condition leads to poor track performance. In March 2007, as a result of the impact wheel loads and poor track condition, one rail broke in an approach track at a mud pumping hole. Figure 4 shows the broken rail that occurred at this test site.

be replaced with ties with rubber pads preinstalled on the bottom surface. In addition, the ties in the approaches will be replaced with regular concrete ties. Drainage will be improved to prevent mud hole development. The same measurements will be repeated to quantify if the load environment changes and how track performance may improve as a result of improved track resilience, damping, and track geometry.

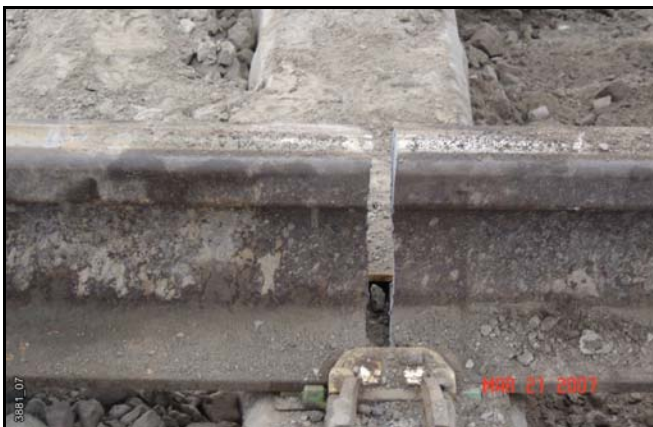
Figure 4. Broken Rail that Occurred in a Mud Pumping Hole

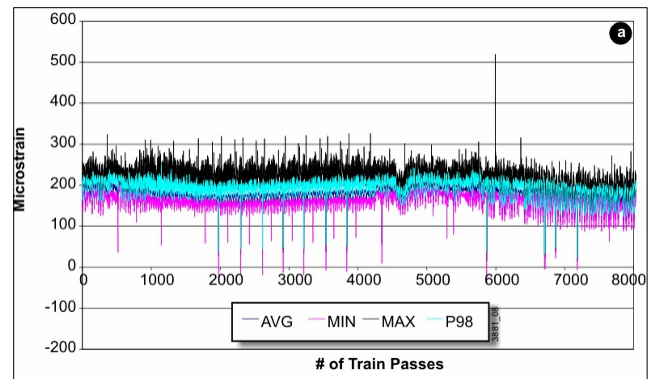
Figure 5a shows a tie in the approach with stable support, as indicated by the consistent tie bending strain results throughout 8,000 train passes. Conversely, Figure 5b shows a tie with increased center binding (on the bridge), indicated by increased magnitudes of the measured tensile strain. Center binding is a condition in which the tie is supported primarily at the center as opposed to being supported under rail seats – considered to be one of the main reasons for causing concrete ties to crack. This condition can occur when ballast breaks down under the rail seats or due to inadequate or improper ballast tamping.

Figure 5a. Tie Bending Strain Results with Stable Support

For the two ties shown in Figure 5, the tie support condition shown in Figure 5a was better than the one shown in Figure 5b, although magnitudes of tensile strain recorded under those 8,000 train passes for both ties were below the allowable capacity (with few exceptions).

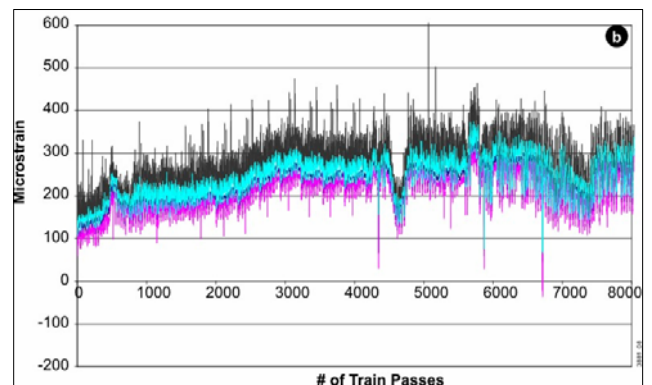
Figure 5b. Tie Bending Strain Results with Center-bound Bridge Tie

Note that Figure 5 also indicates a period of slow orders between train passes 4,500 and 4,700. As shown, slow orders had a greater effect on the tie with the center binding condition (Figure 5b) than on the tie with the stable tie support (Figure 5a).

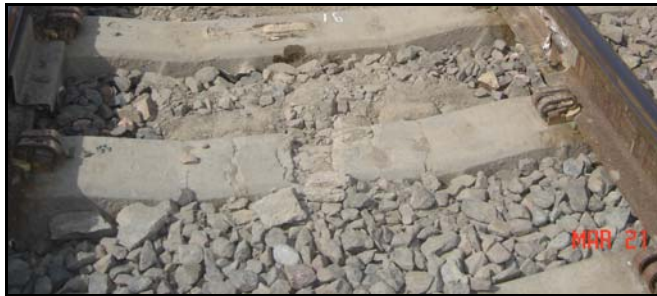
A concrete tie will crack on the tension surface when bending levels exceed both the concrete precompression (imparted by the prestress tendons) and the available concrete tensile strength. For the concrete ties installed at this site, the allowable tensile strain capacity was estimated to be between 470 and 650 microstrains, although individual tie calibration was not performed.

For the eight instrumented ties, four showed stable or improved tie support over time; whereas, the other four ties exhibited either increased center binding or an unstable ballast support condition due to fouled ballast and mud pumping (showing hairline or severe crack). The poor tie support condition was another reason why, 1 year following the start of this experiment, some ties started to crack. In places where ties showed cracks, there was mud or fouled ballast present. Toward the end of Phase 1, a few ties at this test site cracked severely. Figure 6 shows an example of severely cracked concrete ties.

Figure 6. Severely Cracked Concrete Tie

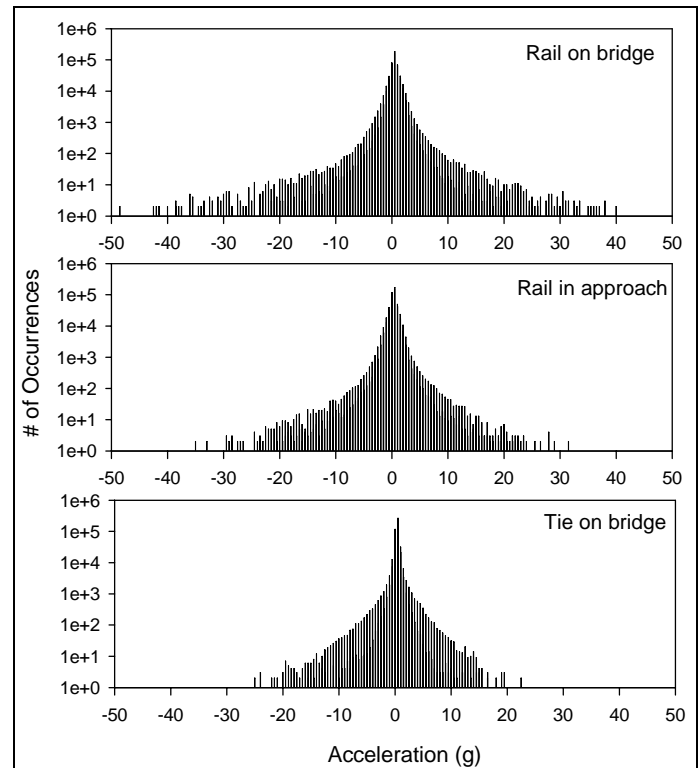
Figure 7. Rail and Tie Vibration Results

Figure 7 shows examples of rail and tie acceleration results obtained under two passing trains. The range of rail vibration was from -50 to 50 g, while the range of tie vibration was from -30 to 30 g. Consistent with wheel load results, shown in Figure 2, vibration on the bridge also appeared to be higher than vibration on the approach for the same reason previously mentioned.
