Recommended Nondestructive Inspection Guide for Side Frame, Bolster, and Knuckle Castings

Daniel Carter

Summary

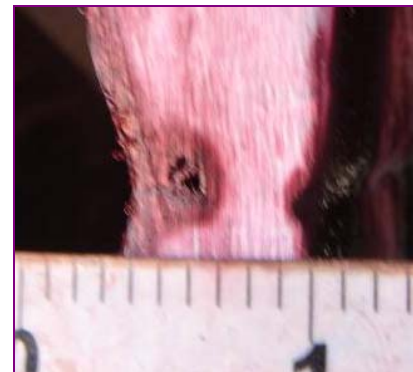
TTCI inspected 25 bolsters of which 56 percent had relevant indications, while 44 percent did not have any relevant indications. Of the bolsters that had relevant indications, 57 percent had indications located around the brake rod hole, 21 percent had indications located on the transition radius, and 21 percent had indications at both the brake rod hole and the transition radius. The longest indication found on the bolsters was 2 inches long, and the smallest indication was 1/16 inch long. The indications found on the bolster castings include porosity, inclusions, tears (cracks), and some scabs. Most of the ribs from the bolsters had a seam from the mold, and one had porosity. Figure 7 shows the porosity on one of the inside ribs. Figure 8 shows a tear on the transition radius. Inspection of the bolster using this technique takes 40 minutes using one technician.

Figure 7. Porosity on Inside Rib

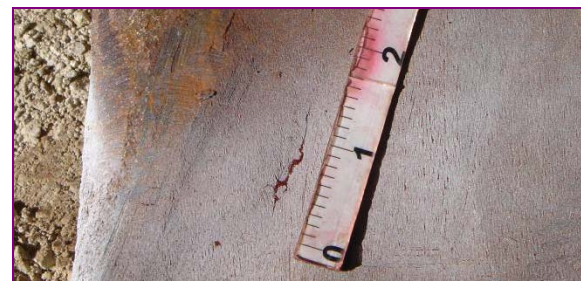
The tears were considered relevant according to M-210 5.5.1.12, which states that a crack, hot tear, surface shrinkage is a condition on the castings that was formed during the manufacture or processing of the casting.¹ These foundry-related defects must be removed by either grinding or excavation and repair welding. The tears (cracks) are also labeled as a “cause for renewal” in the *Field Manual for the A.A.R Interchange Rules*, specifically Rule 47 concerning bolsters and Rule 48 concerning side frames.^{3,4} A new AAR specification is being finalized by the CSTCC to include the indication relevancy used for the knuckle inspections. All cracks found were considered relevant according to the guidelines set forth by the Federal Railroad Administration Motive Power and Equipment Compliance Manual, specifically regulation §215.123 Defective Couplers.⁵

Figure 8. Tear on Transition Radius

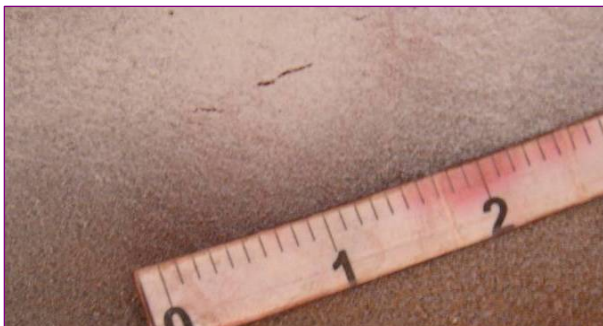
Figure 9 shows an average tear found in the spring seat radius. Figure 10 shows a scab located on the pedestal roof. The longest indication found during the side-frame inspection was 2 1/4 inches long and the smallest indication was 1/16 inch long. Indications found on the side-frame castings included porosity, tears (cracks), and some scabs. It takes a technician 30 minutes to inspect the side frame using this technique.

Figure 9. Tear on Spring Seat Radius

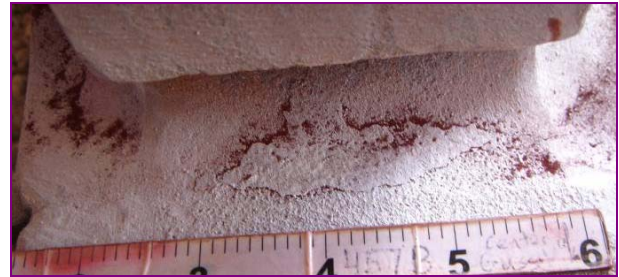
Figure 10. Scab on Pedestal Radius

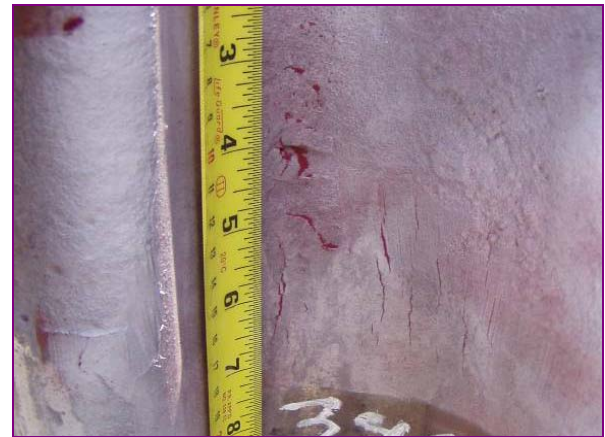
TTCI inspected 169 knuckles of which 28 percent did not have any surface indications, and 72 percent did have surface indications. Of the 72 percent of knuckles that did have surface indications, 54 percent were removed from service. Figure 11 shows a knuckle that was inspected and found to have tears and a gouge. The indications found during the inspection of the knuckles included tears (cracks), porosity, and gouges. It takes a technician 10 minutes to inspect a knuckle using this technique.

Figure 11. Tears and Gouge on Pulling Face
