Performance of Two Concrete Bridges at FAST for 500 MGT

Duane Otter and Brian Doe

SUMMARY

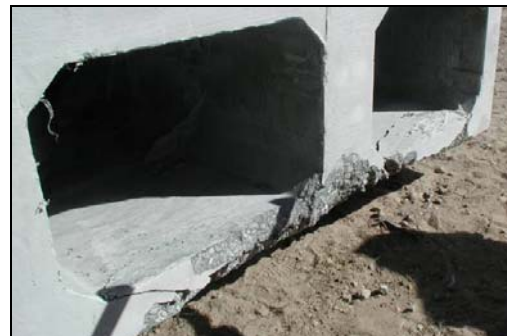
Both of the 30-foot concrete box girders were damaged during transport from the precasting plant to FAST. The damage was mainly at the girder ends (see Figures 3 and 4). The concrete was repaired using Sikadur High Mod 33 (two-part epoxy) mixed with dried masonry sand. This is considered a 10,000 psi grout. The repair was then covered with a skim coat of Hilti RM800. The repairs were performed in the field at FAST by the manufacturer. The repairs were performed before the girders were installed in the bridge, as Figures 5 and 6 show. After 517 MGT of 315,000-pound GRL traffic, no chipping or spalling is evident in the repaired areas.

Figure 3. Damaged Concrete Box Girder A before Repair

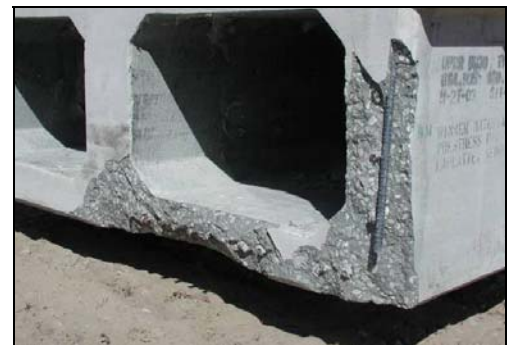
Figure 4. Damaged Concrete Box Girder B before Repair

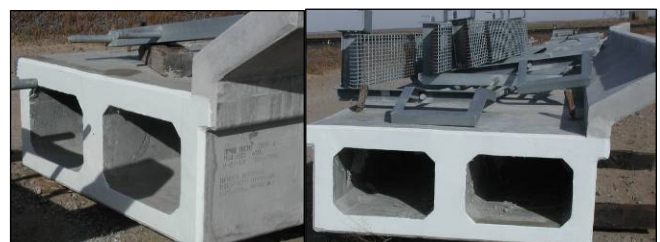
Figure 5. Repaired Concrete Box Girder A (left photo) and Figure 6. Box Girder B (right photo)

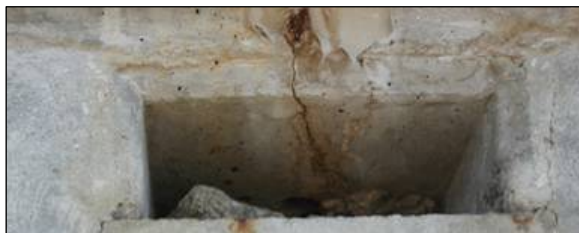
Cracks initiated from several of the deck drain openings and propagated in ballast curbs. Figure 7 shows these cracks. The ballast curbs were cast separately at the plant, after the box girders were removed from the prestressing bed. The curbs are cast with asphalt separation panels along their length to minimize the amount of live load they carry. The asphalt panels are centered at the drain opening locations. Since the ballast curbs are not a structural part of the main girder, the cracks do not seem to pose any problems at this point. Figure 8 shows the largest of these cracks.

Figure 7. Typical Cracking near Deck Drain Opening

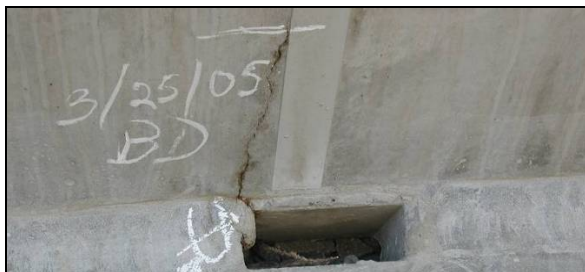
Figure 8. Largest Crack near Deck Drain Opening

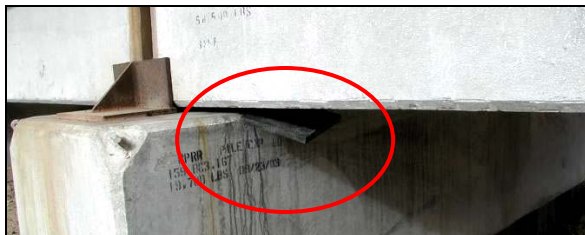
Figure 9 shows a bearing pad on one span at the center pier of the conventional bridge that had a tendency to work its way out from under the girder. To restrict movement, this pad was glued to top of the pile cap. Shortly thereafter, a crack was observed at the girder corner nearest that pad, as Figure 10 shows.

Figure 9. Bearing Pad Working Out from Concrete Span

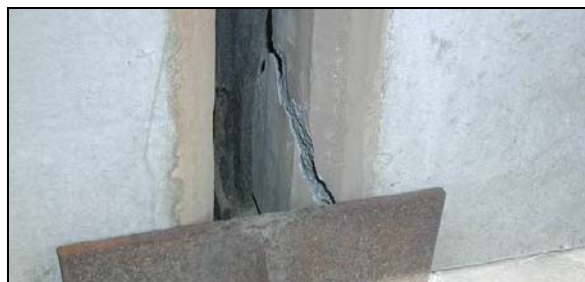
Figure 10. Cracked Girder Corner after Bearing Pad was Glued in Place

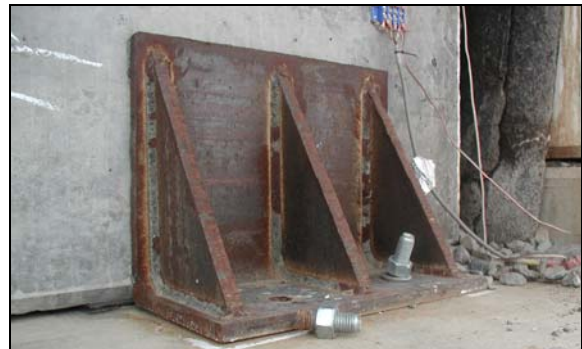
Figure 11 shows bent and broken anchor bolts on the 42-foot span of the SOA bridge. The span has moved outward slightly on the 5-degree curve.

Figure 11. Bent and Broken Anchor Bolts on SOA Bridge

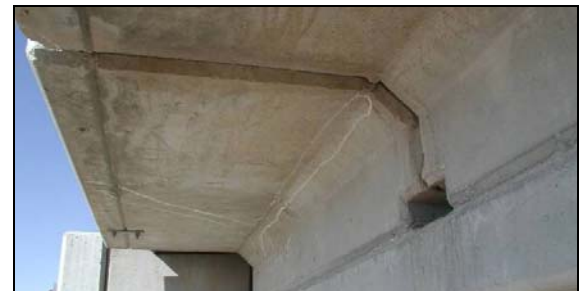
During a normal track surfacing operation, a regulator struck the ballast curb at the southwest corner of the conventional concrete bridge. This appears to have caused a crack in the curb. Figure 12 shows the ballast curb crack.

Figure 12. Ballast Curb Crack after Regulator Strike

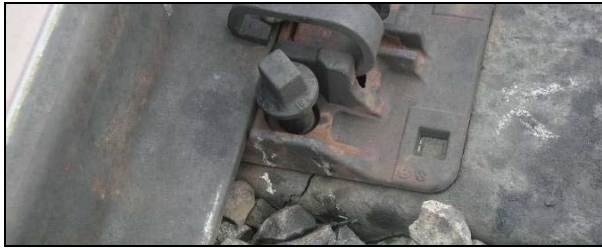
A total of 10 plastic ties cracked on the SOA bridge. On the outside (high) rail, there were nine cracked or broken ties. On the inside (low) rail, there were three broken or cracked ties. Two ties were cracked under both rails. There were two broken tie plates on the outside rail and two broken tie plates on the inside rail. Also, three ties on the outside rail had screw spikes that loosened significantly. All of the cracks pass through the holes for the screw spikes. Figures 13 and 14 show plastic composite tie cracks and a broken tie plate on the SOA bridge.

Figure 13. Cracked Composite Tie with a Loose Screw Spike

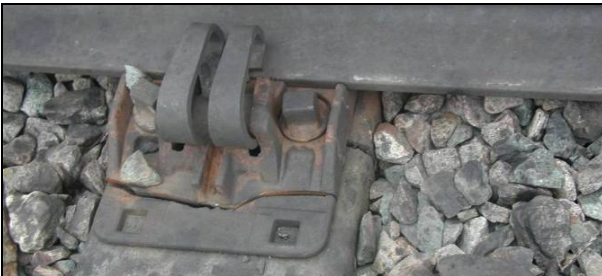
Figure 14. Broken Tie Plate on Cracked Plastic Composite Tie

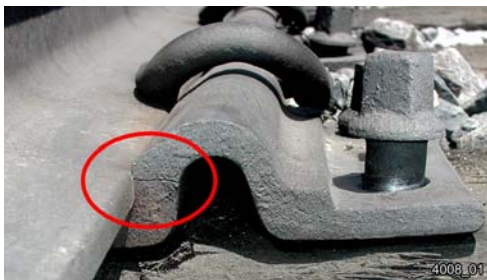
Thirty-six timber ties (oak) on the conventional bridge accumulated 335 MGT of 315,000-pound GRL traffic. Some ties became slightly skewed so that the rail is wearing into the inside of the curved part of the Pandrol plate causing a crack. Figure 15 shows a cracked Pandrol plate with a loose screw spike on the high rail of the conventional bridge. This wearing caused the cracking of 12 tie plates, all on the high rail. Four of the plates were side by side. All 12 plates were replaced. Two of the plates had the screw spikes broken off. Others had loose screw spikes. A cut spike was used to hold each plate temporarily. Similar problems have been noted in the tie and fastener experiment at FAST.⁴

Figure 15. Cracked Pandrol Plate with Loose Screw Spike

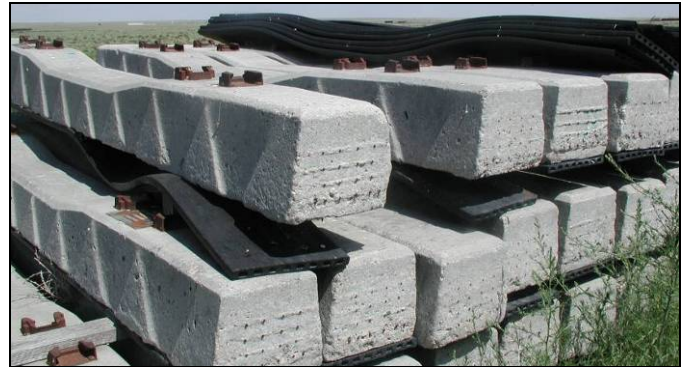
Two generations of UP prestressed concrete ties with rubber pads attached to the bottoms have been installed on the SOA bridge for over 100 MGT each. The first generation ties featured rubber pads glued to the bottoms. After 130 MGT, the rubber showed no signs of wear. But the pads became partially unglued on some ties, as Figure 16 shows. The second generation ties featured rubber pads cast into the bottoms. After 155 MGT, some deterioration of the interface was evident near the edges, as Figure 17 shows.

Figure 16. Concrete Ties with Glued and Unglued Rubber Pads

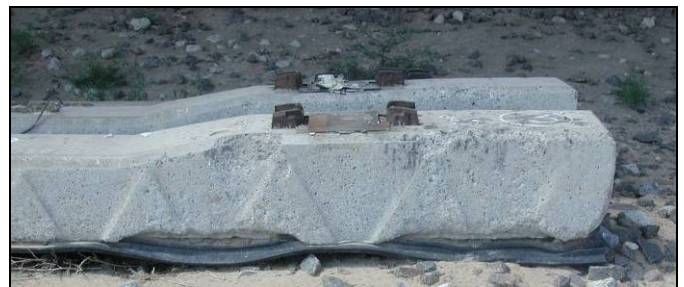
Figure 17. Concrete Ties with Cast-In Rubber Pads
