Interim Performance Results of Premium Rails in Revenue Service at Mega Sites

Dingqing Li, Sam Atkinson* and Russell McDaniel**

Summary

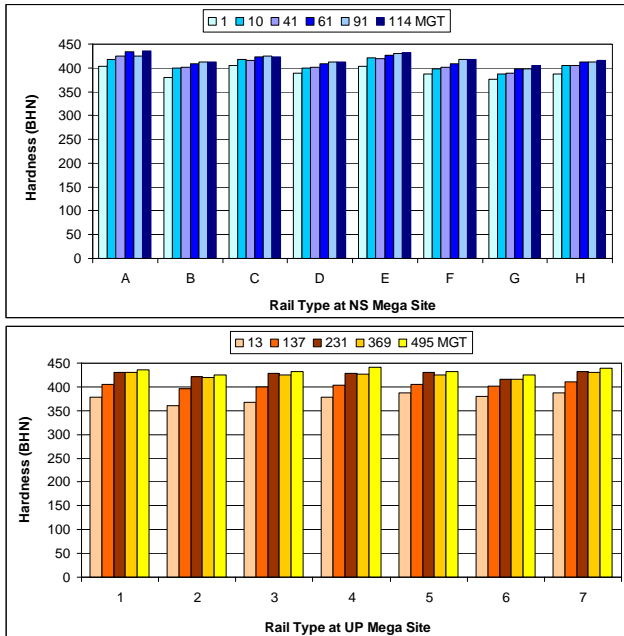
Rail surface hardness measurements were obtained at the mega sites. Figure 1 shows average hardness results obtained for all the test rails at various MGT levels. As illustrated, surface hardness increased with traffic, obviously as a result of work hardening effect of wheel/rail interaction. Although there is variation of hardness among different test rails, all rails had hardness measured above 400 BHN after approximately 60 MGT of traffic at the eastern mega site and 130 MGT of traffic at the western mega site. At FAST, the average hardness of all test rails after 200 MGT was measured to be 410 BHN. Note that AREMA (American Railway Engineering and Maintenance Way Association) requires 370 BHN as a minimum of hardness for high-strength rail.

Figure 1. Average Rail Surface Hardness Test Results

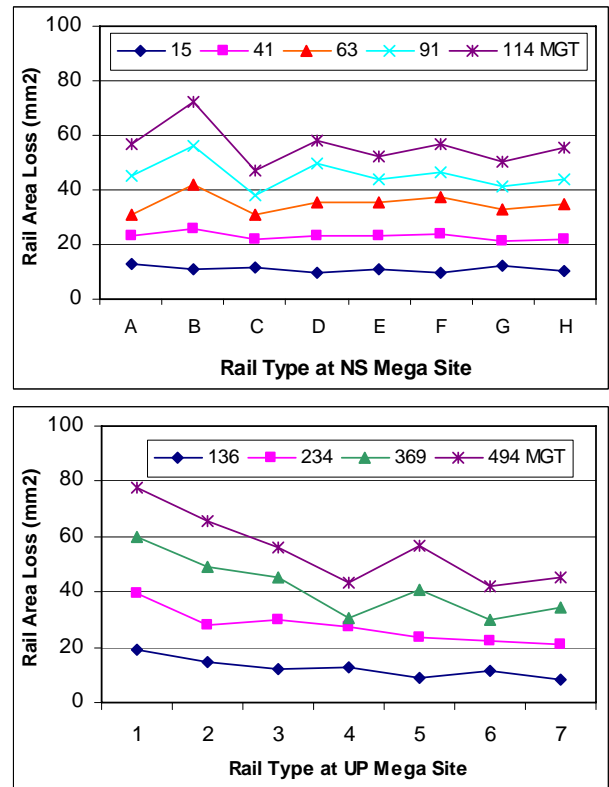
Figure 2 shows the measurement results for the test rails (high rail) in a 10-degree curve at the eastern mega site and in a 2-degree curve at the western mega site, respectively. As illustrated, the maximum head area loss due to wear was 70 mm² for the 10-degree curve at 114 MGT and 80 mm² for the 2-degree curve at 494 MGT. Compared to the total railhead area (3466 mm²), the amount of wear was essentially insignificant (counting less than 2.4% of the total head area). At FAST, rail wear was 7.2 percent of the head area at 300 MGT in a 5-degree test curve (Note: 1 in² = 645 mm²).

In terms of gage or top face wear, the maximum wear rate was 1.75 mm (gage) at 114 MGT at the eastern mega site and 2.78 mm (gage) at 494 MGT at the western mega site. Assuming an allowable wear limit of 16 mm (gage or top surface), the minimum wear life of the premium rails can be estimated to be 1,000 MGT for a 10-degree curve at the eastern mega site (with excellent gage and top face lubrication) or 2,800 MGT for a 2-degree curve at the western mega site (Note: 1 in. = 25.4 mm).

Figure 2. Average Rail Wear (High Rail, 10-Degree NS Curve and 2-Degree UP Curve), 1 in² = 645 mm²

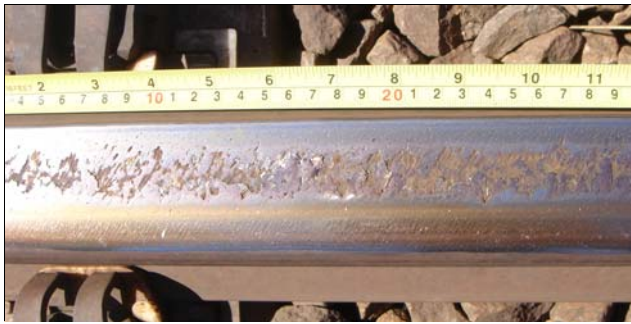
At the western mega site, however, significant RCF started to show up on the low rails in the two 2-degree curves at about 300-350 MGT. Figure 3 shows an example of RCF observed at approximately 370 MGT. However, no significant RCF has been observed after about 520 MGT on the high rails for the two 2-degree test curves. In addition, no RCF has been observed on both the high and low rails in the 1-degree test curve.

Figure 3. Example of RCF on Low Rail of 2-Degree Curve at UP Mega Site

Microcleanliness was not the only factor that contributed to RCF on the low rails. An investigation of the RCF issue at the western mega site suggested that the following four factors be the main contributors to the RCF problem observed:

- Curvature – only the two 2-degree curves had RCF issues on the low rail, whereas the 1-degree curve did not.
- Under-balanced speed (as mentioned earlier) caused higher normal and tangential wheel/rail forces on the low rails in the two 2-degree curves.
- Very dry rail surface (with friction coefficient measured at or above 0.5).

- Misalignment related to plant welds used to connect all test rails, which were spaced 40 feet from one rail type to another.

To remove RCF on the low rails in the two 2-degree curves, a corrective rail grinding was performed at 375 MGT. Figure 5 shows the changes of rail profiles as a result of the grinding. As illustrated, the amount of rail removed from grinding was more than the loss of rail due to wear from the first 375 MGT.

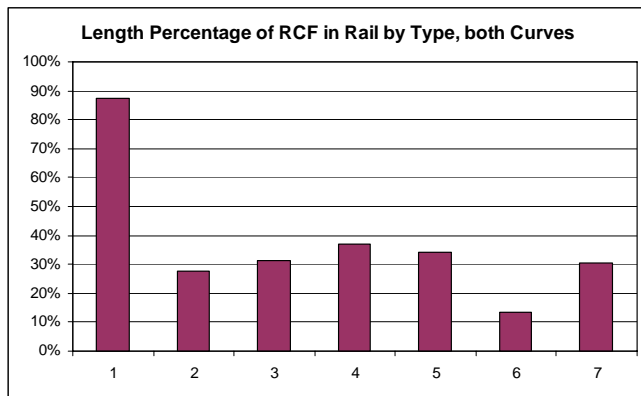
Figure 4 shows the RCF mapping results for the low rails in the two 2-degree curves obtained at approximately 370 MGT. As shown, the length of each rail type that was covered with RCF ranged from 14 percent to 87 percent. Similar RCF problems were also observed at FAST between 100-150 MGT, and the investigation at FAST suggested that the variation of RCF extent from one rail to another was caused by change of microcleanliness (the extent or quality of nonmetallic inclusions observed by examination under a microscope).²

Figure 4. RCF Distribution among Different Rail Types

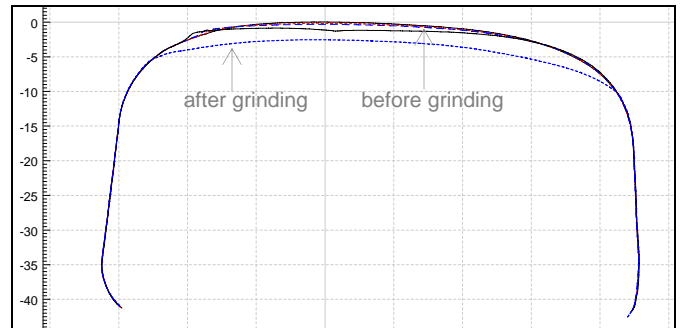
Figure 5. Rail Profile Change due to Grinding
