## Evaluation of Tie Plate Cracking on Composite Ties

Kari Gonzales, Richard Reiff, David Davis, and Daniel Gutscher

### Summary

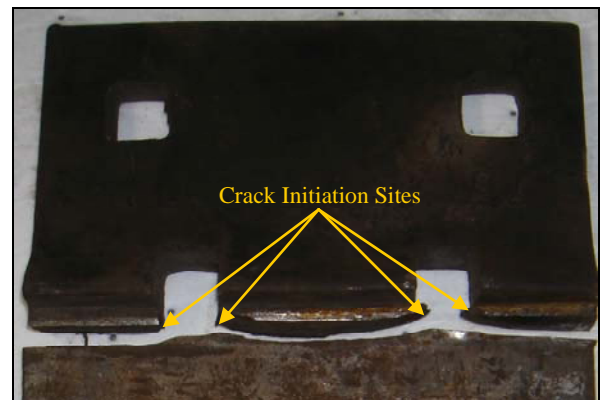
Three broken tie plates were studied. The fatigue crack initiated and propagated similarly for all three plates. Figure 2 shows one of the fractured plates and the corresponding crack initiation points. Evaluation of the fracture surface showed that all of the plates had multiple crack initiation sites on the base of the tie plate at the inner spike hole corners nearest to the rail seat. The crack then propagated along the field side shoulder of the tie plates until final fracture.

Figure 2. Broken Tie Plate showing Crack Initiation Locations

The fatigue cracks propagated parallel to the rolling direction of the train, which indicates that the plate experienced high tensile stresses oriented perpendicular to the rolling direction of traffic. Since the fatigue cracks propagated perpendicular to the rail base, the evaluation concluded that the failure of the plates was not caused by shear stresses in the plate.

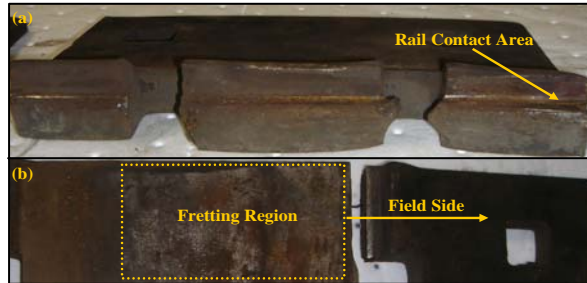
In addition to the fatigue cracks in the shoulder of the plates, several other locations on the tie plate exhibited damage. Fretting occurred in the bearing seat and on the ridge between the bearing seat and the shoulder of the plate. Figure 3 shows the fretting on the ridge above the shoulder of the plate and in the bearing seat.

The fretting damage was observed on all three plates on the field side only. Little or no fretting damage was found on the gage side of the plate. The location of fretting is important because it helps to determine its affect on the fatigue damage in the plate. It is unlikely that the fretting caused the fatigue

initiation because of the crack initiation points. If fretting was the primary cause of the failures, the initiation points would be near the ridge of the plate (Figure 3(a)). The crack initiation and propagation, in this case, would be due to lateral loads imparted on the plate causing contact between the toe of the rail and the ridge of the plate. Since there is no evidence of crack initiation points in this area, the evaluation concluded that lateral forces alone, were not the cause of the failures. Although the fretting is not the primary cause of the fatigue failures, it can be used to understand the loading profile on the plates and its affect on the failures.

Figure 3. Rail Contact and Fretting Regions on Tie Plate

The prominent fretting toward the field side of the tie plate indicates that the field side of the plate supports the majority of the load. Studying the dynamic conditions in Section 25 shows that operations occur at overbalance speed, which may contribute to the field side fretting and cracking. Train operations at speeds above curve balance speed puts more vertical load on the high rail of the curve. At FAST, the average high rail vertical load is about 45,000 pounds.<sup>1</sup>

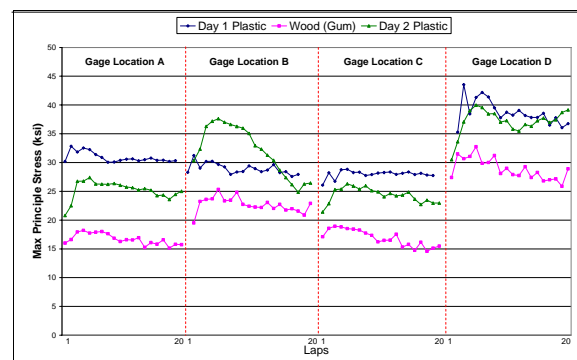
The first day of testing was conducted in a plastic tie section (Zone 10 in Section 25). The second day of testing was completed in the gumwood tie section (Zone 4), and the final day of testing occurred in a second plastic tie section (Zone 5). Figure 5 shows the maximum principal stress data collected using plate 1 for each of the three zones. The plot shows the maximum principal stress for each lap for all of the gages. The x-axis is the lap number, and the y-axis is the maximum principal stress.

values are reaching critical yield, the plates are still being affected by material fatigue. Figure 6 shows the average stress (all gages combined) values for all laps over each zone. In all cases, the stress in the plastic tie sections is higher than those in the wood tie zone. Again, none of the values exceed the yield strength of the material, but are still contributing to fatigue. The results from testing at FAST indicate that the plates mounted on plastic ties are experiencing higher stress than plates mounted on wood ties.

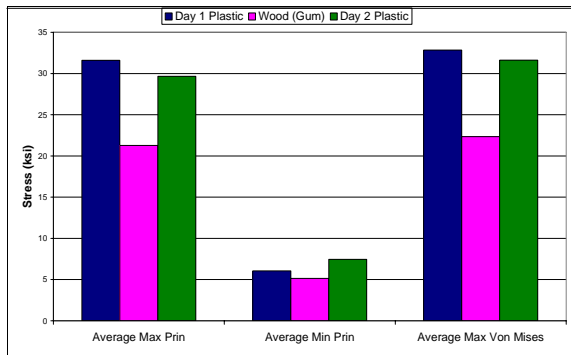
Figure 6. Average Stress for All Plates and All Gages

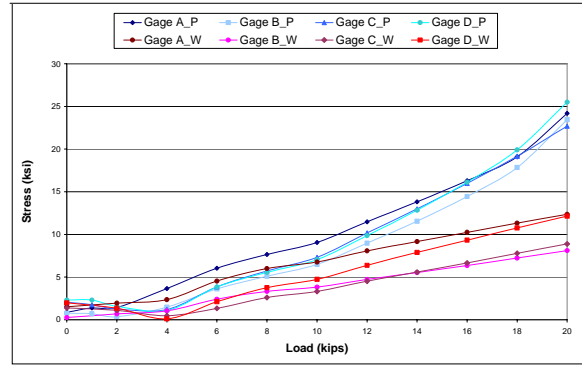
Figure 8. Maximum Principal Stress for Half-Tie Test

Once again, the stress for plastic ties (blue hues) is greater than the stress for wood ties (red hues). The maximum value of stress, 25.5 ksi, was recorded at Gage D for the plastic tie test, which is the same location that experienced the highest stress during field-testing.

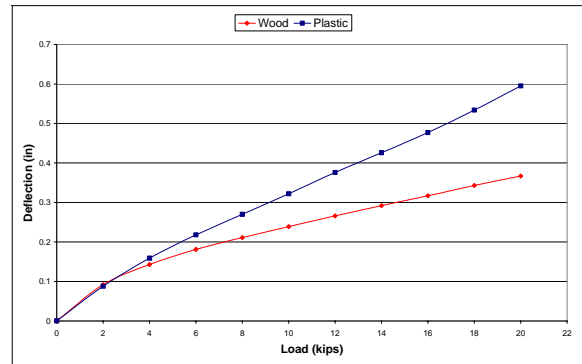
In order to correlate the higher stress in the tie plate to the tie itself, the total deflection is shown in Figure 9. This figure represents the total deflection in the ties for loads ranging from 2,000 to 20,000 pounds. Figure 9 shows that the total deflection in the plastic tie condition is much greater than the wood-tie condition.

Figure 9. Total Deflection Recorded during Half-Tie Test
