## Gas Pressure Welds and Hollink Slot Welds Testing at FAST

### Summary

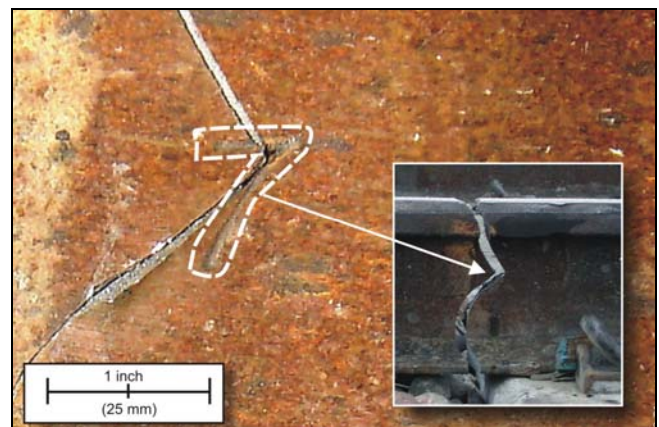
The test experienced its second weld failure at 165 MGT when GPW No. 05 fractured during train operations. Examination revealed that the fracture originated in the web of the rail in the heat-affected zone. Further examination identified the origin of the failure as being a rail manufacturer number stamped in the rail, which acted as the crack initiation site. Figure 3 shows the fracture origin. Similar failures have been noted recently at FAST involving electric flash-butt welds in which rail manufacturer stamps located in the heat-affected zone have acted as the initiation site for fatigue cracking.

Figure 3. GPW Break Showing Rail Manufacturer Stamp in Weld Heat-Affected Zone. Inset shows the Full Break in Track

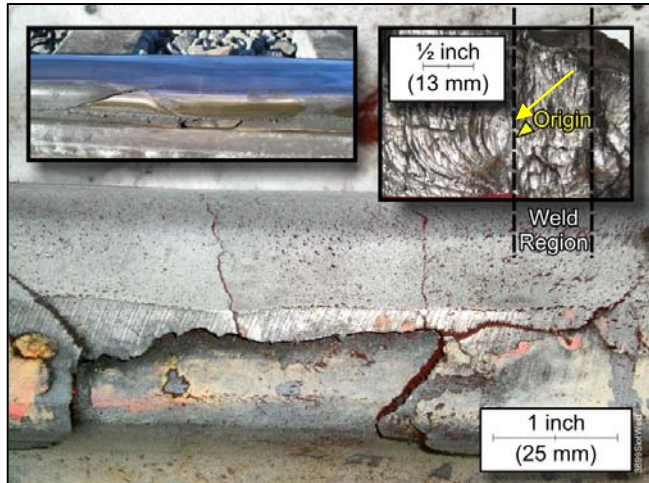
Figure 4 shows the first failed slot weld that occurred at 124 MGT. Figure 4 insets show the barred weld in track and the opened fracture surface. The fracture initiated at the weld fusion line approximately 0.9 inch from the gage face and at a depth of 0.5 inch. The arrow in the Figure 4 inset indicates the origin of the crack and the dashed lines show the approximate location of the fusion lines.

**Figure 4. Horizontal Fracture in Railhead of Slot Weld. Left Inset, Barred Weld in Track. Right Inset, Fracture Surface after Opening the Break for Inspection**
