## Teardown Results of Coal Cars Identified by Truck Performance Detectors

Ron Lang, Benjamin Madrill, and Harry Tournay

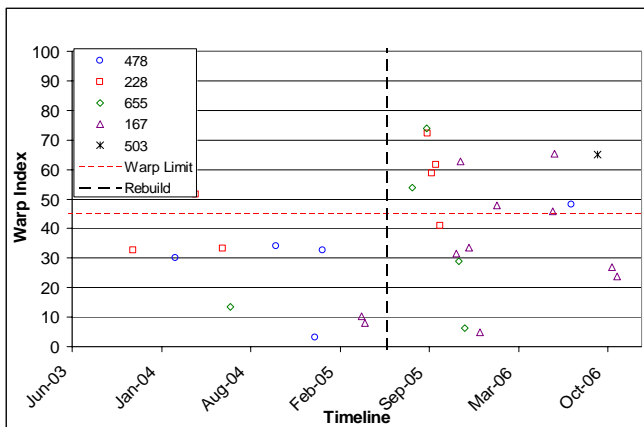
Figure 1. Warp Index History

Two of these metrics developed by TTCI are Warp Index<sup>2</sup> and Gage Spread Force,<sup>3</sup> which when used together can determine a car's performance. Figure 1 shows the warp history of the five cars inspected. Warp Index is defined as a percentage of how warped a truck becomes while traveling through a curve.

These figures show that there was a significant deterioration in performance after July 2005, thus the cars were identified as poor performers and were selected for inspection.

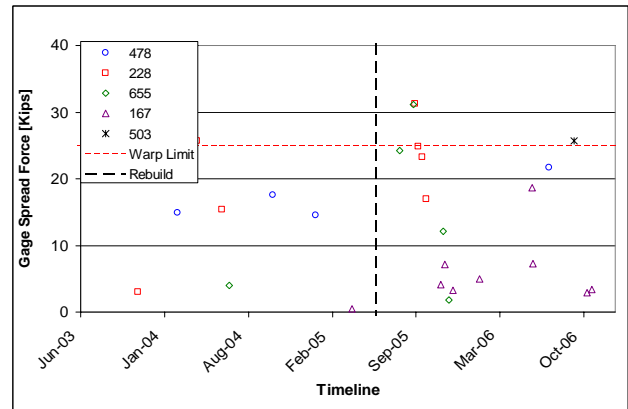
Figure 2. Gage Spread Force History

Figure 2 shows the gage spread force history of the same five cars. Gage Spread Force is defined as the lateral force input into the track structure.

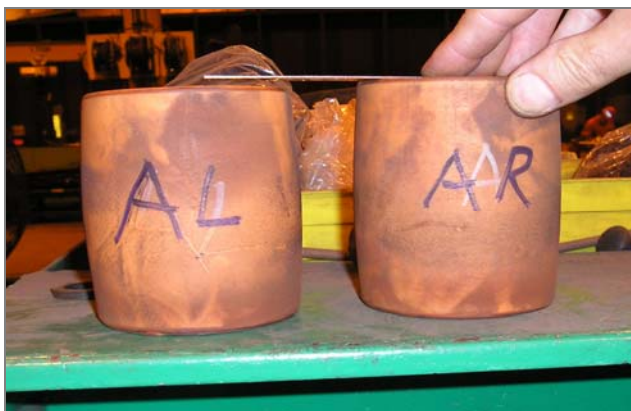
Figure 3. Side Bearing Heights

The four cars that went through the rebuild program were fitted with long travel constant-contact side bearings. These cars were brought into the shop one at a time in the unloaded condition. The constant-contact side bearing heights were measured. Table 1 shows the side bearing heights and car twist of the inspected cars (highlighted measurements are out of tolerance). Car twist is measured by subtracting the side bearing delta from each truck.

Figure 3 shows the polymer elements of the constant-contact side bearings from one of the inspected trucks. A difference in heights can be seen.

Since these cars were inspected, the four that went through the rebuild process have been repaired and returned to service. The repairs included properly adjusting the constant-contact side bearing heights and repairing the center plate on Car 228. Figure 6 shows the warp index history of the cars, which indicates that the cars returned to service are performing significantly better.

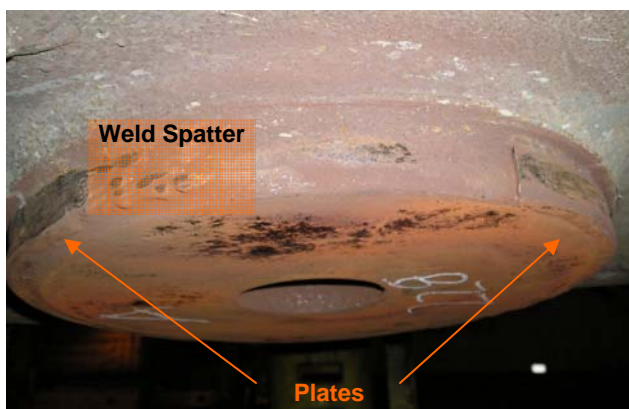
Figure 4. Center Plate of Car 228

During the inspection of Car 228, an improper repair to the center plate was discovered. Figure 4 shows the improper repair.

The center plate had worn elliptically and two bars had been bent and welded onto the center plate in an attempt to make the center plate once again circular. This improper repair will increase rotational resistance between the center plate and center bowl.

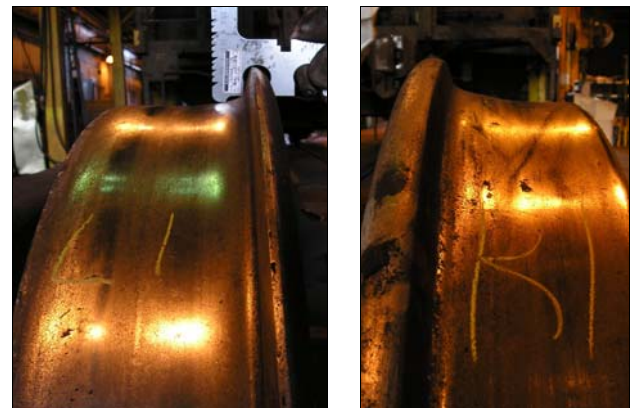
Figure 5. Axle 1 Wheelset on Car 478

Inspection revealed both high wedge heights and asymmetric wheel wear. High friction wedges are a major cause of truck warp. Figure 5 shows the asymmetric wheel wear.

There are many causes of asymmetric wheel wear, one being low truck warp restraint. Because the trucks of this car had high friction wedges, this could explain the asymmetric wear.

The poor performance of the car scheduled for rebuild was likely caused by low truck warp restraint as a result of high wedges. This low truck warp restraint could also lead to asymmetric wheel wear causing the performance to deteriorate even more.
