# Broken Wheel Inspections

## Summary

This *Technology Digest* describes an inspection of 24 wheelsets with broken wheels conducted by Transportation Technology Center, Inc. at a wheel shop in Canada. The inspection was completed to gather data to increase the industry's state of knowledge regarding broken wheels. This work was conducted as part of the Association of American Railroads' Strategic Research Initiatives program.

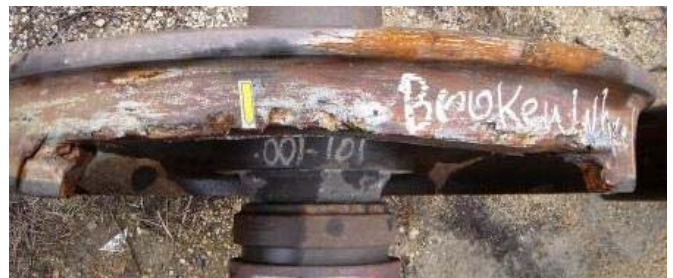
The failure mode of the majority of broken wheels inspected was VSR, as Figure 1 shows. Other failure modes observed were vertical split flange (VSF), as Figure 2 shows, and cracked wheel and a combination of shattered rim and VSR, as Figure 3 shows. Table 1 contains a listing of the failure modes and wheel designs

Figure 1. Vertical Split Rim

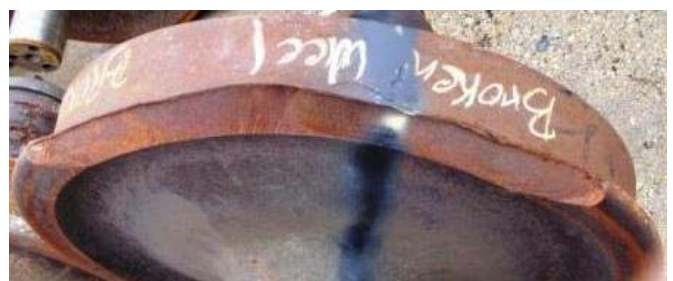
Figure 2. Vertical Split Flange

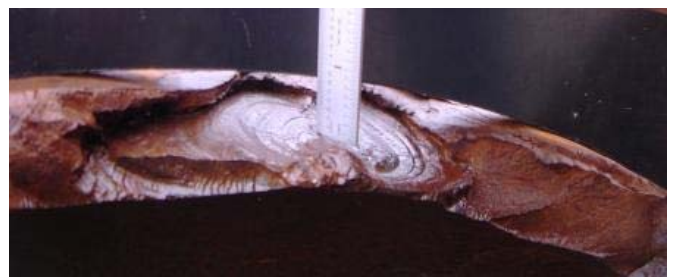
Figure 3. Radial Depth Measurement of a Wheel with Combination Shattered Rim and Vertical Split Rim

The radial depths of the three shattered rim defects were measured in inches to be 0.875, 0.875, and 0.625. The lateral defect location of VSR wheels did not show any correlation to the mate wheel flange thickness.

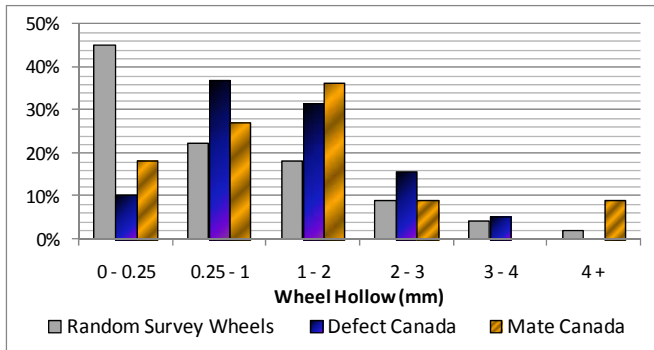
The tread hollow of the broken wheels and their mate wheels was compared to the tread hollow of a random survey of 6,628 wheels,<sup>1</sup> as Figure 4 shows. It appears that the broken wheels and their mate wheels had more

hollow wear than the comparison group of wheels. This is consistent with an earlier analysis of tread profiles of VSR wheels.<sup>2</sup> This may be a natural consequence of the age of the tread of the broken wheels (time elapsed between the bearing locking plate date and the removal from service date), as Figure 5 shows. The hollow wear rates of the broken wheels and their mate wheels show much scatter in Figure 6.

Figure 4. Wheel Hollow Wear

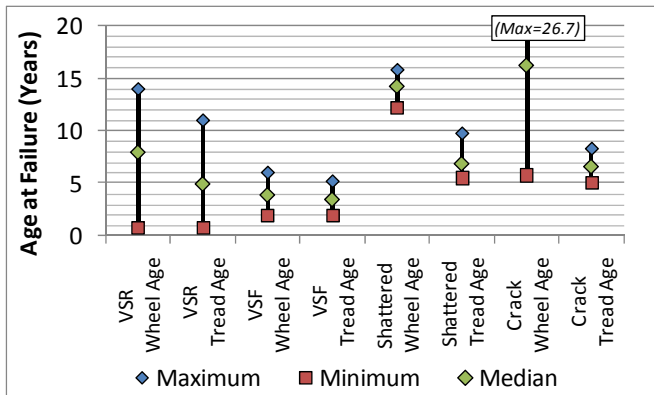
Figure 5. Ages of the Broken Wheels

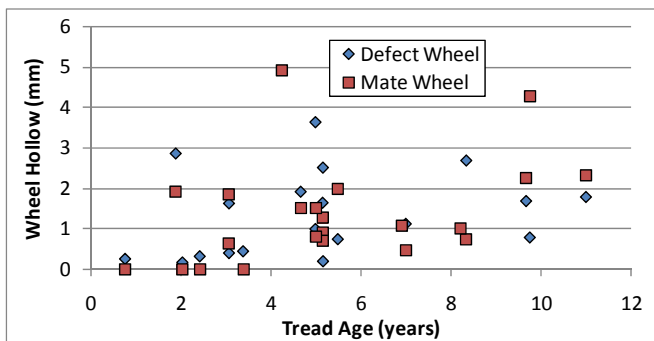
Figure 6. Wheel Hollow versus Tread Age

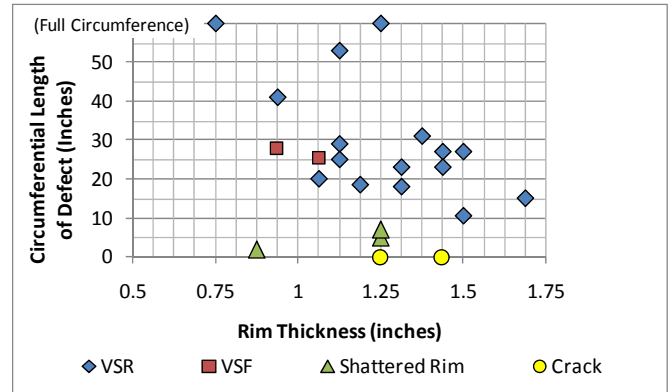
Failure geometry did not appear to be strongly related to rim thickness, as Figures 7 and 8 show. Figure 8 shows that most VSR failures occurred outboard of the tapeline. This is also where wheel shelling is most prevalent.<sup>3</sup> Six of the twelve broken wheels for which historical WILD data was found exceeded a 90,000-pound impact load prior to failure. The other six broken wheels did not exceed a 73,000-pound impact load prior to failure. Table 2 shows the car types of the broken wheels.

Figure 7. Circumferential Length of Defects versus Rim Thickness

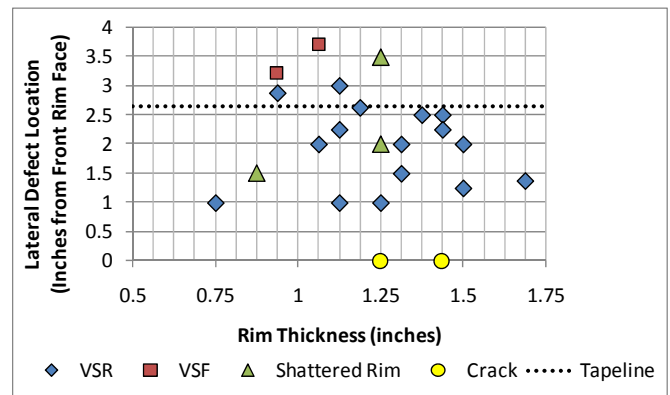
Figure 8. Lateral Defect Location versus Rim Thickness

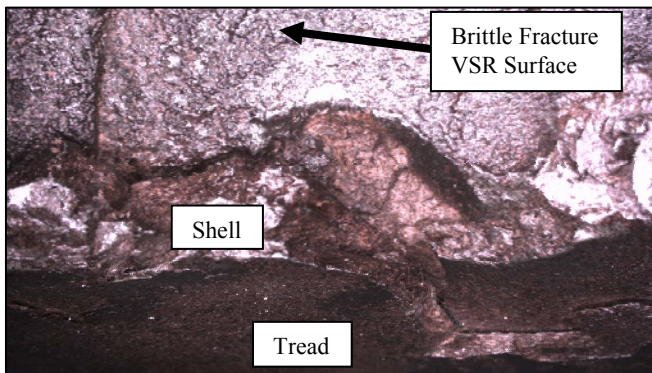
Four wheels with VSRs were sectioned and de-rusted for fracture analysis. All of the fractures showed initiation from either a rolling contact fatigue initiated shell or spall defect. The depth of initiation on all wheels was approximately 0.1-inch-deep crack at the bottom of the shell or spall. Fracture then occurred in a brittle manner that formed the large area of the VSR, as Figure 9 shows. Because the formation of the VSR is by the process of brittle fracture and the depth of the initiating crack is known, the stress necessary to cause fracture may be calculated from the following equation:

Figure 9. Fracture Surface of Vertical Split Rim

Because the role of residual stress in causing VSRs is not well understood, additional research should be conducted to determine the subsurface axial residual stresses in the wheel rim. This should be conducted on a number of wheels removed from revenue service with varying degrees of wear and rim thickness because the normal deformations associated with rolling contact can change the residual stresses.

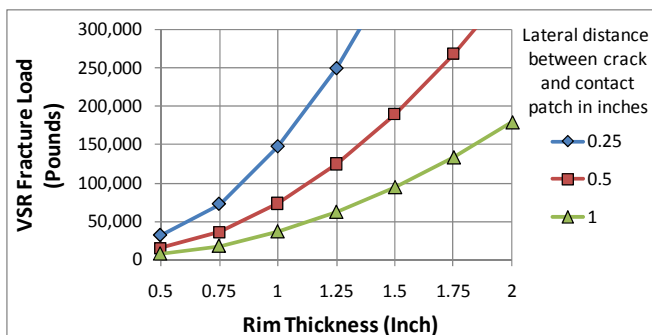
Substituting these values into the equation gives a fracture stress of 56,700 psi. Using a simple bending formula,  $\sigma = Mc/I$ , the relationship between rim thickness, lateral distance between crack and contact patch (moment arm), and fracture load for a 0.12-inch-deep crack is shown in Figure 10.

Figure 10. Calculated Effects of Rim Thickness and Contact Position on VSR Fracture Load for a 0.12-inch-deep Crack
