## Preliminary Performance of Wide-Gap Welds at Eastern Mega Site

Daniel Gutscher, Dingqing Li, and Russell McDaniel\*

### Summary

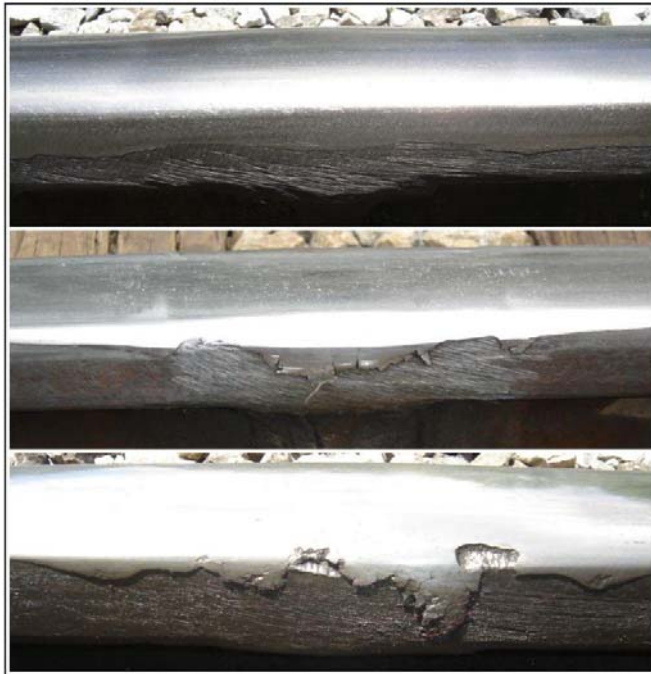
As of December 31, 2008, the Orgo-Thermit welds have accumulated 180 MGT, and the Railtech Boutet welds have accumulated 122 MGT. Overall, the welds are visually in good condition with the exception of some plastic flow and minor shelling on the gage corners on some welds. Figure 2 shows several welds that represent various overall weld conditions. In this figure, the top picture shows the typical good condition of a test weld, the middle picture shows a weld with some plastic flow, and the bottom picture shows a weld with some minor shelling.

**Figure 2. Sampling of Weld Conditions: (Top) Good Weld Condition; (Middle) Plastic Flow on Gage Corner; (Bottom) Plastic Flow and Minor Shelling on Gage Corner.**

Table 1 summarizes conditions for each of the welds and shows 69 percent of the Orgo-Thermit welds and 63 percent of the Railtech Boutet welds were experiencing some degradation in the form of plastic metal flow or both plastic metal flow and minor shelling. On the high rail welds in the 10-degree curves, 100 percent of the shelling for both products is occurring.

The WGWs at the eastern mega site will be ground with a handheld grinder in the spring of 2009 to remove plastic flow and minor shelling.

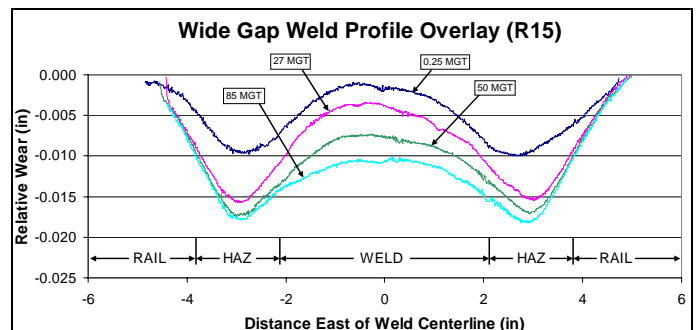
TTCI collected longitudinal profiles for the welds at different MGT levels and then plotted the profiles. The overlaid plots for the different tonnages were used to examine weld longitudinal surface degradation trends. Figure 3 shows an example profile overlay for Railtech weld R15. This type of overlay places the profiles based on the assumption of zero head wear in the parent rail. As a result, the overlays highlight wear rates of weld relative to the parent rail by the distance between the successive profiles. As shown, the profiles for the test welds are consistent with profiles typical of thermite welds, in which the softer HAZ wears or batters quickest followed by wear/batter of the weld metal. The maximum wear measured was less than 0.02 inches, currently with no observed strong correlation between wear and weld condition. Note that the scales in Figure 3 are different between horizontal and vertical axes.

**Figure 3. Weld Profile Overlay (Weld regions are approximate)**

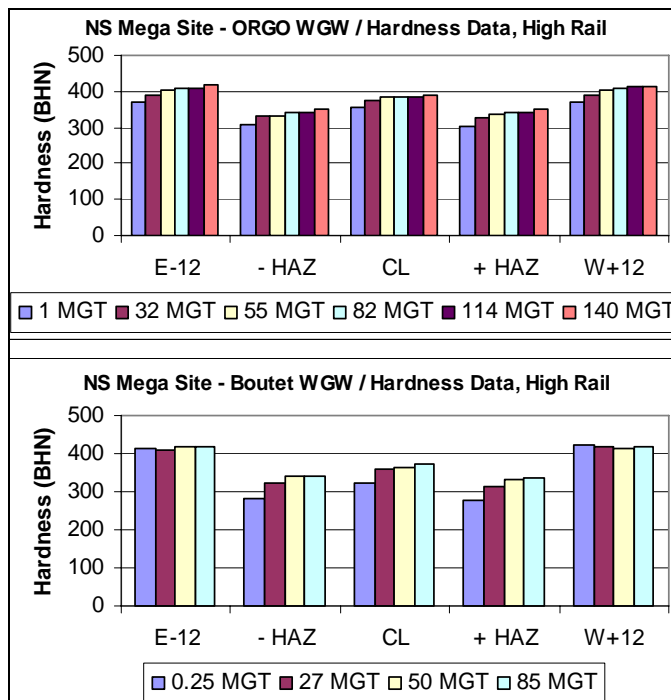
Weld surface hardness values were also measured at various MGT levels and analyzed to determine any trends. Figure 4 shows a summary of hardness test results obtained at various MGT levels for both weld products (for those welds located in the high rails). As shown, the welds experienced typical work hardening in the HAZ and at the weld centerline, meaning that surface hardness of the test welds increased with traffic. In addition, the hardness values measured at the centerline were slightly lower than those of the parent rails, which are head-hardened premium rails. As expected, the hardness results measured in the HAZ were lower than those measured for both the parent rails and the welds.

Figure 4. Average Weld Hardness for High Rail Wide-Gap Welds. (Top) Orgo-Thermite. (Bottom) Railtech Boutet.
