## Update of Experiments at the Revenue Service Mega Sites

Dingqing Li, Russell McDaniel\*, Dwight Clark\*\* and Luis Maal\*\*\*

### Summary

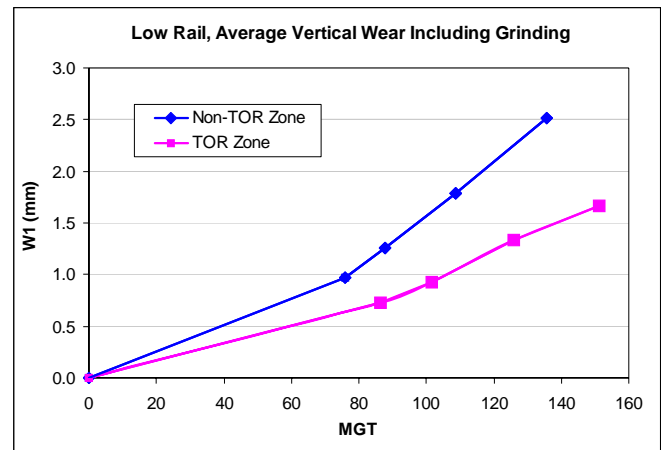
Also, at the eastern mega site, rails with mixed ages and mixed types in two groups of curves (six curves in each group) were monitored for TOR friction control performance effects on rail life. One group of curves has both GF lubrication and TOR friction control, whereas the other group has only GF lubrication. Measurements to date (150 MGT) have shown that implementation of TOR friction control reduced vertical wear by approximately 30 percent. In addition, TOR friction control reduced loss of rail metal from rail grinding operations, suggesting that TOR friction control reduced the occurrence of RCF. Figure 1 shows a comparison of average vertical wear on low rails between these two groups of curves, one with TOR friction control and the other without. Vertical wear shown in Figure 1 included both natural wear and loss of metal from rail grinding.

Figure 1. Effect of TOR Friction Control on Low Rail Vertical Wear

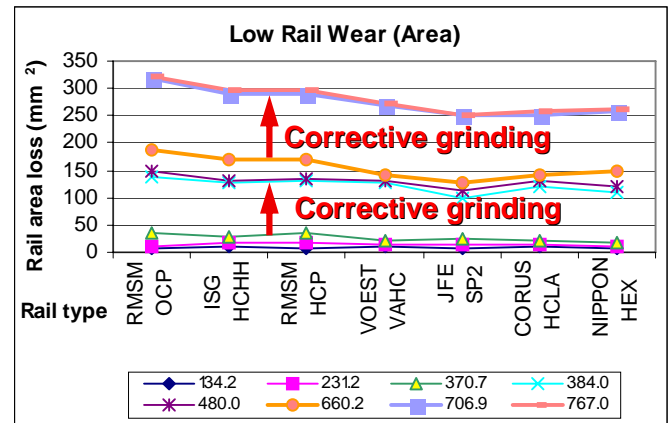
has three rail test curves with curvatures in the 1- to 2-degree range. All test rails have shown excellent wear performance with projected minimum wear lives of 2,800 MGT.<sup>1</sup> But RCF became a problem for the 2-degree test curves, which required corrective grinding on the low rails at 375 MGT and then again at 690 MGT (see Figure 2). The high rails also required corrective grinding to remove RCF at 690 MGT.

Figure 2. Loss of Rail Metal due to Natural Wear and Corrective Grinding at Western Mega Site

Starting in September 2008, the focus of the premium rail test at the western mega site was shifted to rail life extension using TOR friction control or preventive grinding. To accomplish this, one 2-degree test curve was set up with a TOR friction control unit, while a regimen of one-pass preventive grinding every 60-90 MGT was implemented on the other 2-degree curve. Because of little RCF on the 1-degree curve to date (880 MGT), no TOR friction control or preventive grinding has been implemented on this curve. Currently, performance monitoring is ongoing regarding these practices to prevent RCF and thereby extend rail life.

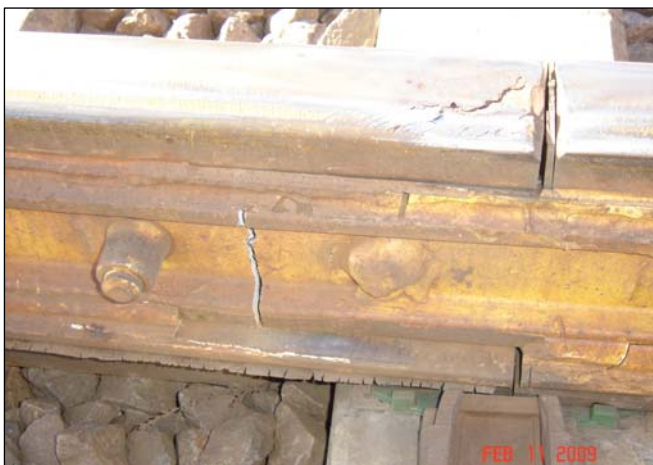
Eight test IJs were installed at the western mega site in the summer of 2004.<sup>5</sup> Seven IJs had an improved design; whereas, one, which failed at 330 MGT in 2006, used a traditional design. This test was concluded in 2007 in terms of measuring load environment data of these test IJs, but monitoring of their long-term performance continued. After approximately 1,000 MGT, two of the seven test IJs failed from cracked joint bars, resulting in a life at least three times as long as the conventional design. Figure 3 shows a failed IJ due to a cracked joint bar. Notice the rough running surface that generated high wheel impact forces and contributed to the breakage of the joint bar.

Figure 3. IJ Failed due to Crack Bar at 1,090 MGT

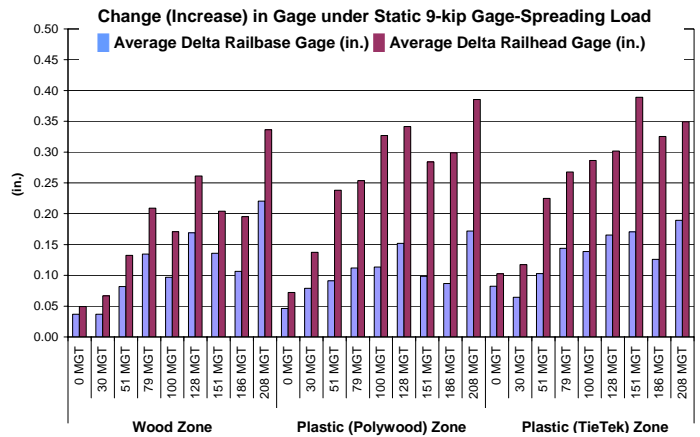
At the eastern mega site, performance monitoring of two types of plastic ties installed on a 6.8-degree curve has been ongoing since November of 2004. After 250 MGT, these plastic ties continue to perform well. Figure 4 shows gage strength degradation test results using a lightweight track loading fixture for two types of plastic ties and for wood ties located in the same curve. Although showing slightly higher gage spreadings, these plastic ties have exhibited gage strength degradation trends similar to the wood ties.

Figure 4. Gage Strength Degradation for Plastic Ties

In April 2009, the entire test curve was regaged due to wide gage issues in the adjacent spirals (equipped with wood ties) of the same curve. Note that the regaging operation for plastic ties followed the same procedure used for wood ties in terms of spike removal, spike hole filling using a synthetic material, and respiking the tie plates. Predrilling was done only for the spikes next to the side edges of the plastic ties. Except for a small crack on two ties, respiking did not cause cracking problems for plastic ties.

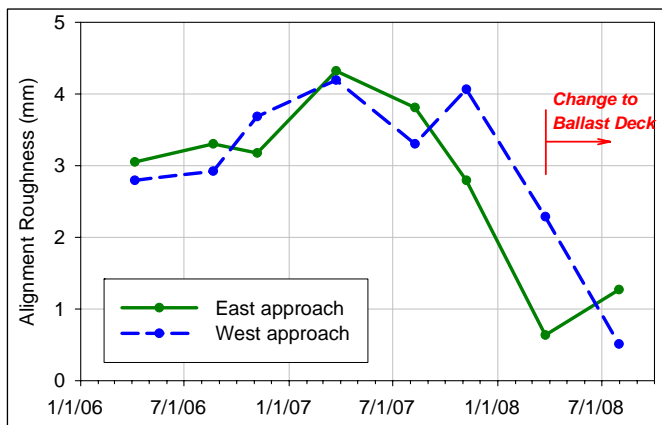
At the eastern mega site, the problems are associated with open deck steel bridges located in sharp curves, which tend to have track alignment and cross-level problems, mainly because of inconsistent lateral track strength (at both the rail-tie and tie-ballast/bridge girder interfaces), skewed bridge abutment, and in some cases subgrade issues. One effective remedy is to replace the open deck with a ballasted deck, which essentially addresses the lateral track strength and cross-level support issues. Two bridges located in 10- to 11-degree curves, which had required track geometry maintenance on a monthly basis in the past, have not had any track geometry issues since deck replacement in September 2007 and March 2008, respectively.

Figure 5 shows the improvement in the lateral alignment problem (in terms of roughness, which is a mean square calculation based on actual track geometry car alignment data) for the two bridge approaches to an open deck steel bridge located in a sharp curve. As shown, alignment roughness was significantly higher prior to the remedy (deck replacement) than after the remedy.

Figure 5. Improvement in Alignment due to Deck Change

Change from an open deck to a ballasted deck, although effective, is an expensive remedy and will not address bridge approach problems caused by subgrade issues. Currently, TTCI is investigating alternative remediation methods, which can be less expensive or can address subgrade problems.
