Bridge Approach Remedies in Revenue Service

Dingqing Li, Abe Meddah, Bill GeMeiner* and Russ McDaniel**

Summary

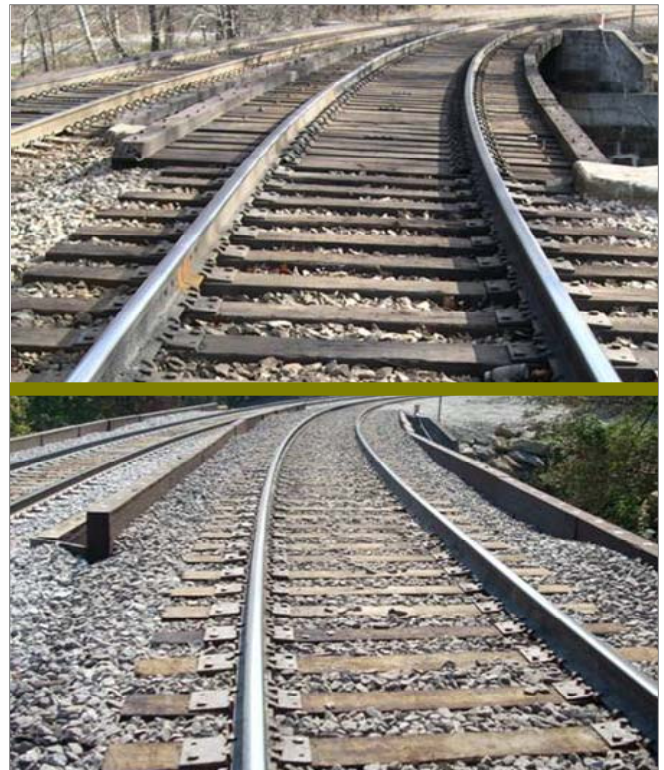
Figure 1 shows the bridge located at MP 352.2 before and after deck replacement. Prior to implementing this remedy, ties on the bridge were fixed to the deck and the rails were fastened to the ties with elastic fasteners. In addition, tie spacing was smaller on the bridge than in the approaches, all of which led to inconsistent lateral track strength from the bridge to its approaches. When the track in the approaches moved laterally due to temperature changes, which can be as large as several inches in a sharp curve, the track on the bridge could not move, thus leading to misalignment. Over time, the misalignment would not only grow and worsen but would also cause significant vehicle/track interaction problems.

Figure 1. Open Deck (top) to Ballasted Deck (bottom)

As a result of the deck replacement, the track is now essentially the same from the approaches to the bridge, allowing the track to deform laterally in the same manner. In addition, this remedy has eliminated the cross-level differential support issue, because the ballast now supports all ties at the ends of the bridge.

The remedy selected was to change from open deck to ballasted deck, which resulted in two important improvements: The lateral track strength (panel shift strength at the tie-ballast interface and gage strength at the rail-tie interface) is now consistent from the bridge to the approaches, which allows the track on the bridge to move laterally, due to temperature change, in a consistent manner with the track in the approaches. Further, there is now a smooth ballast layer transition from the approaches to the bridge, eliminating the cross-level differential support issue due to the skewed back wall.

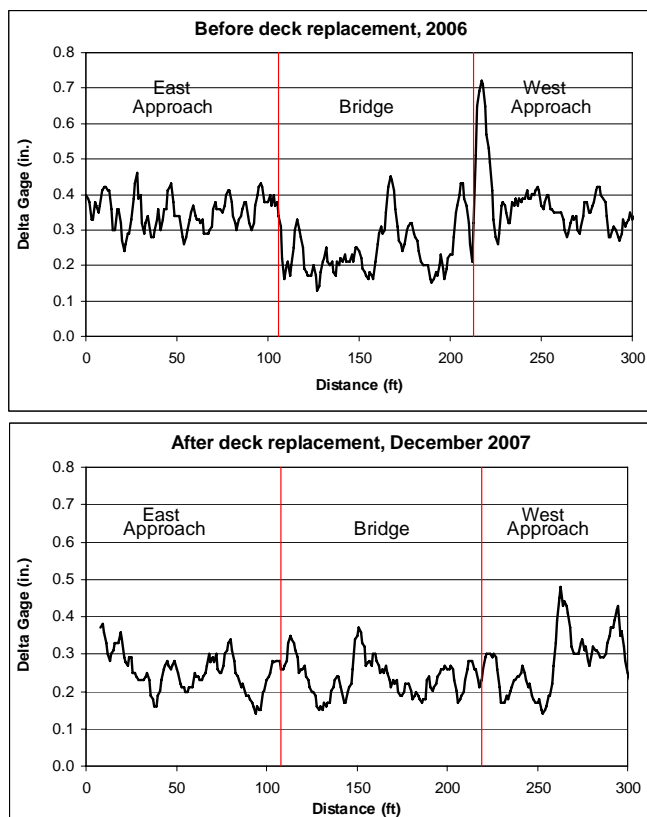
Figure 2 shows a comparison of lateral gage strength measured for the bridge located at MP 352.2 and its approaches. Prior to deck replacement, delta gage (loaded track gage minus unloaded track gage under constant vertical and lateral test loads) was significantly lower for the track on the bridge than for the track in the approaches. In other words, the track on the bridge had higher gage strength than the track in the approaches. After deck replacement, gage strength is now more consistent.

Figure 2. Gage Strength Comparison

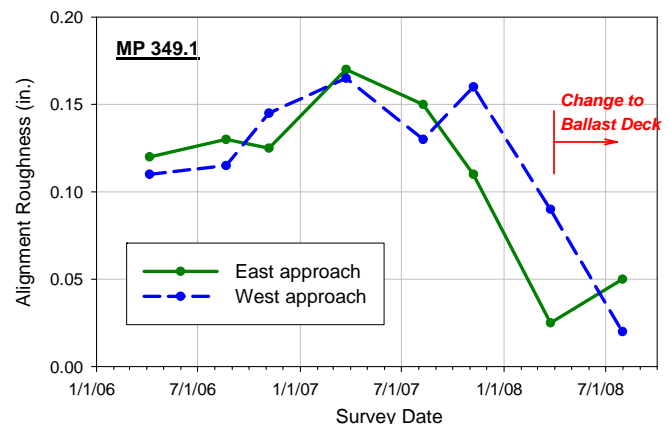
Figure 3 shows track geometry performance for the bridge at MP 349.1 and its approaches. Lateral misalignment is shown in terms of roughness, which is a mean square calculation based on actual track geometry car

alignment data. As shown, alignment roughness was significantly higher before the remedy was implemented. Similarly, track geometry in vertical plane (surface and cross level) has improved greatly.

Figure 3. Reduction of Alignment Roughness from Remedy

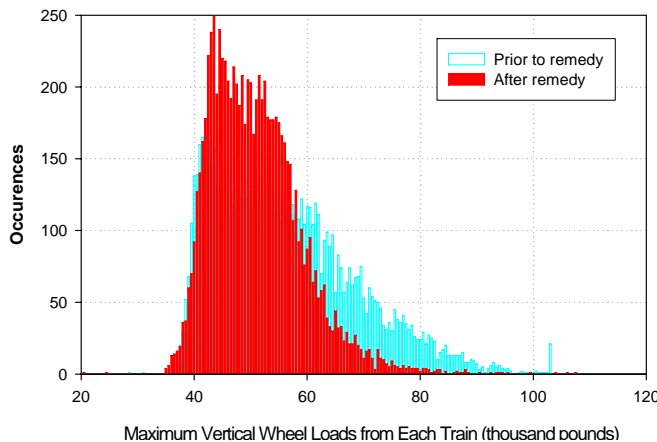
Figure 4 shows the reduction in wheel impact forces measured using the instrumentation at this test location. Each histogram is a summary of maximum wheel loads recorded from a large number of passing trains. As shown, there has been a significant reduction in large impact forces as a result of this remedy, especially in the range of 60,000 to 105,000 pounds.

Figure 4. Reduction of Impact Forces from Remedy

Union Pacific, with consultation from TTCI, decided to test a remedy using concrete ties fitted with rubber pads on the bottom of the ties. In September 2007, standard concrete ties on a short span concrete bridge were replaced with ties fitted with rubber pads. Also, as part of the track work, fouled ballast was replaced and track drainage was improved.

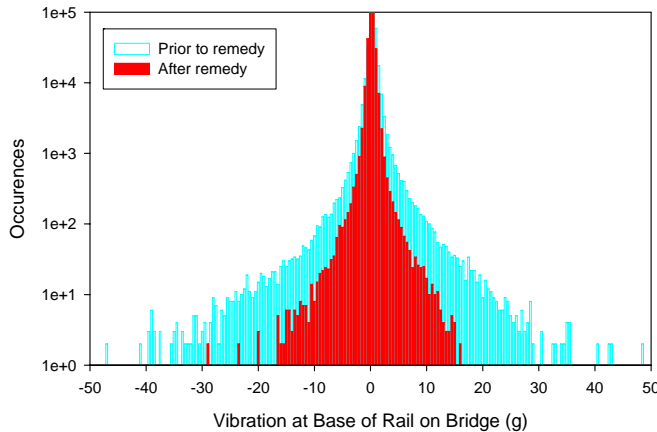
As part of these measurements, vibration of the track was recorded at various track locations before and after remediation. Figure 5 shows a comparison of the vertical vibration results taken at the base of the rail for the track on the bridge. Consistent with what is shown in Figure 4, installation of the remedy led to a significant reduction in high amplitude vibration expressed in terms of acceleration.

Figure 5. Reduction of Vibration from Remedy

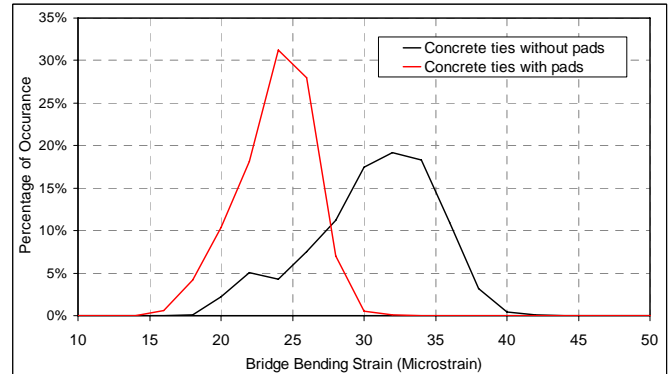
Strain gages were installed on the bottom surface of the concrete bridge at the center of the span. Figure 6 shows the reduction in bending strains measured under HAL train traffic. On average, a 30 percent reduction in dynamic bending strains was achieved by implementing this remedy.

Figure 6. Reduction in Bending Strains from Remedy
