## Bridge Life Extension through Ultrasonic Impact Treatment of Weld Details

Duane Otter and Brian Doe

### Summary

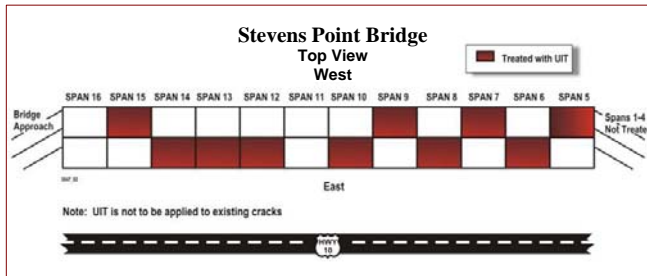
**Figure 1: Schematic of Test Bridge and UIT Application Pattern**

The CN bridge at Stevens Point was selected because it has many spans that are reasonably accessible, and it already had some fatigue cracks, indicating the likelihood of more cracks to occur in the near term. This bridge offers about 200 weld details for this study. Figure 1 shows a schematic plan view of the bridge and the portions treated. Span 11 was not included in the test because it is over water. Spans 1 through 4 were not included because a number of cracks in those spans had previously been repaired or retrofit. The treatment pattern alternates to minimize differences from one rail to another.

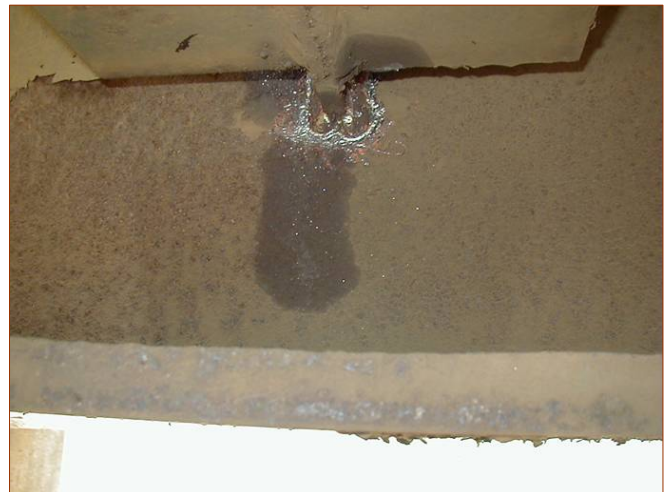
**Figure 4: Treated Weld Detail between Beam and Cross-Frame Member**

Figure 2 shows an overview of the test bridge. Figure 3 shows the bottom side of a typical span. The details of concern are the welds between the beams and the cross-frame diaphragm members. Figure 4 shows a typical weld between a cross-frame and a beam, after application of UIT. Note the UIT leaves a hammered white metal finish.

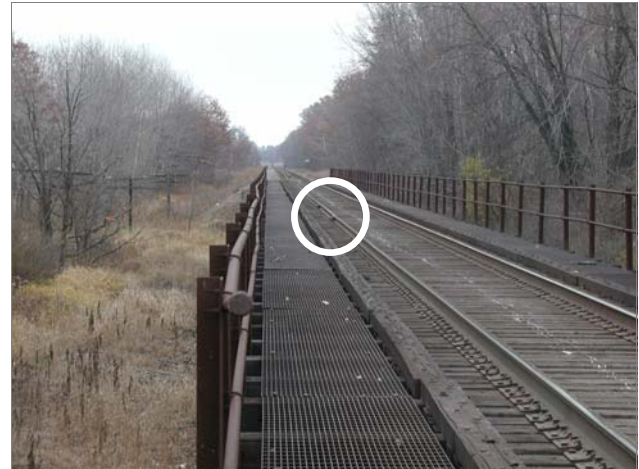
**Figure 5: Bolted Rail Joints on East Rail above Span 5 and Span 6**

During the most recent inspection, a total of five new cracks were found. Two of them were located in spans 5 and 6. The remaining three were in the remaining nine spans in the test. Spans 5 and 6 had bolted rail joints from a rail plug repair. It is likely that the bolted rail joints caused increased impact forces leading to the higher rate of crack initiation in these spans. In addition, several existing cracks grew significantly, particularly in span 5. The new cracks and crack growth in spans 5 and 6 were under the east rail with only one exception, as shown in red on Figure 6. The bolted rail joints were also on the east rail.

Increased fatigue crack initiation and growth under rail joints have previously been noted on the steel bridge at the Facility for Accelerated Service Testing. It is important to remove bolted rail joints from bridges as soon as possible to minimize the chances of crack initiation and growth in steel bridges.

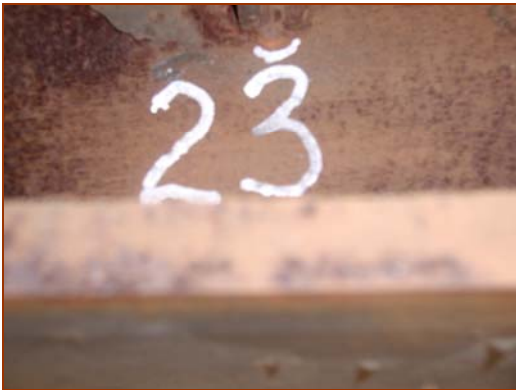
Figure 7 shows the crack in detail number 23 on span 6. It propagates from the untreated weld on the opposite side through the web and through the UIT that was applied only to one side of the web. A bolted rail joint is located above this detail.

Figure 7: Crack in Partially Treated Weld in Span 6

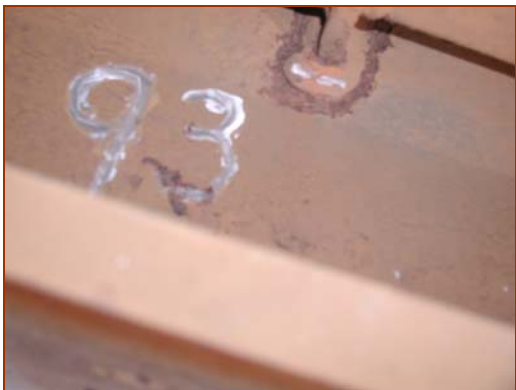
Figure 8 shows the crack in detail 93. Detail 93 was treated at the toe of the weld to the beam web. But the crack appears above the treatment on the untreated toe of the weld to the stiffener.

Figure 8: Crack in Weld above Treatment Application in Span 10

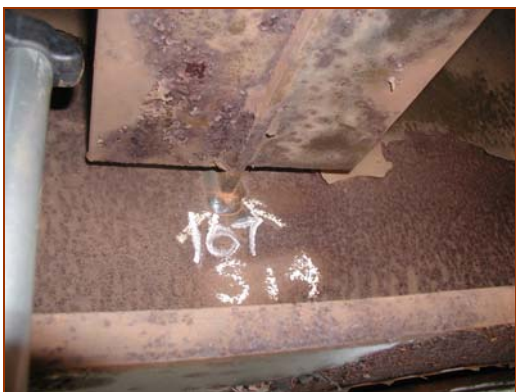
Figures 9 and 10 show additional cracks found in the most recent inspection.

Figure 9: Crack in Weld above a Previous Crack in Span 14

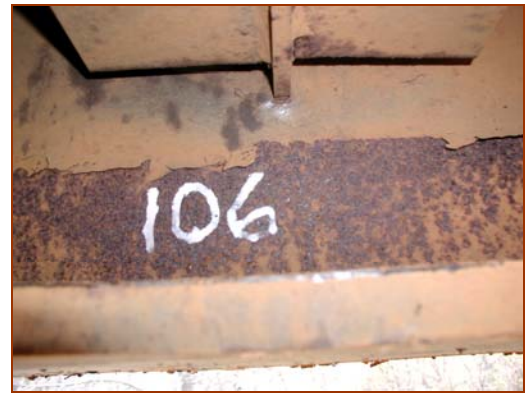
Figure 10: New Medium Crack on Previously Okay Detail in Span 10
