## Evaluation of Wheel Performance over Flange Bearing Frog Crossing Diamonds in Revenue Service

David D. Davis and Rafael Jimenez

### Summary

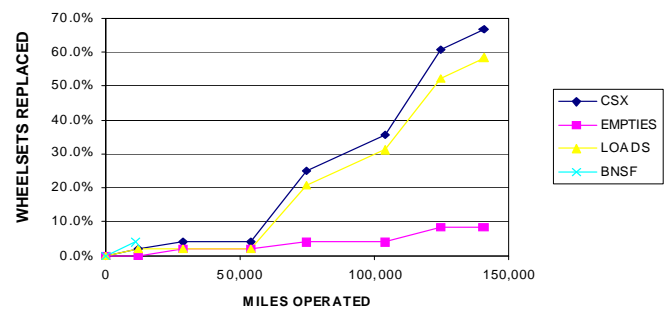
Figure 1. Wheel Removals for FBF Inspection Fleets

The CSX and BNSF waiver fleets have been operating at relatively high rates of usage for up to 3 years. The waiver requires that 60,000 miles per year are accumulated. For loaded cars in the fleets, this is a high amount of traffic, which is equivalent to the loaded mileage accumulated by 120,000 miles of operation. Each fleet contained components that had been in service before FBF diamond-crossing operation began. Thus, a wide range of wheel conditions were present at the start of the tests. Figure 1 shows a plot of wheelset replacements versus miles operated since the beginning of FBF diamond operation.

As expected, the removal rate of wheelsets in the loaded cars is higher than the removal rate of wheelsets in the empty cars. Note that two-thirds of the CSX fleet wheelsets were replaced during the 2.5 years of FBF diamond operation. None of the replacements were due to flange bearing. They were typical wheel axle and bearing failures found in freight car operations, with mostly wheel tread defects, wheel tread wear, and bearing related defects. Figure 2 shows typical tread shell defect wheels.

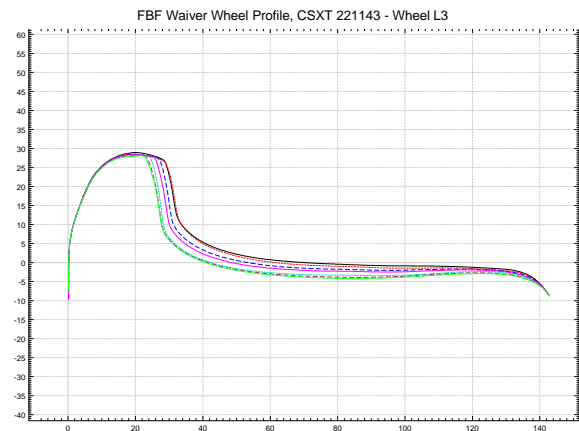
Figure 3. Time Series of Wheel Profiles for CSXT 221143 L3 (Load)

Figure 3 shows a time series of wheel profiles for car 221143 3L — a loaded car. The profiles show very little change in shape over time. The flange tips flatten from their nominal 0.5-inch radius to a 5- to 7-inch radius surface with sharper corners. As Figure 3 shows, there is no gross deformation of the rest of the flange.

The profile match over eight inspections is good on the back side of the flange. Wear from curving is seen on the tread side of the flange. These profiles demonstrate that contact stresses are manageable in flange bearing. Wheels do stabilize under these operating conditions with minimal plastic flow. Wear of the flange quickly becomes the dominant cause of flange height loss. However, wear of the tread is likely to be higher for most revenue service operations.

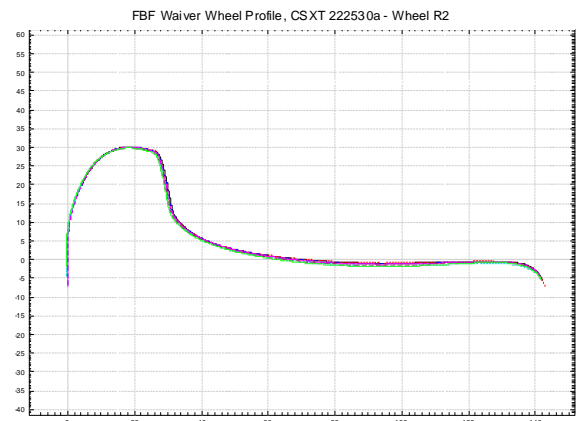
Figure 4. Time Series of Wheel Profiles for CSXT 225530 R2 (Unloaded)

Figure 4 shows a time series of wheel profiles for car 225530 2R — an empty car. These profiles show even less change in shape over time. The empty car shows less vertical and lateral (curving) flange wear than the loaded car, as would be expected.

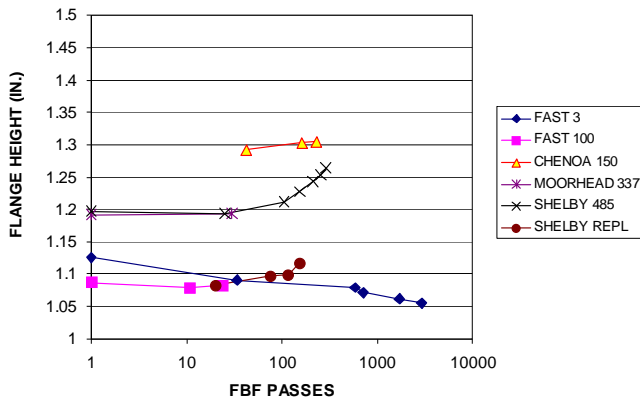
Figure 5. Comparison of CSX FBF Fleet Flange Height to Various Flange Bearing Operations

The effect of FBFs on wheel wear was determined from the running surface profiles taken during quarterly inspections. Figure 5 shows the time series of wheel flange height measurements for a range of flange bearing operations. The CSX FBF fleet (500 miles per FBF pass) is performing similarly to Rail America locomotives using a One Way Low Speed (OWLS) diamond at Chenoa, Illinois (150 miles per FBF pass), the BNSF waiver fleet operating over FBF

diamonds at Moorhead, Minnesota (337 miles per FBF pass), and the train cars at FAST running over test diamonds at the rate of one diamond per 100 miles. CSX FBF fleet loaded car data are shown for direct comparison to the other loaded car operations. On this graph, the CSX FBF fleet is divided into two groups (1) original wheels and (2) replacement wheels. Original wheels were in the cars prior to the start of FBF operations, and replacement wheels were installed after the start of FBF operations.

All groups, with one exception, show the same trends. Flange height remains relatively constant for the first 10-30 FBF passes. Beyond about 30 FBF passes, flange heights increase. This indicates that initial flange height losses are similar to wheel tread height losses. Initial flange height losses can be larger than subsequent losses due to the deformation of the flange tip to a conformal shape. After the initial “wear-in” period, the flange tip shape stabilizes and flange height loss rates are reduced below tread height loss rates. After the first few passes, wheels behave as they do in preflange bearing days, with wheel flange heights increasing over time.

The fleet that did not follow this flange height growth scenario was the train at FAST during the initial prototype tests. During the first prototype test at FAST, most of the train ran over a FBF diamond every 3 miles. Under these operating conditions, the wheel flange heights decreased with mileage. Also, note that the CSX replacement wheels are performing similarly to the CSX original wheels. The replacements, which are either new or reprofiled wheels, have shorter and wider flanges. Yet the rate of flange height change is similar to the original wheels.

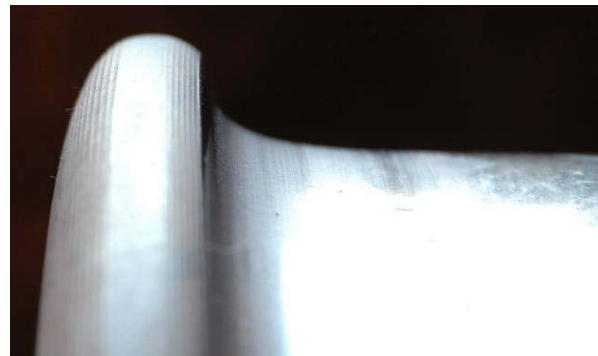
Figure 6. Flange Tip Shape for a Full Flange in Flange Bearing

The other factor affecting the flange tip shape is the back-to-back spacing of the wheelset. On wider-spaced wheelsets, the flange bearing surface is sloped toward the tread side of the wheel. On narrower-spaced wheelsets, the flange bearing surface is sloped away from the tread. This reflects the relationship of the wheel flanges to the worn grooves in the one FBF diamond they encounter. Because the cars are not turned at either yard, the same wheels contact the same side of the diamond on each pass. Figure 6 shows a typical full flange tip contact shape.
