Testing of 1.5-inch Gap Thermite Welds at FAST

Daniel Gutscher

Summary

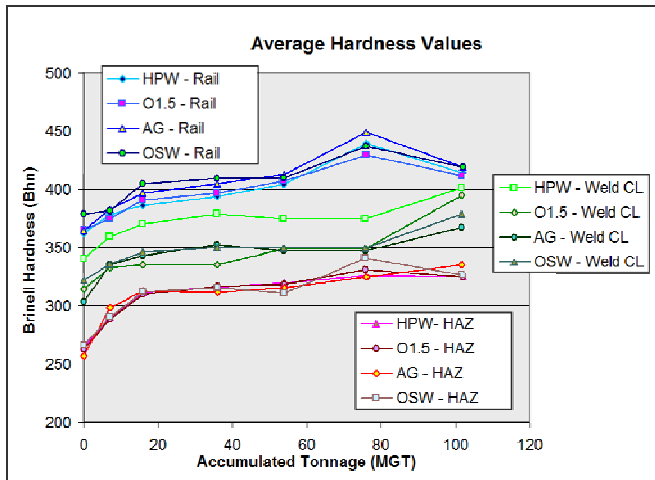
Figure 2: Average Bhn values for the test welds taken at the parent rail, the HAZ, and the weld centerline.

Figure 2 presents the average running surface hardness values for each weld type in the parent rail, the weld HAZ, and the weld metal in the center of the weld. The HAZ hardness values for the various welds were all similar, with a standard deviation of 4 Bhn. Weld centerline hardness for the alloy hardened HPW welds was on the average 27 Bhn higher than the other welds in the test. This difference was maintained from installation through approximately 76 MGT.

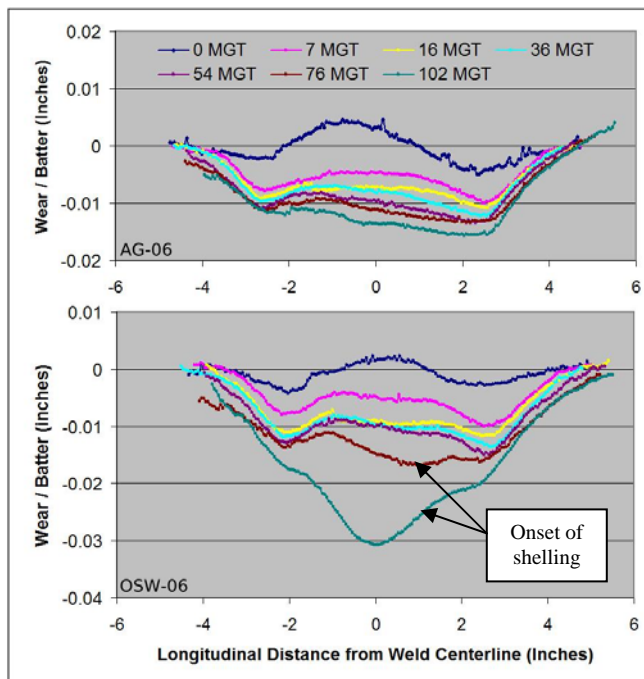
Figure 3: Longitudinal profiles on the running surface of two welds. Advanced Geometry Weld AG-06 (top), and standard 1-inch gap Orgo SKV weld OSW-06 (bottom).

Longitudinal profiles of the test welds revealed typical dips in the weld HAZ regions adjacent to the weld centerline. The weld profiles correspond generally to the hardness values in which harder regions experienced less batter than adjacent regions of lower hardness. Figure 3 shows the longitudinal profiles for one of the test welds (top) and one of the control welds (bottom). The profiles shown are typical for all the welds in the test. The welds showed similar profile degradation when shelling occurred, regardless of weld type.
