Results of Thermite Railhead Repair Weld Testing at FAST

Daniel Gutscher

Summary

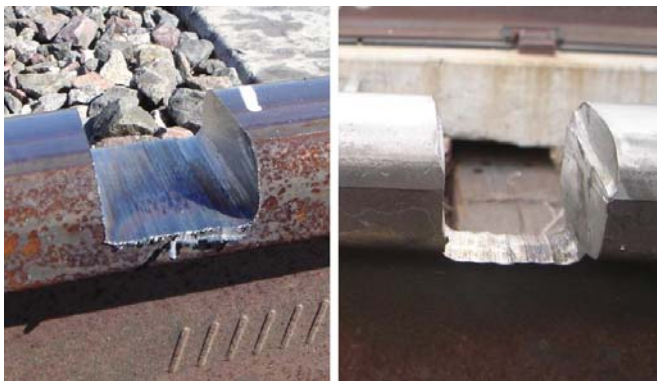
Three sets of welds were installed at FAST. The first set of welds was the Orgo-Thermit 1 1/8-inch depth Railhead Repair Weld (OW-1 group) installed in February 2008. This set consisted of 10 welds installed throughout the high rail in HTL Section 31, which is a 5-degree curve with 4-inch superelevation. The second set of welds was the Orgo-Thermit full-head depth Head Repair Weld (OW-2 group) that was installed in April 2008. The OW-2 group of welds was also installed in HTL Section 31. The last set of railhead repair welds was the Railtech Boutet Head Wash Repair Welds (BW-1 group) with a 1-inch depth slot. The BW-1 group of welds was installed in October 2008 in HTL Section 3, which is also a 5-degree curve with 4-inch superelevation. Figure 1 shows the slot depths for the BW-1 and OW-2 group welds.

Figure 1. Ground Slots for Railhead Repairs. Railtech Boutet 1-inch Depth Slot (left) and Orgo-Thermit Full-Head Depth Slot (right)

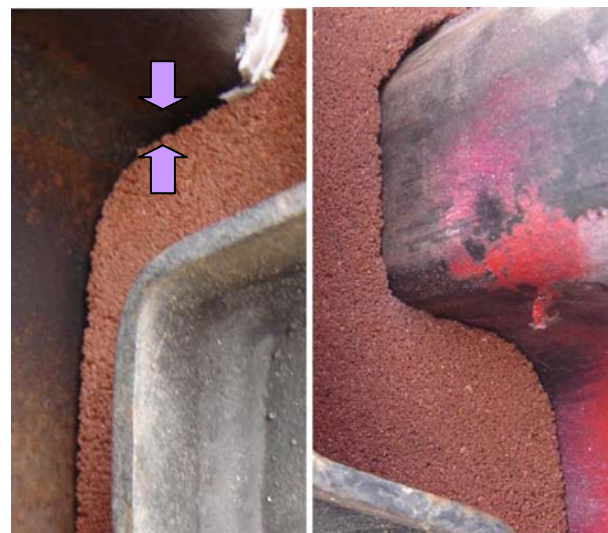
During the initial laboratory investigation of the OW-1 welds, significant cold lapping was observed under the railhead. Both OW-2 and BW-1 groups did not have any cold lapping under the railhead in the laboratory test welds. During installation at FAST, however, all three weld types experienced problems with cold lapping. This was determined to be a design issue for the OW-1 group and a procedural issue for both the OW-2 and BW-1 groups.

Molds from both manufacturers were designed to be used on head-worn rail. As a result, when installing the welds in newer rail, the molds must be filed to ensure they properly fit with the rail. A common practice in thermite welding is to rub the molds against the rail to achieve a good fit. When this occurs, the mold is rubbed away in areas under the railhead. It can create a gap between the mold and the rail that allows liquid metal to flow beyond the fusion zone and cold lap against the bottom of the railhead. Therefore, it is important that welders be instructed to minimize rubbing and use a file-to-fit practice when possible. Figure 2 shows the gap that may form if the mold does not fit properly under the railhead.

Figure 2. Fit under the Railhead Poor Fit (left) and Good Fit (right)

Both manufacturers have continued to improve their products since installation at FAST. Each now produces weld molds specifically designed for various rail sections. This will also reduce the occurrence of cold lapping under the railhead.

- Rubbing of the molds against the rail to improve the fit can result in the formation of a gap between the rail and the mold under the railhead. The best practice is file-to-fit rather than rub-to-fit weld molds when possible.

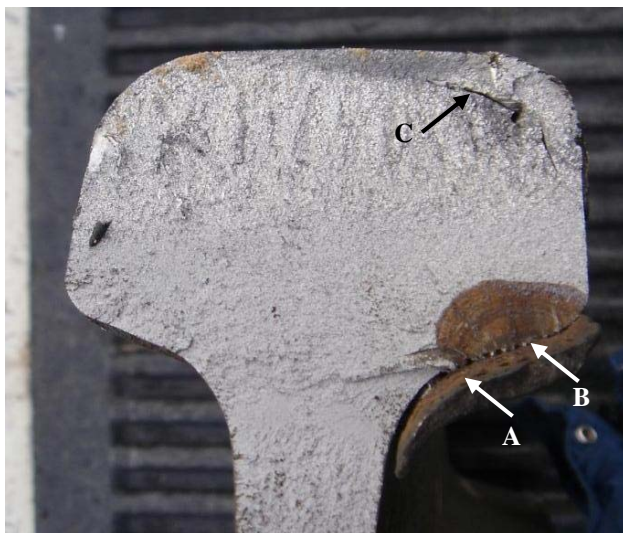
Weld failures that occurred during the test were generally vertical fractures that initiated under the railhead. Shelling also occurred. Cold lapping under the railhead creates stress risers that promote the initiation of fatigue cracking. Figure 3 shows a fracture that started at the underside of the railhead at a flashing. All weld breaks that occurred during the test period fractured transverse to the rail with the breaks following the arc of the heat-affected zone to the bottom of the weldment and then fracturing vertically through the base of the rail. Figure 4 shows the fracture pattern for two Orgo-Thermit welds.

Figure 3. Fatigue Fracture of a Railhead Repair Weld. (A) Cold Lapped Weld Material under Railhead (B) Fatigue Fracture Initiation Site (C) Subsurface Shelling at Gage Corner

In research conducted previously by TTCI, cold lapping at the weld collar to rail transition in the web and base of the rail was identified as a stress concentrator.² Cold lapping acts as a preexisting crack that serves as an initiation site for fatigue cracking in welds. Cold lapping under the railhead can contribute to fatigue failures in a similar manner to cold lapping observed under the rail base.

- When fitting the weld mold to the rail, it must fit well under the railhead. Failure to ensure a proper fit can result in significant cold lapping or flashing under the railhead, which can act as initiation sites for fatigue failures.

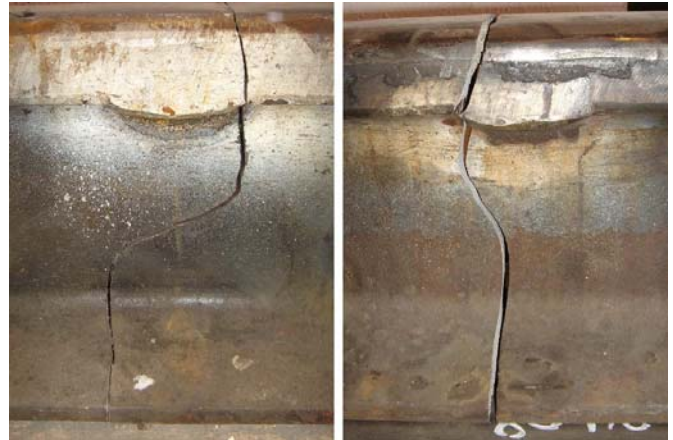
Figure 4. Photos Showing Typical Railhead Repair Weld Fractures

Of the 10 OW-1 group welds, two were removed due to vertical fatigue fractures, and three were removed due to shelling at the gage corner of the rail. Both of the welds that failed due to fatigue had been installed above ties. The remaining welds from the OW-1 group accumulated approximately 132 MGT. The OW-1 group welds received maintenance grinding to reduce the impact of shelling on the gage corner of the rail. Manual grinding was performed at approximately 35 and 50 MGT on welds as needed using a standard post weld grinder.
