Performance of Diamond Crossing at Northport, Nebraska

Dingqing Li, Rafael Jimenez, David Davis, and Ed Kohake (UP)

Summary

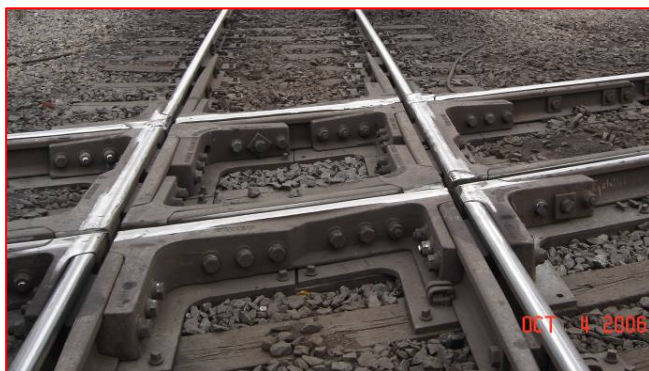
The investigation has focused on the diamond crossing on track 2 because of the higher axle loads and traffic. It is a straight rail reversible diamond and is the latest design for heavy axle load operations. Figure 1 shows the crossing that was in service in October 2006. Performance problems at this crossing include frequent track component breakage (e.g., broken castings, plates, and bolts) and rapid running surface degradation (e.g., battered and spalled rail end corners).

Figure 1. Diamond Crossing in 2006 (looking east)

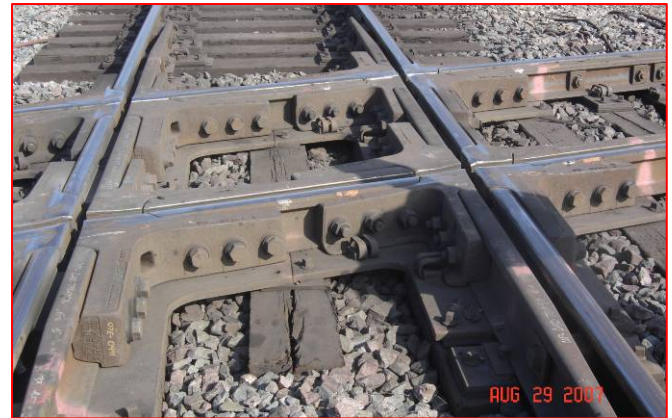
The diamond was replaced in August 2007 and then again in September 2008 due to broken components and excessive running surface degradation. Figure 2 shows the diamond design installed in 2007 and again in 2008. In comparison, the diamond crossing in Figure 1 had the casting and running rail in one piece on each side, but the diamond crossing in Figure 2 has two castings with a short rail on each side (actually creating two more joints on each side). In addition, there were changes made to improve foundation support to the diamond crossing when it was replaced in August 2007 (see Improvements and Results).

Figure 2. Diamond Crossing Installed in 2007 (looking east)

When the diamond was replaced in August 2007, another change made was to place longitudinal ties in the UP track, rather than in the BNSF track (see the comparison between Figures 1 and 2), because of higher tonnage for the UP track. The BNSF track is supported on discrete cross ties.

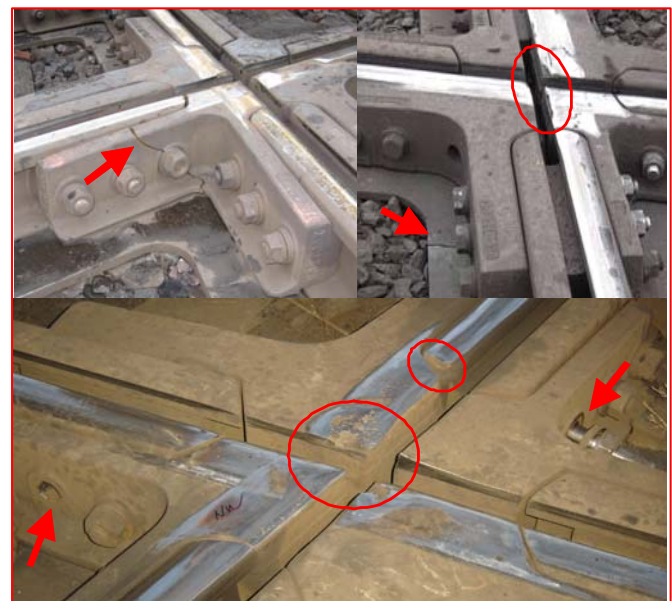
Even under a slow order speed of 25 mph, broken castings, broken plates, broken rails, broken and missing bolts, and rapid running surface degradation have been an ongoing problem associated with this crossing. Figure 3 shows some examples of these problems. This diamond crossing would require complete replacement after just over one year of operation or after 395 to 425 MGT total diamond traffic or 270 to 300 MGT on the track operating higher tonnage.

Figure 3. Broken/Missing Components (arrows) and Running Surface Degradation (circles)

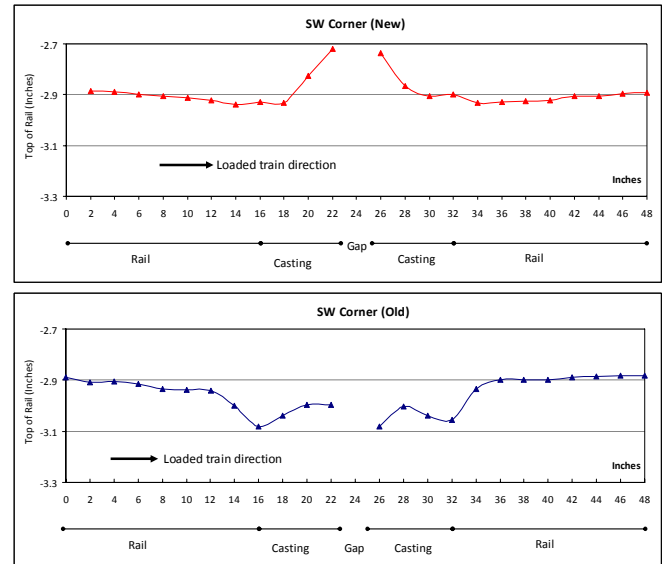
Other methods of improvement include the use of ramped corners and provision of additional resilience and damping to reduce or attenuate impact forces. Ramped corners have been implemented for the diamonds shown in Figures 1 and 2, but have not led to performance improvements significant enough to prevent frequent maintenance requirements (note that ramps are more effective for speeds higher than 25 mph, e.g., 40 mph). Figure 4 shows the running surface profiles (measured using a digital caliper and a straight edge) for a corner of this diamond when it was new and after eight months of traffic (170 MGT on the UP track). As shown, the new profile had the ramped-up surface towards the gap, but eight months of traffic led to significant profile degradation (0.2-inch dipping or 0.4-inch running surface height loss from its original position).

Figure 4. Ramped-up and Degraded Running Surface

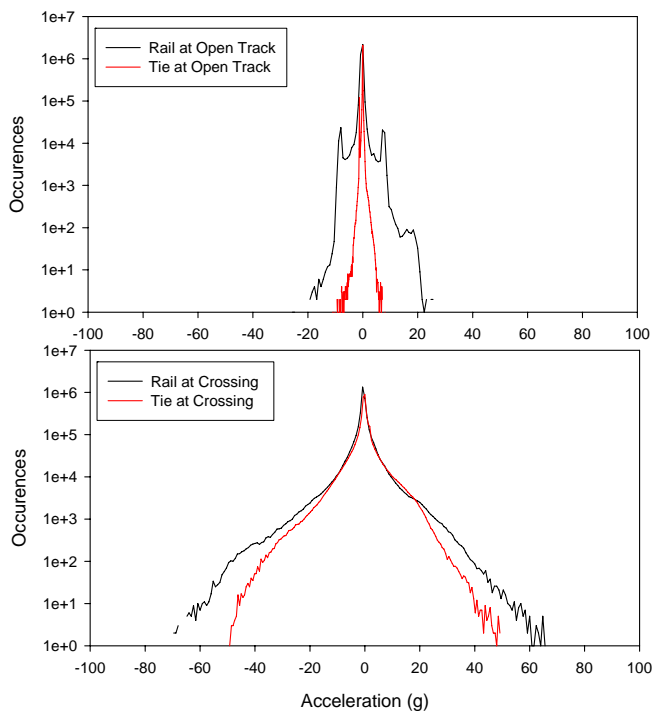
As mentioned earlier, performance improvements to date have not been significant enough for the diamond crossing installed in either 2007 or 2008. Trains are still slow ordered to 25 mph. Figure 5 shows vibration results obtained in October 2007, two months after the crossing replacement in August 2007. Note that for this vibration test, the sample rate was 4,096 samples per second with a low pass filter of 360 Hz.

In Figure 5, the graph on the top shows the results from a spot on open track about 60 feet from the diamond crossing. Acceleration results were measured from the rails to ties (see Figure 6). The graph on the bottom of Figure 5 shows the results at the diamond crossing, again from the rail to tie (see Figure 6). As illustrated, under slow ordered train operation (25 mph), vibration at the diamond crossing was at least three times as high as that measured on the open track.

Figure 5. Vibration Results between Diamond Crossing and Adjacent Open Track under 25 mph Coal Train
