Laboratory Testing of Thermite Railhead Repair Welds

Daniel Gutscher

Summary

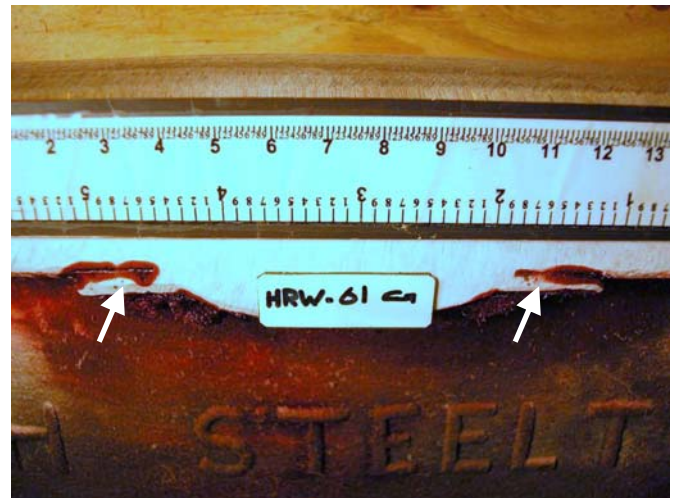
Visual inspection of the as-received OW-1 samples revealed severe cold lapping on the bottom of the railhead. Orgo-Thermit eliminated the cold lapping by increasing the slot depth to remove the full railhead. The OW-2 weld and the BW-1 welds did not have any cold lapping under the railhead. Dye penetrant and magnetic particle testing were conducted on the OW-1 samples to determine the extent of the cold lapping. Figure 1 shows dye-penetrant testing of an OW-1 weld.

Figure 1. Dye Penetrant Examination of Cold Lapping under the Railhead of the 1/8-inch Depth Orgo-Thermit Weld. Arrows indicate the locations of cold lapping.

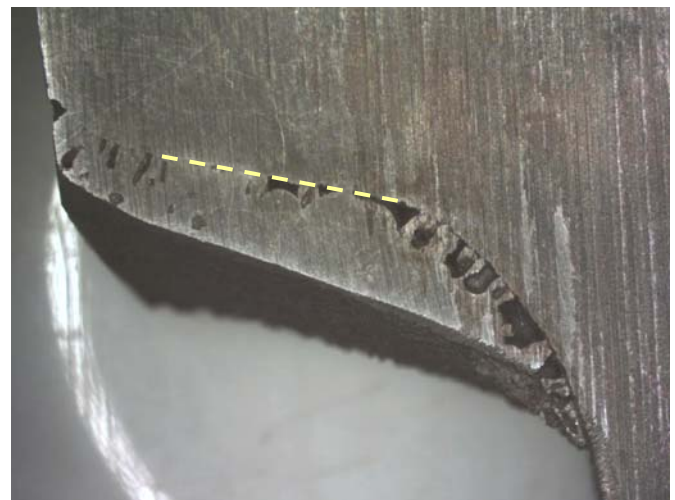
Ultrasonic inspection of all three weld types revealed a small increase in fusion line porosity compared to standard thermite welds. The porosity was found using a 70-degree probe on the side of the railhead aimed in the direction of the weld fusion line boundary near the top of the rail. In the OW-1 welds, severe porosity was associated with the cold lapping that occurred under the railhead. Porosity under the railhead is very difficult to detect ultrasonically as it is located immediately under the nonwelded portion of the railhead. The

ultrasonic inspection technician sees what appears to be the normal back-wall reflection from the bottom of the railhead and cannot see the underlying material. This can give the false impression of good porosity free material. Figure 2 shows porosity in the cold-lapped region under the railhead.

Figure 2. Transverse Cut of an OW-1 Weld showing Porosity in a Cold Lap under Railhead. Dashed line indicates location of bottom of railhead.

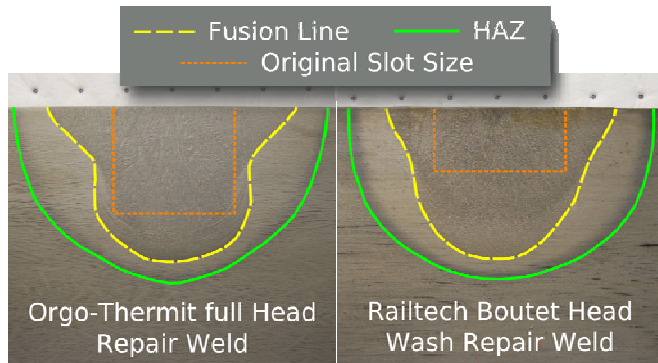
Macro etches were made of the welds. Samples were prepared by making vertical cuts in the longitudinal direction along the weld centerline. The resulting surfaces were ground and etched to reveal the weld macrostructure. No weld defects, such as porosity or lack of fusion, were observed in the sections for either manufacturer. Figure 3 shows the weld macros for OW-2 and BW-1. The approximate original slot size is included for reference purposes. In general, both welds had similar heat affected zone widths at the top of the rail although the overall width of the welds varied by 0.6 inch.

Each had similar depths of penetration having a difference of 0.17 inch. Table 1 shows the weld dimensional characteristics measured from the macrosections for both manufacturers.

Figure 3. Longitudinal Cross-section Macro-etches of Thermite Railhead Repair Welds. OW-2 (left) and BW-1 (right)

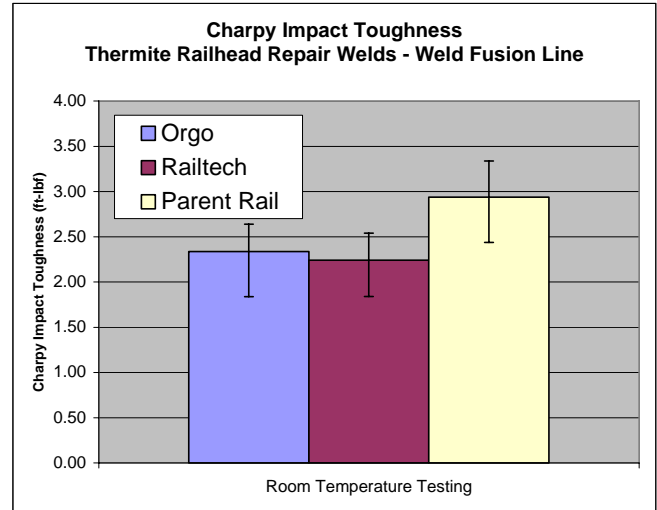
Figure 4. Charpy Impact Toughness Testing Results

tests were oriented so that the notches were located on the weld fusion line. Figure 4 shows the results for the OW-2 and BW-1 welds. The fusion line impact toughness values for both manufacturers were similar. Results for the railhead repair welds were consistent with results for standard thermite weld fusion lines.

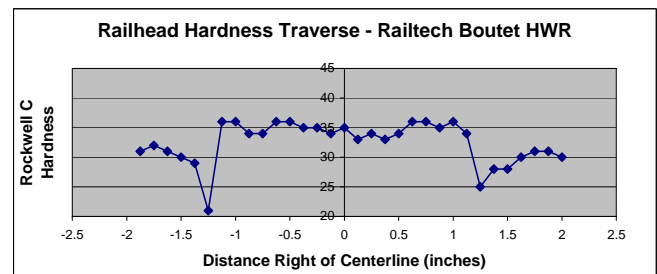
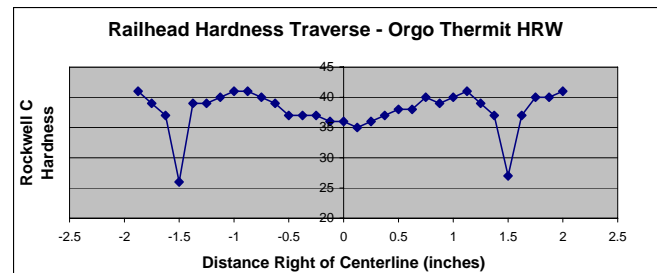
Figure 5. Hardness Traverses of BW-1 (top) and OW-2 Welds (bottom)

Internal hardness traverse measurements were performed on the welds similar to the American Railway Engineering and Maintenance-of-Way Association's procedure for testing electric flash-butt welds. Both welds exhibited the typical thermite weld hardness profiles with the adjacent heat affected zones exhibiting the lowest hardness values. Figure 5 shows the hardness traverse results for the BW-1 and OW-2 welds. The BW-1 weld in this measurement was made on standard rail and the OW-2 weld was made on premium rail.
