Shell Defect Analysis Using Scanning Electron Microscopy Techniques

Daniel Szablewski and Francisco C. Robles Hernández (University of Houston)

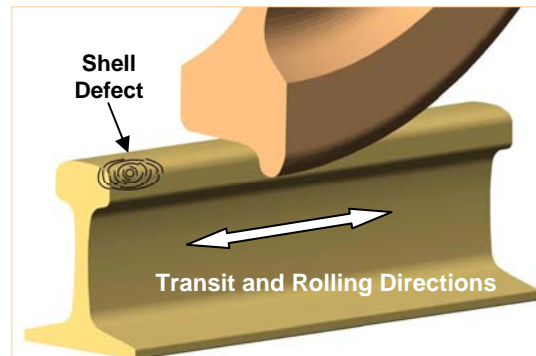
A survey of all the shell defects found on the HTL indicates that the rail shells originate as cracks in the subsurface of the high rail gage corner 1/4 to 3/8 inches from the gage corner surface of the rail, as Figure 1 illustrates. The cracks propagate in a plane parallel to the gage surface of the rail outward in all directions until they reach the head surface, resulting in shell separation from the railhead. In the cases investigated here, complete shell separation from the railhead did not take place. As a result, the shells had to be cut out of the rail using a band saw.

Figure 1. Schematic of a shell defect formed in the head region on the gage side of the railhead at FAST-HTL

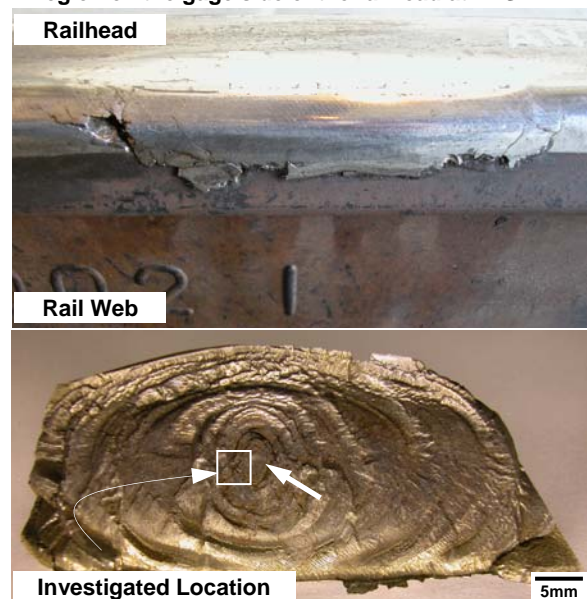
Although many of the shell fracture surfaces were severely damaged during their formation, the shell fracture growth rings (also referred to as saw tooth topology) are clearly visible on each fracture surface (see Figure 2). The characteristic steps in these saw tooth marks have previously been associated with the changes in the direction of train travel.⁹ Counting these saw tooth marks and relating that information to the number of nights the test train at FAST runs in each direction and combining that information with the MGT accumulated by the rails during that time indicates that the shell formation takes 20-40 MGT from initiation to final fracture.¹⁰

Figure 2. Rail shell defect as observed in the Railhead, and post-removal from railhead, SEM analysis location indicated.

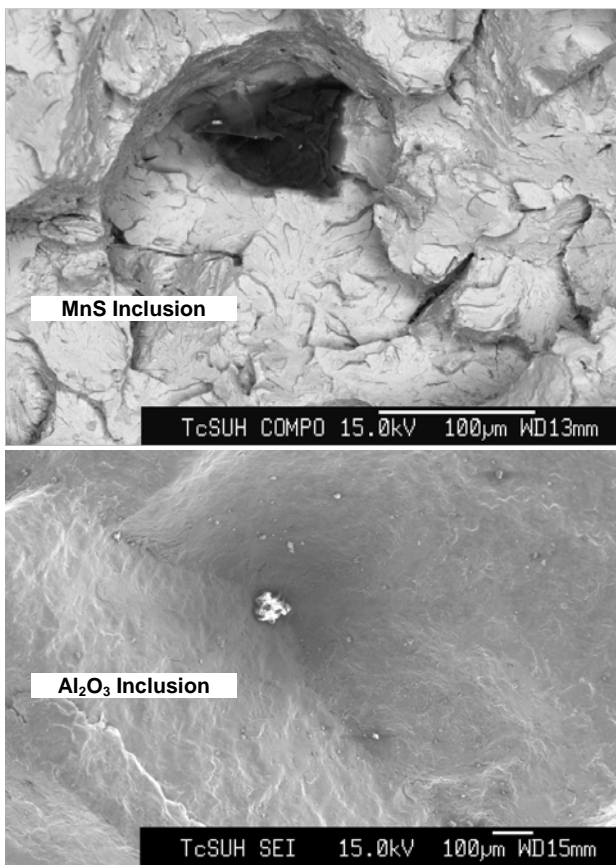
The inclusions that had a predominant presence in all the shells investigated were Al₂O₃, complex oxides and MnS. The observed inclusions ranged in size from 50 μm to 100 μm. They were located mainly in the ridges of the saw tooth marks, probably because of their stability in this location of the shelled surface. They were, however, severely damaged as Figure 3 indicates. Of particular interest is the clear evidence of cleavage (brittle fracture) that is initiated by the presence of the inclusions shown in Figure 3 (top photo). It is very likely that these types of inclusions contributed to the formation of the shell defects.

Figure 3. SEM micrographs of the MnS and Al₂O₃ inclusions present in the ridges of the shelled surface

A recommendation to eliminate shells in curved track would be to produce rails with reduced amount of inclusions, in order to reduce the amount of stress risers in the high shear stress field located in the high rail gage corner of the railhead.

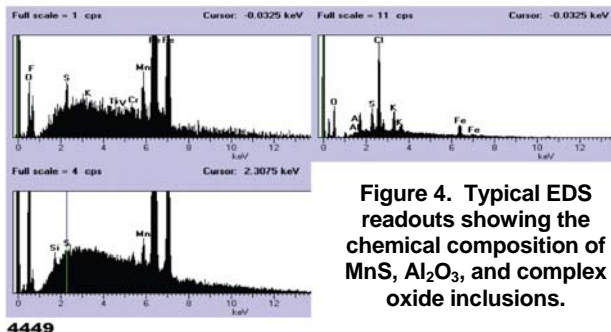
Figure 4 shows an EDS spectra attained for a soft (MnS), hard (Al₂O₃) and complex oxide inclusions, respectively. Mn and S peaks can be clearly distinguished. The presence of K, Cl, O in the inclusion is an indication of a complex oxide inclusion. Other labeled peaks indicate the neighboring steel matrix structure.

Figure 4. Typical EDS readouts showing the chemical composition of MnS, Al₂O₃, and complex oxide inclusions.
