Track Inspection Using an Instrumented Freight Car in Revenue Service

Abe Meddah, Dingqing Li, and Sirius Roybal

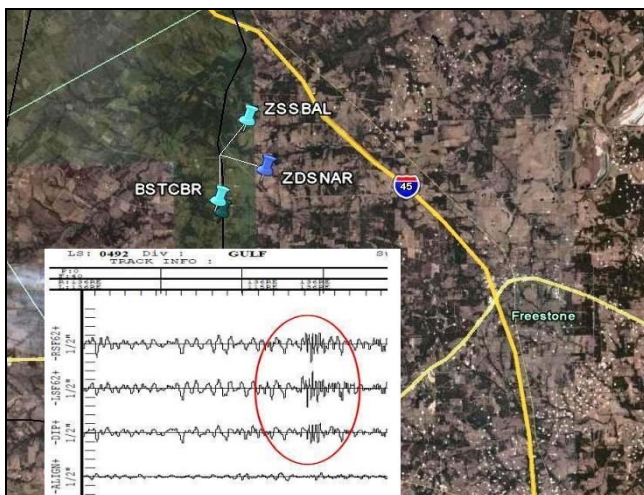
Figure 2. Muddy Track Location Identified by IFC

At an operating speed of approximately 34 mph, three different transducers exceeded the preset allowable levels and identified the track location to be an exception. The transducers that triggered the event were the vertical spring nest displacement on the right side of the car, the side bearing on the left side of the car, and the right top chord bending strain gage.

The geometry at this track location consisted of a rough surface and contained no defect as defined by current track inspection standards. Yet, an undesirable vehicle response was generated. After field verification, the track personnel determined the location had muddy ballast and required subsequent surfacing and tamping. Figure 2 shows the geometry deviations and a visual illustration of the three transducers that identified the location.

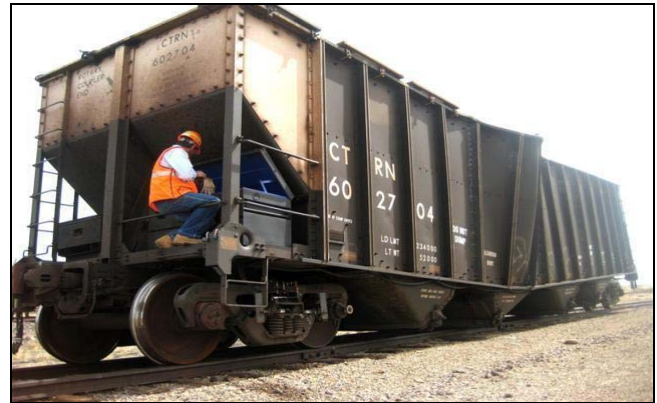
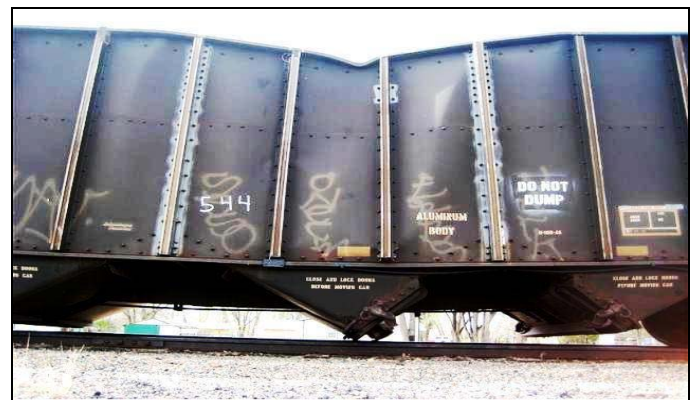
Figure 3. Buckled IFC

Another illustrative case was a track location that the IFC identified on two separate occasions. On January 23, 2009, the IFC top chord axial stresses on the left side of the car exceeded the threshold limit by about 1,000 psi, while operating at a speed of 49 mph, signaling the track location was producing an adverse vehicle response. On April 23, 3 months after the January 23 event, the IFC flagged the same location as an exception, but with unfortunate consequences this time. Both IFC top chords severely buckled. They bulged at the same spot near the chord center. Figure 3 shows two photos of the buckled IFC.

The presence of in-phase surface deviations (1.25 inches maximum) and the operating speed excited the car into a bounce mode, which produced large compressive stresses that led to failure of the top chords. The top chord stresses on the left side of the car read -41,031 psi, which is about twice as high as the threshold limit for safe operations. An operating speed of about 55 mph was recorded at the time the exception occurred. The surface deviations did not constitute maintenance exceptions as defined by current track geometry standards. Table 2 shows the two exception reports on two

separate occasions. Figure 4 displays the geometry data recorded on the day the top chords buckled. This type of car is slow ordered to 40 mph by one operating railroad to avoid top chord failures.
