Revenue Service Track Substructure Investigation

Summary

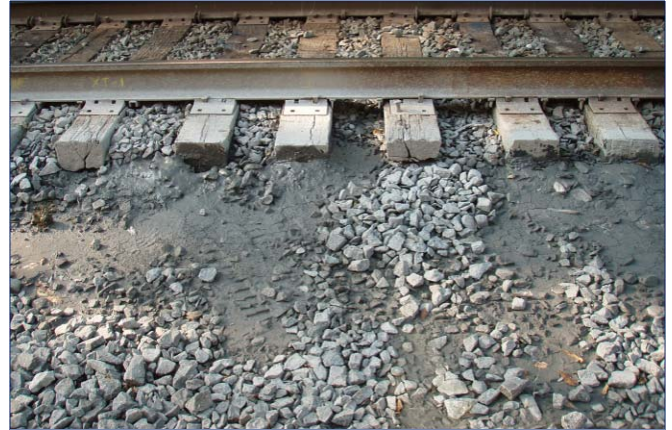
Figure 1. Site 1 Mud Spot

- Site 1 (55 MGT annual traffic) — Double track with reoccurring mud spots of moderate severity in a shallow cut area (Figure 1). There was a well-defined ditch about 12 feet from the south rail ballast shoulder.
- Site 2 (46 MGT annual traffic) — Double track with a number of severe and reoccurring mud spots creating rough track geometry on Track 1 (Figure 2). A well-defined ditch was located about 20 feet from Track 1. The adjacent Track 2 showed no sign of mud or rough track.
- Site 3 (73 MGT annual traffic) — Single track with numerous mud spots over several miles.

Three cross trenches were dug at Site 1. One trench was dug at the mud spot shown in Figure 1 and labeled XT-1, and two others were dug at nearby locations where mud was not visible on the surface and labeled XT-2 and XT-3. The substructure layer conditions at all three trenches were similar, including:

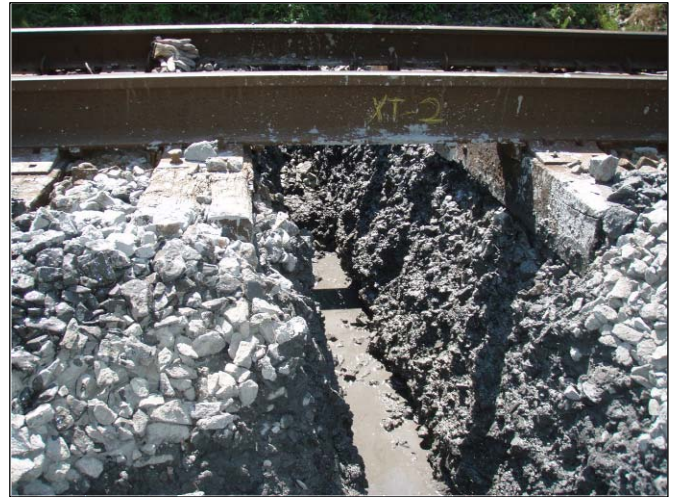
Figure 4. Water Collecting in the Bottom of XT-2 Trench

As Figure 4 shows, the granular layers at all three trenches were very wet and the bottom of the trench filled rapidly with water seeping from the exposed faces of the layers. The amount of water indicated substantial moisture was being retained in the upper ballast layer.

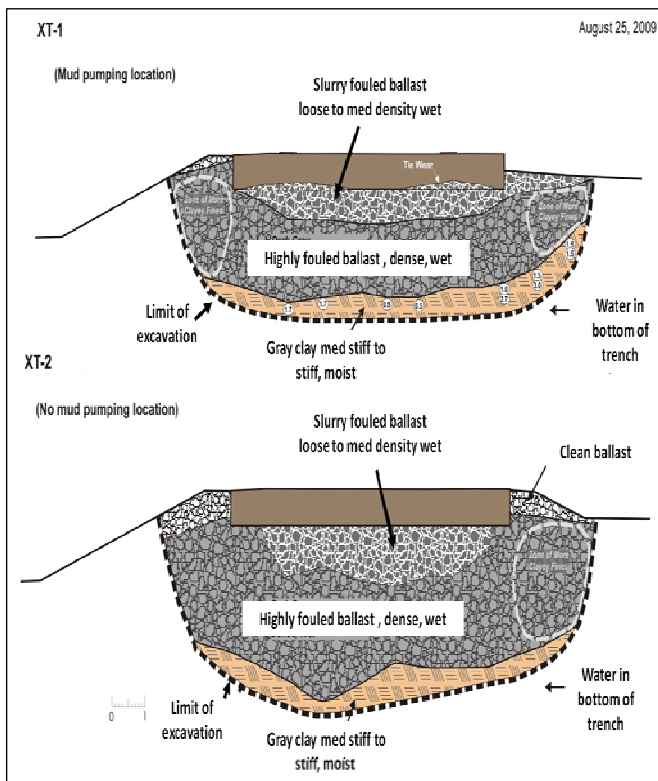
Figure 3. XT-1 and XT-2 Cross Sections

- A top granular layer consisting of loose to medium-dense aggregate that was wet and fouled primarily with mud slurry.
- A second granular layer, denser than the top layer, very wet and fouled, but without the mud slurry.
- Subgrade of moist plastic clay, grey in appearance and moderately stiff at the surface, becoming increasingly stiff a few inches below the subgrade surface.

The only difference in the appearance of the three trenches was that the mud slurry in the top layer had pumped through the shoulder ballast at XT-1 to form a mud spot (Figure 3).

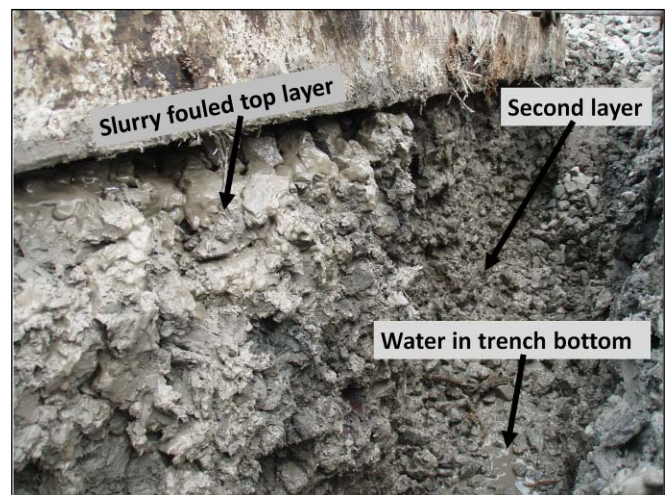
Figure 5. Granular Layer Conditions at the Site 2 XT-5 Trench

Two cross trenches were dug at Site 2 — one at a mud spot labeled XT-5 and the other at a non-mud spot labeled XT-4. The conditions at these trenches were somewhat similar to Site 1, as Figure 5 shows, and are described as follows:

- The mud spot had a top layer less than 12 inches deep that was wet and fouled with mud slurry material.
- It had a second layer, denser than the top layer, also wet and fouled, but without the slurry. Water also collected at the bottom of the trench as at Site 1.
- A hardpan layer, consisting of cemented limestone and slag, was located between the second granular layer and the subgrade. The subgrade that was visible at the edge of the hardpan was moist clay.

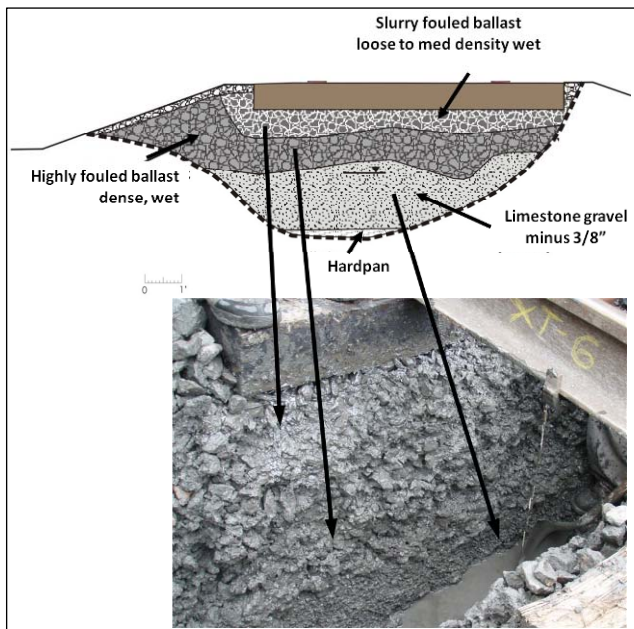
Figure 6. XT-6 Trench at Site 3

Two cross trenches were dug at Site 3 labeled XT-6 and XT-7. As at the other sites, the granular layers were very wet with water collecting on the bottom of the trench, along with slurry-fouled top layer and a denser, highly fouled second layer. However, there was a third layer of medium-dense granular limestone gravel subballast sitting on a hardpan layer (Figure 6). There was a free-water surface within 2 feet of the bottom of tie. This site was slightly different from the other two in that there was a lot more water present, and the slurry tended to pump through the ballast shoulder near the toe, as Figure 7 shows, rather than pumping up around the ties.
