Teardown Study of TTX Equipment Identified by Wayside Detectors

Benjamin Madrill, TTCI
Kim Bowling, CSX Transportation, Inc., and
Jon Jeambey, TTX Company

Summary

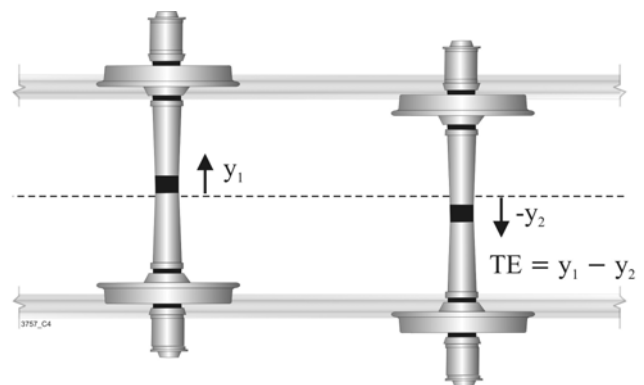
Figure 2. Tracking Error

The articulated intermodal car alarmed for excessive tracking error (TE). TE is generated by an optical-based detector and is a linear measurement of lateral distance between the tracking positions of each axle in a truck relative to the centerline of the track.² Figure 2 shows an example of lateral position and TE on tangent track.

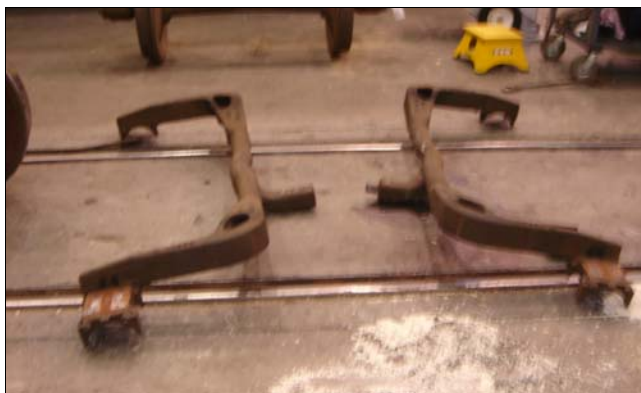
The autorack car was equipped with 70-ton capacity Ride Control trucks with AR-1 steering arms designed to increase truck warp resistance while permitting axle radial alignment in curves. Figure 3 shows the disassembled AR-1 steering arms. The AR1 steering arms connect through the bolster lightning holes and bolt on to each of the four bearing adapters.

Figure 3. Autorack — Disassembled AR1 Steering Arms with Bearing Adapters Bolted in Place

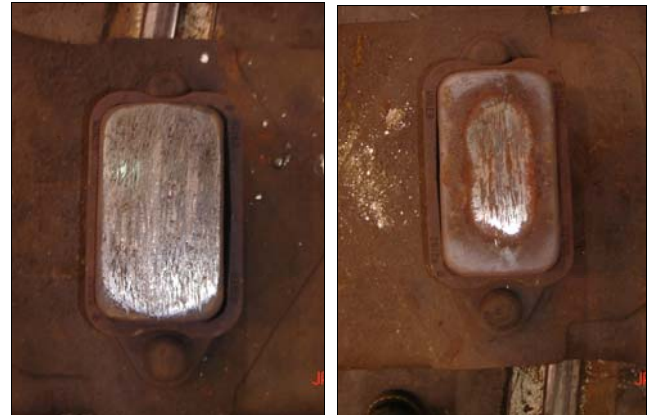
A review of car repair billing data for this autorack car showed that in May 2009, both of the constant-contact side bearings on truck B were replaced because one bearing was worn out and the other bearing was broken.

There was no evidence of recent shim adjustment on any of the bearing wear plates on this car. The side bearing work in May was likely in response to a truck hunting index of 0.14 recorded in March 2009. During the car inspection at TTC, asymmetrical wear was found on the side bearing caps of truck B. Figure 4 shows the asymmetrical wear. It is believed by the inspectors that the low side bearing set-up heights on opposite corners of the car caused the ELWI alarm.

Figure 4. Autorack — Asymmetric Side Bearing Wear

It appeared that the new side bearing caps and pads were installed without properly adjusting the side bearing set-up heights. Also, if the carbody twist is sufficient to prevent proper adjustment of side bearing set-up height, then the carbody needs to be straightened.

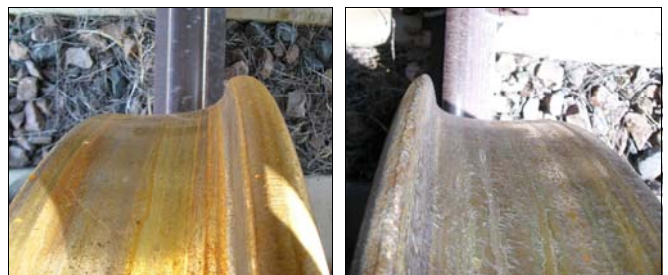
The five-unit articulated all-purpose spine car was alarmed by an optical-based detector for a TE of 37.3 millimeters (1.74 inch) on Truck F. This car was equipped with 70-ton capacity S-2-C trucks with split wedge friction castings. The inspection showed that the side frames were mismatched by 1/8 inch, with the right side frame being longer and the wheels on axle Z showing asymmetric flange wear, as Figure 5 shows.

Figure 5. Articulated Car — Asymmetric Flange Wear on the Wheels of Axle Z

At approximately 60,000 miles, the right wheel on the Z axle (RZ wheel) was condemnably by AAR Interchange Rules for a thin flange.⁴ The previous wheelset in this location was removed for thin flange on the RZ wheel at approximately 267,000 miles.

While an AAR condemnably wheel was found on the alarmed truck, this wheel condition is likely a symptom of the problem and not the cause of the alarm. While no AAR condemnably cause was found on the truck, it should be noted that the side frame mismatch was at the high end of the allowed AAR tolerance. This side frame mismatch coupled with the higher than expected thrust lug spacing for axle Z is most likely the root cause of the flange wear and detector alarm. The car owner plans to address these two issues prior to returning the car to service.

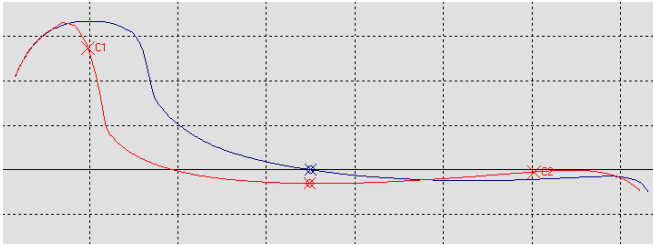
Figure 6 shows the Miniprof™ profiles of the wheels of axle Z.

Figure 6. Articulated Car — Miniprof™ Profiles of the Wheels of Axle Z
