Survey of Failed Couplers and Knuckles

Summary

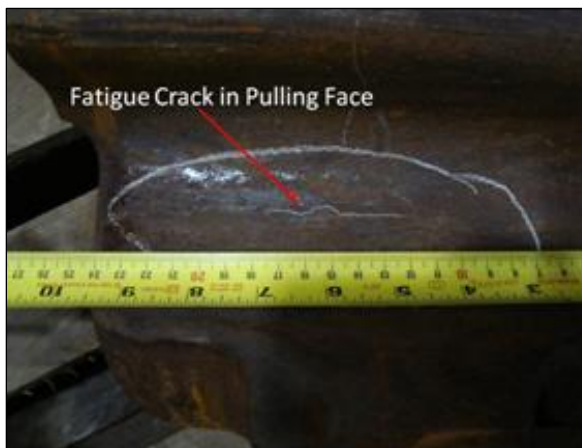
During the survey, TTCI worked with shop employees to determine the proper components to evaluate. The knuckles that were cracked had all been previously inspected using the magnetic particle technique found in AAR Specification M-220.² Figure 1 shows a crack on the pulling face of the knuckle that was identified using the magnetic particle technique.

Figure 1. Fatigue Crack on the Pulling Face of a Knuckle

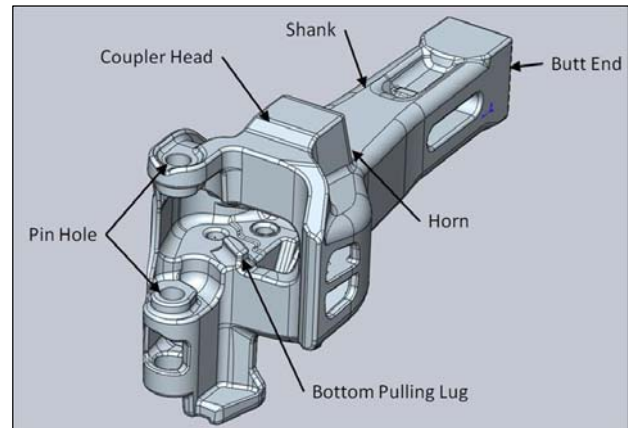
Defects for each of the components were categorized by location on the part. Defect locations for couplers include the horn, shank, lugs, and pin hole. Figure 2 is a labeled coupler body diagram showing the common locations for defects. Also, the survey examined wear and deformation on the coupler shank.

Figure 2. Coupler Diagram of Common Failure Locations

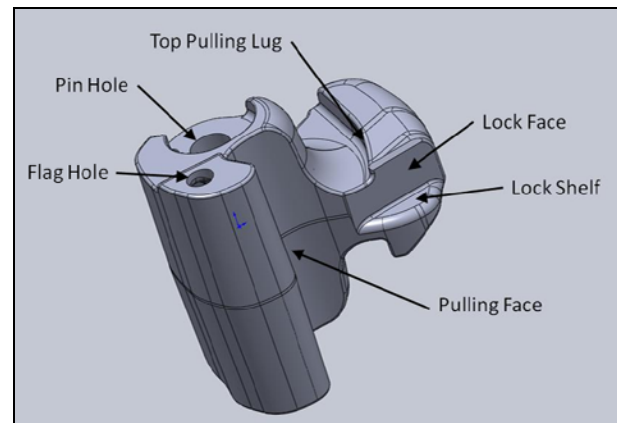
Defect locations for knuckles include the pulling face, flag hole, and pulling lugs. Figure 3 is a labeled diagram of the most common knuckle failure locations. Both knuckles and couplers were checked for fitment issues.

Figure 3. Knuckle Diagram of Common Failure Locations

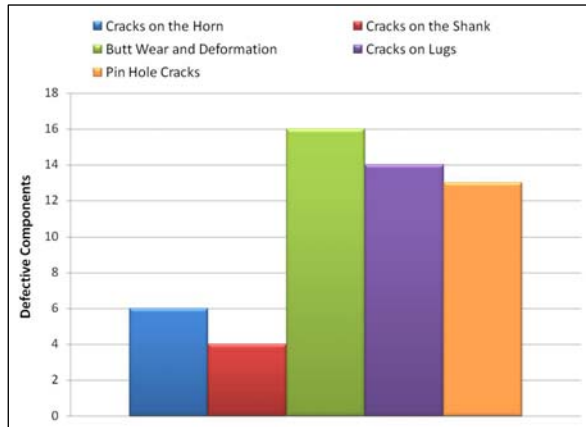
Butt wear and deformation was the most common defect observed on the coupler body. Figure 4 shows that of the 53 couplers examined, 16 exhibited coupler shank butt wear and deformation. Cracks on the lugs and in the pin hole were also frequently observed.

Figure 4. Survey Results for All Couplers Examined

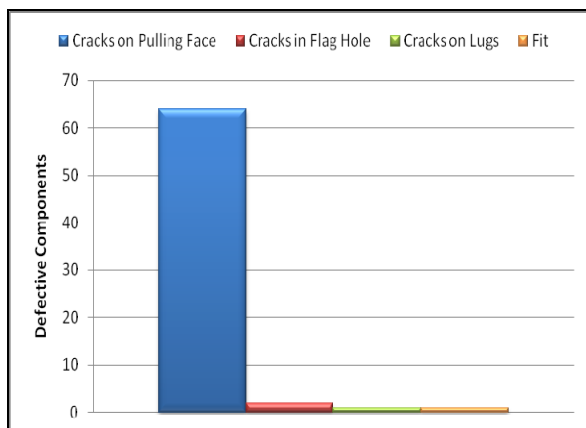
The majority of the defects on the knuckles examined were located on the pulling face. Figure 5 shows that 64 of the 68 knuckles contained cracks on the pulling face. Cracking was also identified in the flag hole and on the lugs of the knuckle. Last, a classification for fitment was necessary due to one knuckle not fitting properly into the coupler body.

Figure 5. Survey Results for All Knuckles Examined

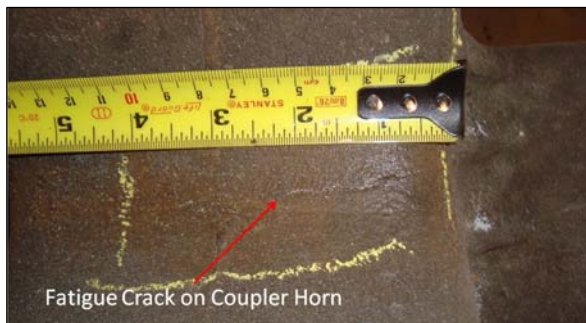
Figure 6. 3.5-inch Fatigue Crack on Coupler Horn

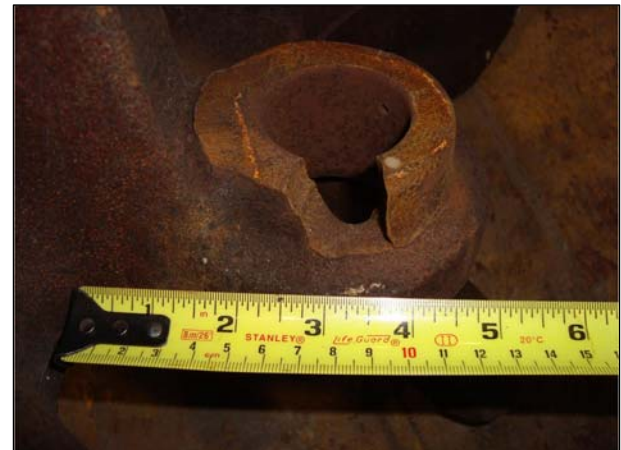
Figure 7. Coupler Pin Hole Defect

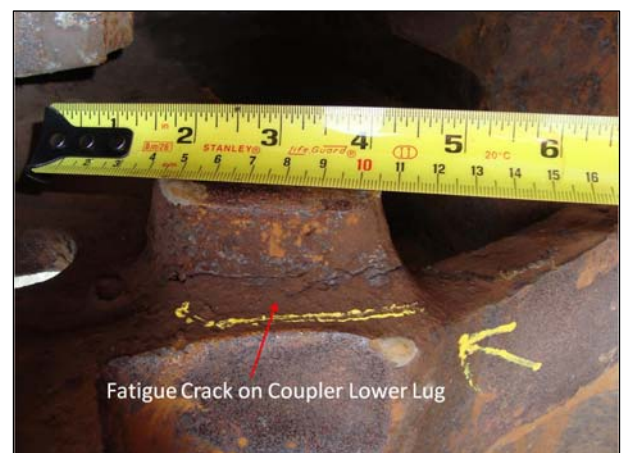
Figure 8. Fatigue Crack on Coupler Pulling Lug

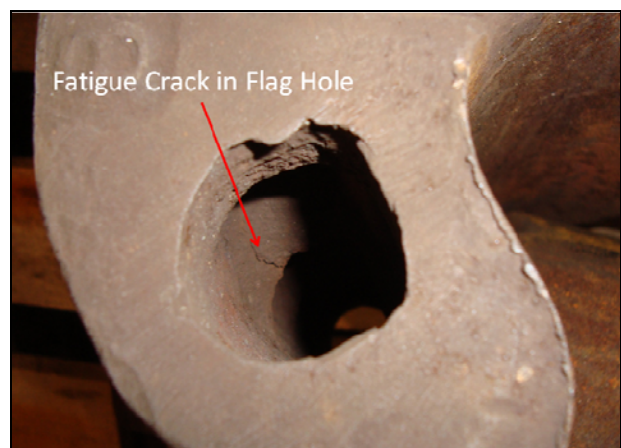
Figure 9. Fatigue Crack in Flag Hole of Knuckle

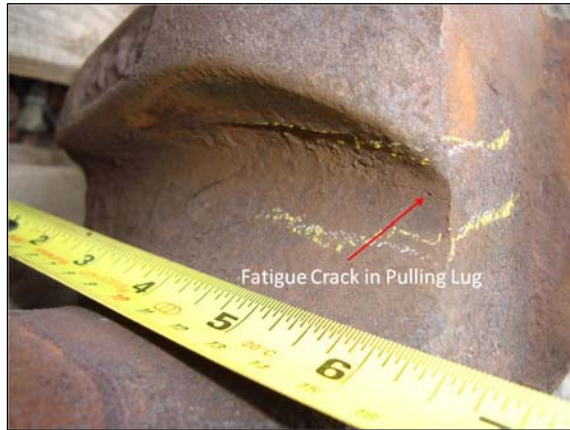
Figure 10. Fatigue Crack on Knuckle Pulling Lug

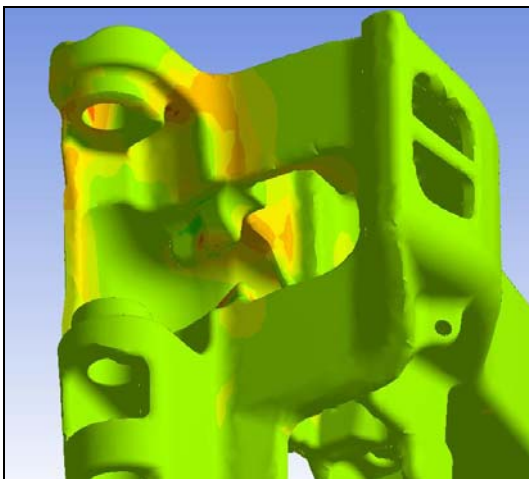
High stress areas determined by finite element techniques in both the knuckle and coupler have been validated by the results of the shop survey. A comparison was made between the high stress areas identified using finite element analysis techniques and the defect locations observed for the knuckle and coupler. The data for each of these analyses shows there is a high correlation between the observed defect locations and the high stress areas of the finite element models. Figures 11 and 12 show the high stress areas found on the coupler and knuckle using finite element techniques; the red highlights show the high stress areas.

Figure 11. Coupler High Stress Areas

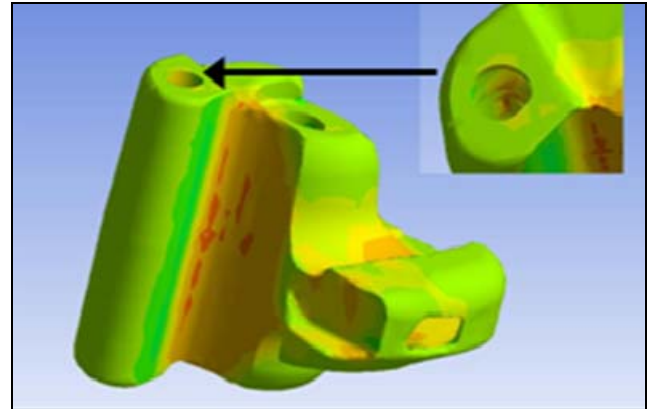
Comparing the finite element results to the survey results shows that the high stress areas predicted by the models are problem areas on the physical parts. Examples of the correlation include the pin hole and lug locations on the coupler body, the pulling face, and flag hole on the knuckle. In both castings, the areas exhibited high stress concentrations in the finite element model and contained a large number of defects in the survey results.

Figure 12. Knuckle High Stress Areas
