# Asymmetric Flange Wear: Data Analysis

Harry Tournay, Scott Cummings, MaryClara Jones, and R.B. Wiley

## Summary

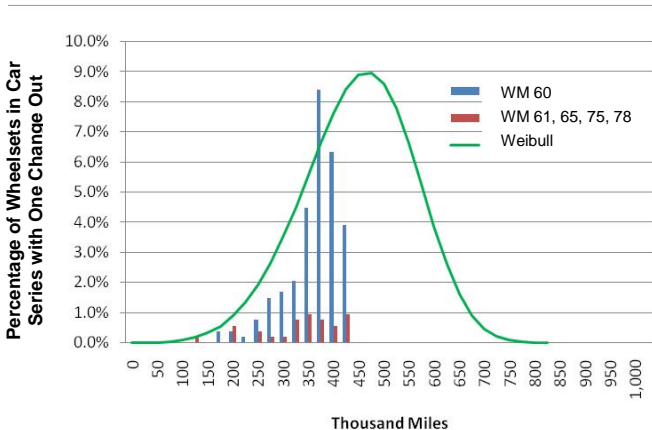
- Only 35% of wheels have been removed to date.
- 82.4% of these wheelsets have been removed for WM 60 (thin flanges).
- Only 10.6% of wheels have been removed for WM 65 (tread defects).

**Figure 1. Percent of Removals by Why Made Code versus Weibull Projection**

A Weibull projection of the data available to date suggests an average wheel life of 503,000 miles may be anticipated; this projection will be updated as further data becomes available. This data was compared with currently available data (Figure 2).

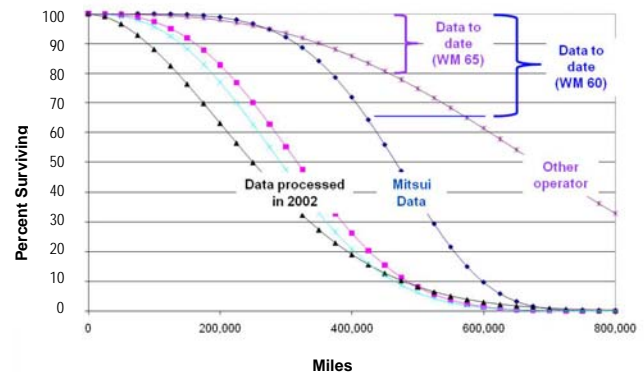
In 2002, a TTCI wheel life survey was made of three trains: one train operating with 263,000-pound cars without M-976 trucks and two trains operating with 286,000-pound cars equipped with M-976 trucks, which indicated average lives of approximately 300,000 miles (depicted in Figure 2 as *Data processed in 2002*).

Also, a survey is in process of wheel life under another series of coal cars equipped with AAR M-976 trucks and indicated as *Other operator* in Figure 2. Interestingly, although only 20 percent of wheels from 120 cars have been removed after approximately 450,000 miles, results show:

- An average wheel life in excess of 600,000 miles is predicted by the Weibull analysis.
- The majority of removals to date have been for WM 65, high impact wheels (HIW) and not for thin flanges.

**Figure 2. Wheelset Survival Curves**

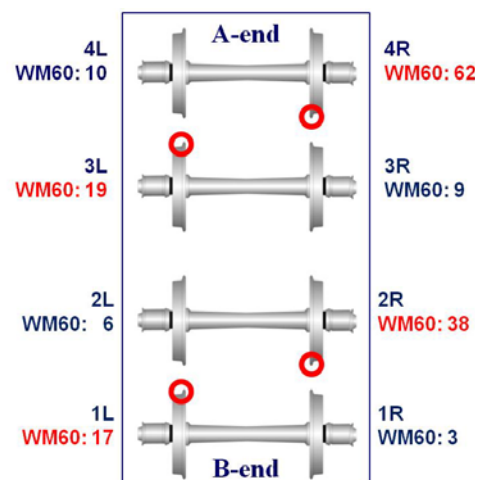
**Figure 3. Distribution of Removals for WM 60 (thin flanges) within the Cars According to Wheel Position**

- Predominate in positions 4R, 3L, 2R, and 1L within the car
- Occur more frequently on axles 4 and 2, suggesting that the car operated more often with the A-end leading
- May occur infrequently in the other wheel positions within the car

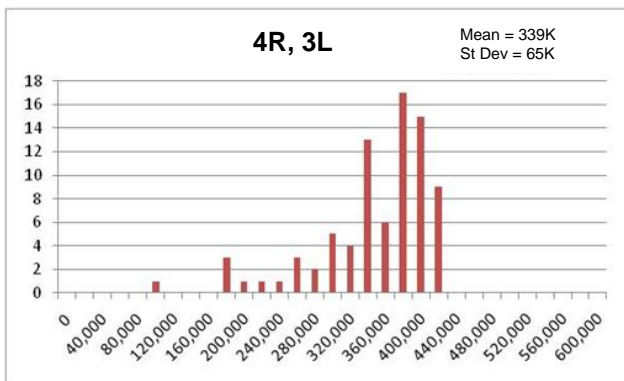
Figures 4 to 7 show the WM 60 (thin flange) data in histogram form for the wheels on each of the four diagonals in the car. Again, it is obvious that removals in positions 4R, 3L, 2R, and 1L within the car predominate.

Figure 4. WM 60 Removals in Positions 4R and 3L

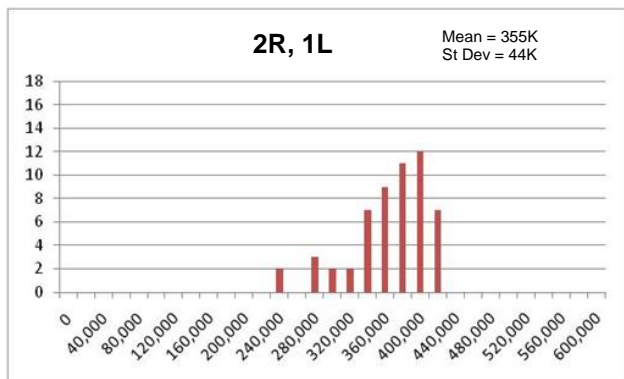
Figure 5. WM 60 Removals in Positions 2R and 1L

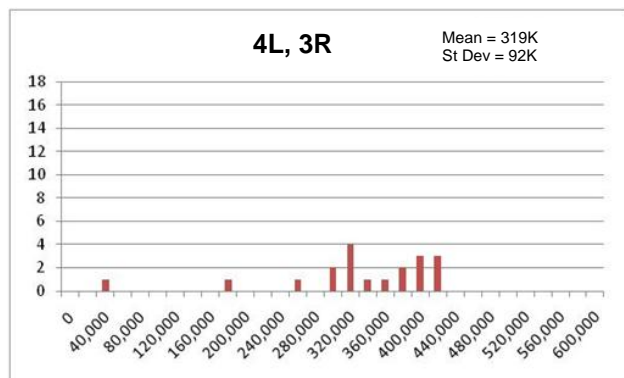
Figure 6. WM 60 Removals in Positions 4L and 3R

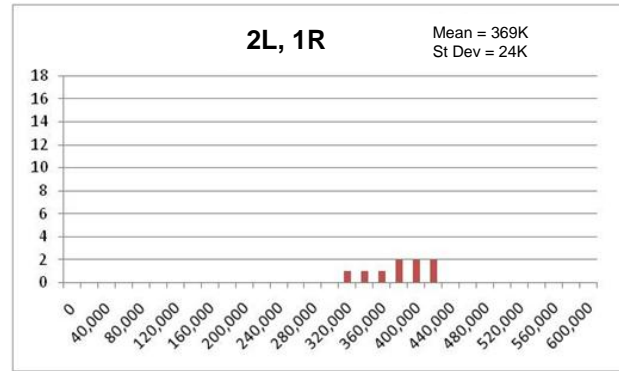
Figure 7. WM 60 Removals in Positions 2L and 1R

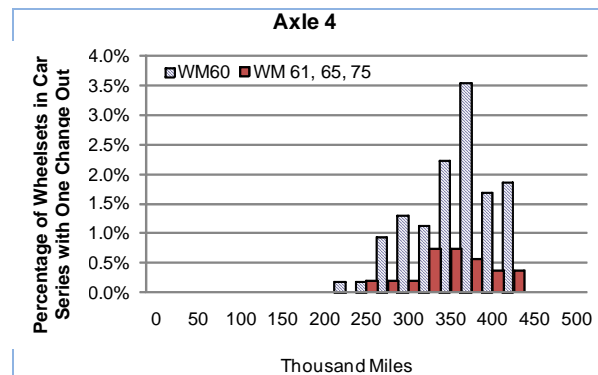
Of further interest is the removal data segregated according to WM code and axle position (Figures 8 through 11). Here it can be seen that the next dominant mode after WM 60 (thin flange) is WM 65 (HIW). This mode dominates on axle 4 which, when considering the flange wear dominance of axle 4, is the predominant lead axle in the car. It might suggest that if the flange wear problem is solved, the next removal mode will be HIW and that HIW are mainly associated with lead axles in the car.

Figure 8. Axle 4 Wheelset Removal Data by Why Made Code

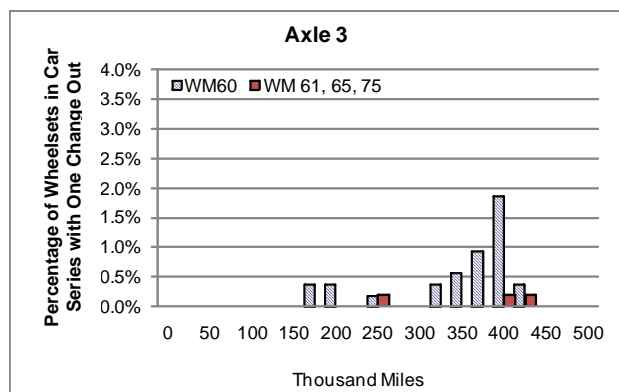
Figure 9. Axle 3 Wheelset Removal Data by Why Made Code

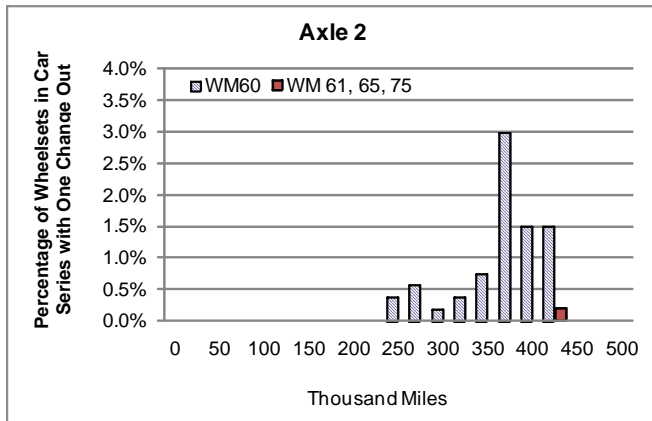
Figure 10. Axle 2 Wheelset Removal Data by Why Made Code

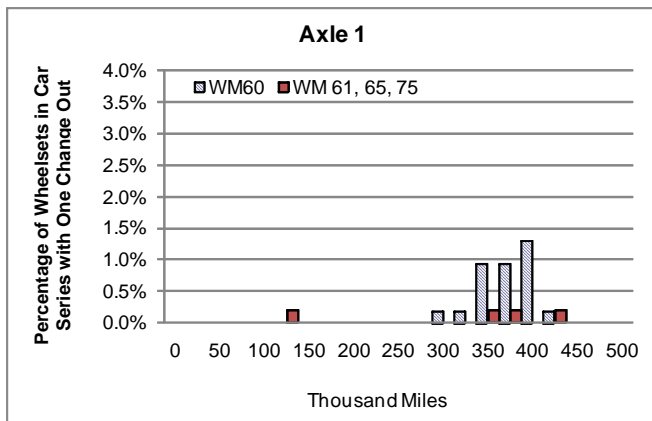
Figure 11. Axle 1 Wheelset Removal Data by Why Made Code
