Asymmetric Flange Wear: Inspection and Teardown Results

Harry M. Tournay, Benjamin Madrill, R.B. Wiley, and Scott Cummings

Transportation Technology Center, Inc. (TTCI) has conducted inspections and teardowns of two cars from a fleet of 134 coal cars reported to be experiencing asymmetric wheel flange wear. These cars are from the same series whose maintenance performance was analyzed and reported previously.¹

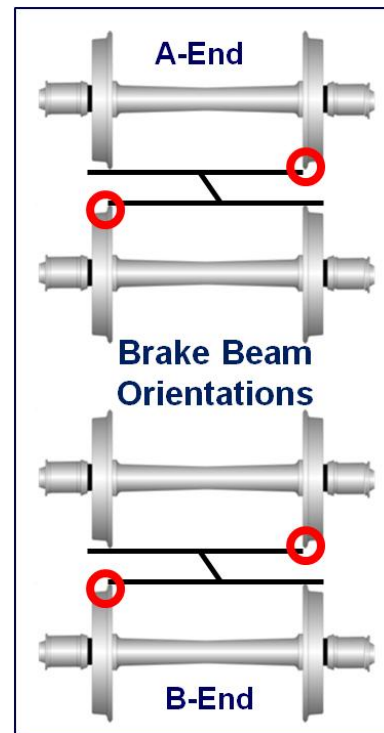
The brake beams migrate in opposite lateral senses, as Figure 1 indicates, from a laterally central position in the truck when all components are new/replaced. The overriding brake shoe is pressed against the most worn flange (Figure 2 and circled flanges in Figure 1) and the overriding shoe contacts the opposite wheel having the least worn flange (Figure 3).

Figure 1. Opposing Lateral Sense of Brake Beams in the Car

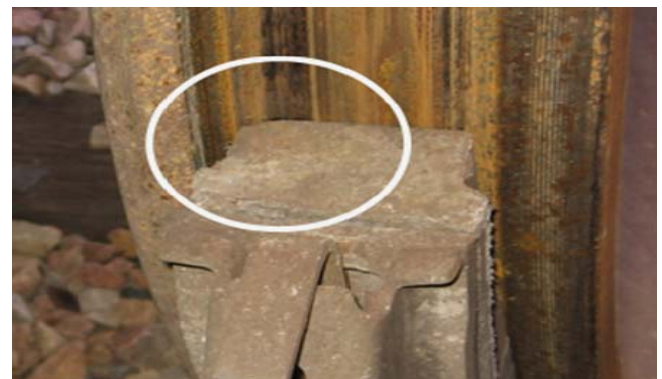
Figure 2. Overriding Brake Shoe Pressing against Worn Flange

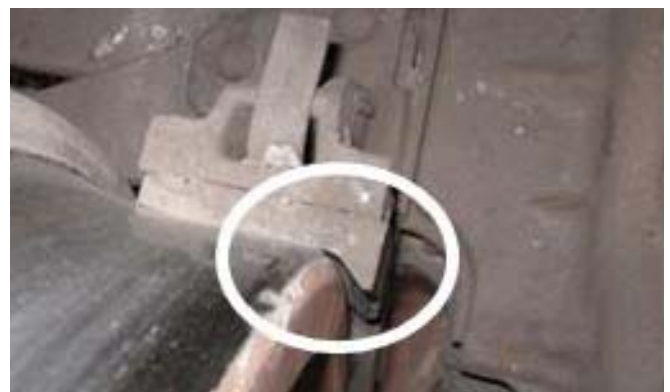
Figure 3. Overhanging Brake Shoe on Opposing Brake Beam/Wheel

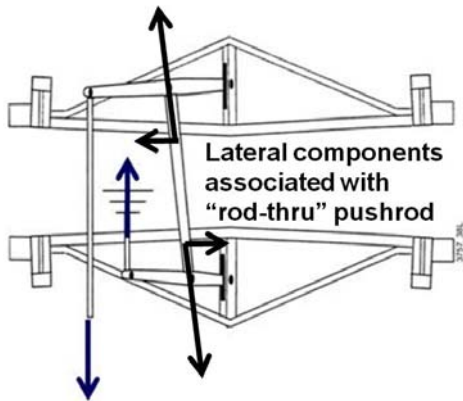
The truck brake rigging is of the rod-through type. Figure 4 indicates the orientation of the A-truck rigging in the same sense as the orientation of the A-truck in Figure 1. By inspection it may be seen that:

- The lateral reactions of the rod-through pushrod are in a sense to force the beams laterally into the opposing lateral senses observed on teardown
- The moment due to the non-co-linearity of the pull-rod and reaction link acts in a sense to move the truck rigging (and brake beams) in the same sense as observed on teardown

Figure 4. Rigging Topology of the A-Truck

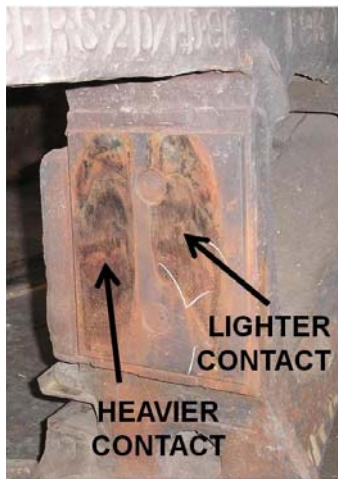
Wear on the truck suspension wedges, column wear liners, gibs, and pedestals was found to be minimal and difficult to measure or quantify. There were indications of differential pressure across:

Figure 5. Indication of Uneven Pressure on Column Wear Liners

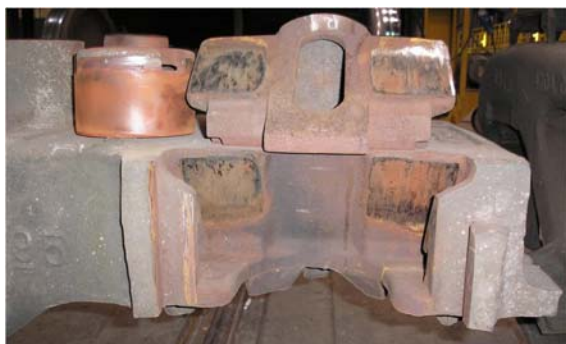
Figure 6. Indication of Uneven Wedge Pressures on the Truck Bolster

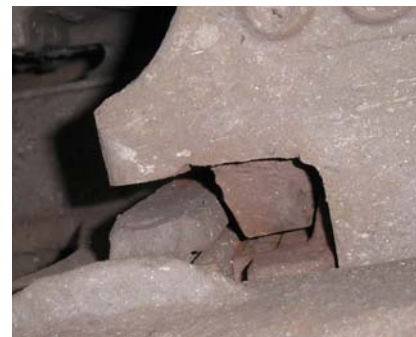
Figure 7. Gib Clearance

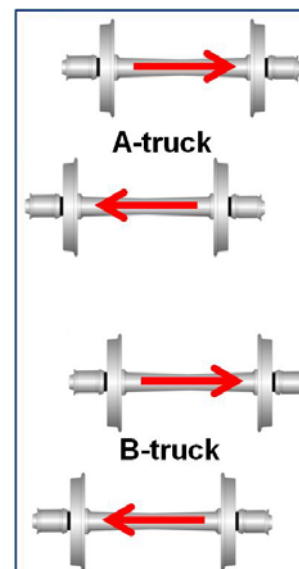
These wear patterns suggest lateral forces acting on the wheelsets in the senses indicated by Figure 8.

Figure 8. Sense of Truck Warp

These forces are in senses opposite to the brake beam migration observed and described earlier in this TD.

Finally, the differential wheel tread wear patterns observed and resulting in the lateral wheel positions indicated in Figure 8 may be the cause for the differential wear patterns on truck suspension wedges, column wear liners, gibs, and pedestals. These patterns are in accordance with a truck resisting the warp, which would be required of a truck to allow the wheelsets to attain the positions that Figure 8 indicates.

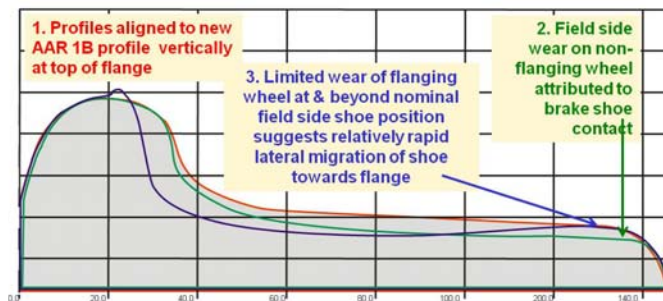
Figure 10 shows the superposition of opposing wheel profiles on the same wheelset together with the original AAR-1B wide flange profile. The left- and right-hand asymmetrically worn wheel profiles and an unworn AAR-1B profile are vertically aligned at the flange tip to approximate their relative diameters.

Figure 10. Comparison of measured profiles of opposing wheels on the same wheelset with the new AAR-1B profile

The asymmetry of the lateral location of the tread wear is evident. In addition, it would appear that the field side of the wheel with the relatively unworn flange has experienced appreciable tread wear. Little contact is made in this region between rail and wheel. This contact is limited to that made in switches and crossings and on the low rail of tight curves having gage at the limit of wide gage. Contact in this region is, however, made between the overhanging brake shoe and the wheel. Conversely, the wheel with the worn flange shows little field side tread wear and more wear closer to the flange; which could be associated with the contact of the overriding brake shoe on that wheel.

It would appear that during the life of the wheel profiles there is a rapid lateral migration of the brake shoe toward the flange of the wheel showing the greatest flange wear and away from the flange of the wheel with the least flange wear.
