Asymmetric Flange Wear: Possible Root Causes & Remedies

Summary

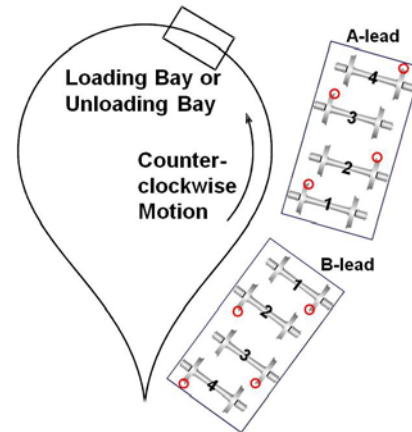
A diagonal wheel flange wear pattern similar to that observed through the maintenance data¹ and teardown inspection observations² can occur in cars negotiating tight curves in a counterclockwise sense, both with the A- and B-ends of the cars leading. This can occur on balloon tracks located at loading and off-loading sites (Figure 1).

A dominantly clockwise loading and off-loading sense as observed above would imply that the opposing flanges to those observed would have to wear. Consequently, it was concluded that the wheelsets were not being asymmetrically worn through a bias in the sense of curves negotiated.

Figure 1. Typical Balloon Track Configuration

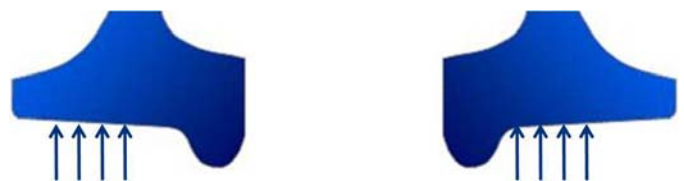
The observed differences in tread wear between wheel profiles with and without tread wear² suggest aggressive wheel wear due to the action of the brake shoes, with the brake shoe rapidly migrating laterally across the tread as the flange wears (Figure 2).

Figure 2. Wheel/Rail Contact Conditions Resulting from Asymmetric Wheel Tread Wear

Asymmetric wheel tread wear can destroy the ability of the wheelset to negotiate tangent track without flange contact with the gage corner of the rail. Then, the loss of steering ability may result directly in flange contact and with a wheelset angle of attack and consequent flange wear. Extended flange contact with the gage corner of the rail on tangent track is known to be the source of extremely aggressive and rapid flange wear, resulting in drastically reduced wheel flange lives.

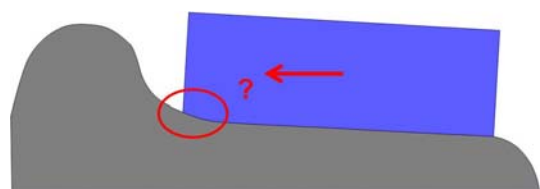
Figure 5 shows the approximate nominal position of the brake shoe on the wheel tread for a 3.4-inch-wide brake shoe and a nominal brake beam length.

Figure 5. Nominal Position of a Brake Shoe on the Tread

- There is no definite lateral support for the brake shoe and brake beam if they are subjected to a lateral force. It ignores any support provided in the brake beam pocket of the side frame.
- There is a large lateral gap between brake shoe and flange, which with minimal lateral brake shoe wear can result in asymmetric contact unless constrained in the brake beam pocket.

- Reduce the lateral clearance between brake shoe and flange to facilitate the guidance of the brake beam. This will reduce the incidence of asymmetric tread wear, the lateral forces on the wheel flange, and consequently, AFWF and overhanging brake shoes.
- Analyze the combined lateral clearances between brake shoe and flange and brake beam and side frame to ensure that no binding will occur between wheel and brake shoe under prevailing truck warp conditions. This analysis should account for the improved warp restraint of M-976 trucks as well as prevailing anti-warp capabilities of non-M-976 trucks. The effect of reduced clearance should be verified through controlled tests.
- Review the optimal width of the brake shoe in relation to the width of the wheel tread, the allowable flange wear, and the length of the brake beam length and associated tolerances.

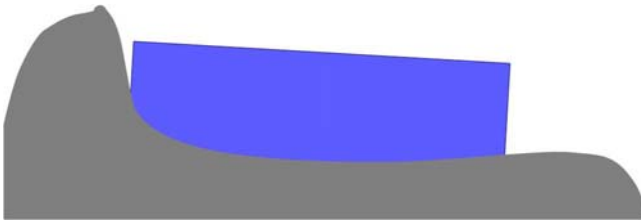
As the wheel flange wears, unless constrained in the brake beam pocket, the degree of asymmetric contact increases so that as the flange approaches condemning limits contact with the tread of the wheel with the worn flange approximates Figure 6.

Figure 6. Brake Shoe Contact with Tread with Worn Flange

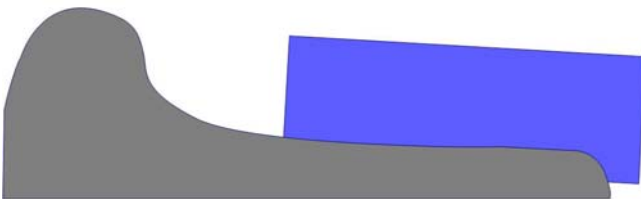
Figure 7 shows approximate brake shoe/tread contact on the opposite wheel.

Figure 7. Brake Shoe Contact with Tread with Worn Flange

This is similar to a picture of observed overhanging brake shoes shown in Figure 3 in Reference 2.
