## Performance of Plastic Composite Ties in Revenue Service – Final Report

Rafael Jimenez and Dingqing Li, TTCI  
Russell McDaniel, Norfolk Southern Railway

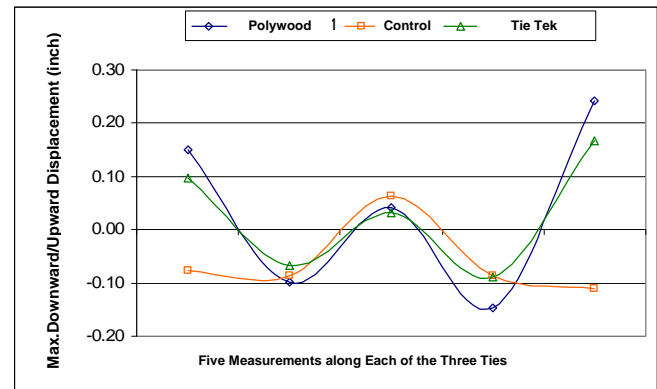
**Figure 1. Vertical Deformation Behavior of Plastic Composite and Wood Ties**

In October 2009, measurements were taken to compare the bending behavior of the plastic composite test ties with the wood control ties under dynamic train loads.<sup>2</sup> Figure 1 shows the measured maximum downward and upward displacement results.

A significant difference between the plastic ties and the wood ties is that the ends of the plastic ties tend to bend upward much more than the wood ties, which is characteristic of the lower bending stiffness of plastic ties as compared to wood ties. Although the plastic ties in both test zones were 6 inches longer than the wood ties in the control zone, where ideally they would have been 3 inches longer on each end, the additional length may not have contributed significantly to the bending profile shown in Figure 1. Many of the ties, both wood and plastic, were not centered in the track.

The results may point to potential long-term problems associated with ballast pumping around the ends of the ties and

large bending stress in the tie plates, which have been observed for some plastic ties evaluated under the program at FAST.<sup>3</sup>

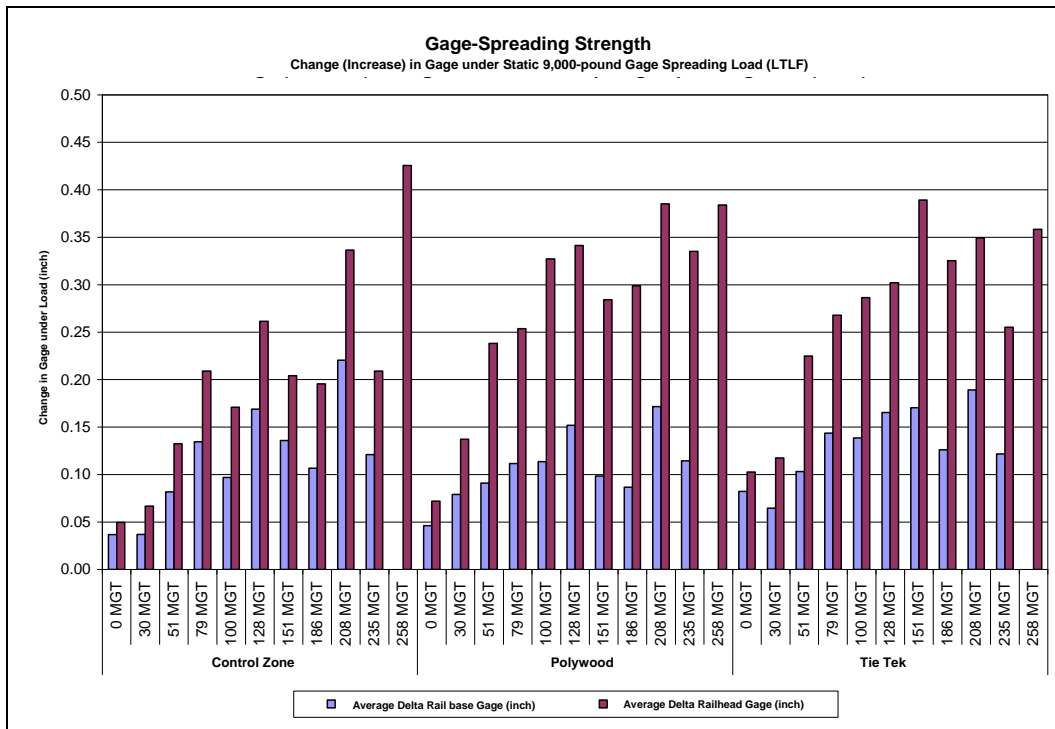
Figure 2. Gage Strength Degradation of Plastic Composite and Wood Ties

For the duration of the test (282 MGT), the plastic composite ties continued to perform well relative to gage strength. Figure 2 shows gage strength degradation test results using a lateral track loading fixture (LTLF) for the two plastic tie types tested and the control wood ties. Although the plastic ties tested exhibited slightly higher gage spreading than the wood ties, they exhibited gage strength degradation trends similar to wood ties.<sup>4</sup>

Figure 2 shows the increased gage-spreading strength in the three zones resulting from regaging, which was done after the 208 MGT and before the 235 MGT measurements. Figure 3 shows that one year after regaging, one short section of track in the spiral past the Tie Tek plastic zone exceeded standard track gage by 0.5 inch.

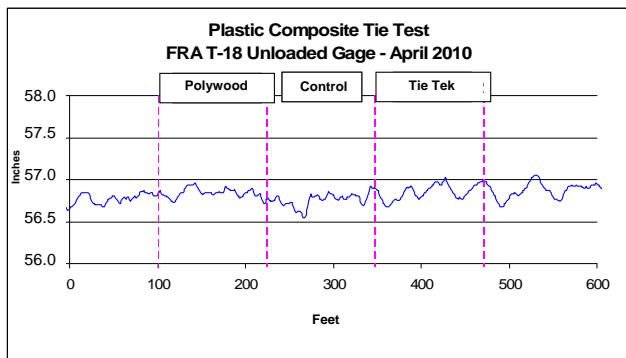
Figure 3. Unloaded Track Gage One Year after Regaging

Figure 3 shows the April 2010, final in motion, unloaded track gage measurement taken in the plastic tie and wood tie control test zones using the FRA’s T-18 gage restraint measurement system (GRMS) test vehicle. The result of the final measurement with GRMS indicates slightly higher, but similar gage in the plastic tie zones as compared to the wood tie control zone.

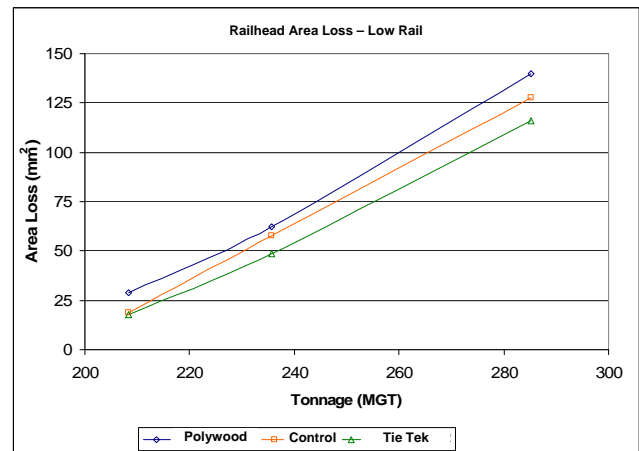
Figure 4. Railhead Area Loss in the Plastic Composite and Wood Tie Test Zones

Railhead profile measurements were taken to determine if the difference in bending stiffness between the plastic composite ties and the wood ties affect rail wear caused by HAL traffic. Four measurements were taken during the life of the test. Figure 4 shows the three cumulative railhead area loss values calculated in each of the three subzones with reference to the first measurement taken. The results indicate that the difference in railhead area loss in the three subzones at the conclusion of the test was less than 0.04 inch<sup>2</sup> (25 millimeters<sup>2</sup>).

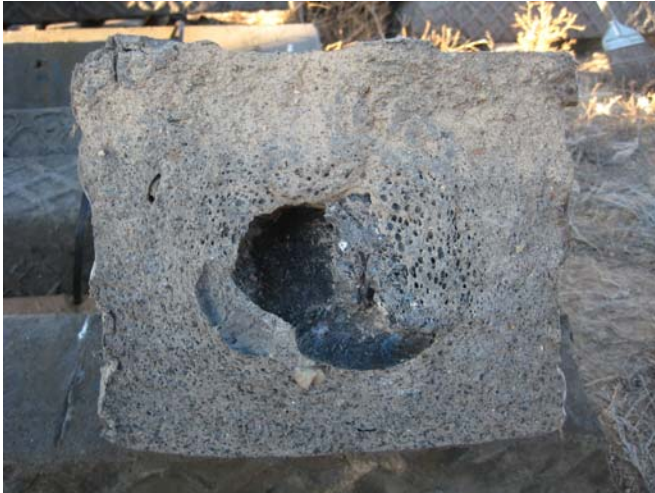
In May 2010 when the test was concluded, five of the 75 Tie Tek plastic ties had completely broken in two. In November 2008, one tie (Figure 5) broke at a material void near its center and was replaced. In April 2010, three more Tie Tek ties were found broken during a scheduled NS/TTCI inspection. One month later, as the ties were removed from track, another broken tie was found. These last four ties broke along the transverse, cut spike plane.

Figure 5. Tie Tek Plastic Composite Tie broke at a Material Void near its Center

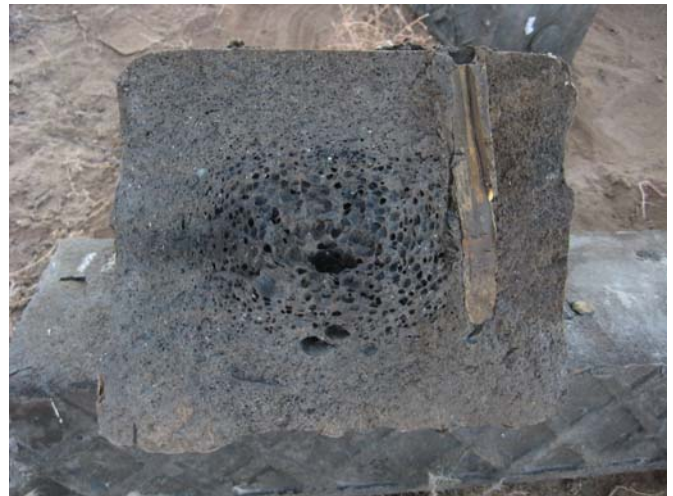
Visual inspection indicates the break initiation appears to be located at spikes holes nearest the edge of the tie for the four ties that broke in two along the spike plane. Figure 6 shows visual evidence that the breaks may have occurred as a result of the wedging force of the spikes driven into the synthetic tie plugging material.

The synthetic tie plugging material used during the regaging operation was drilled for pilot holes before the spikes were inserted. A combination of low plastic composite tie material toughness and the nonresilient properties of the plugging material used, however, may have contributed to these ties breaking. None of the Polywood plastic composite ties broke, which suggests different formulations and manufacturing processes may affect the toughness of the material.

Figure 6. Tie Tek Plastic Composite Tie broke due to Wedging Force of Driving Spike and Very Hard Plugging Material

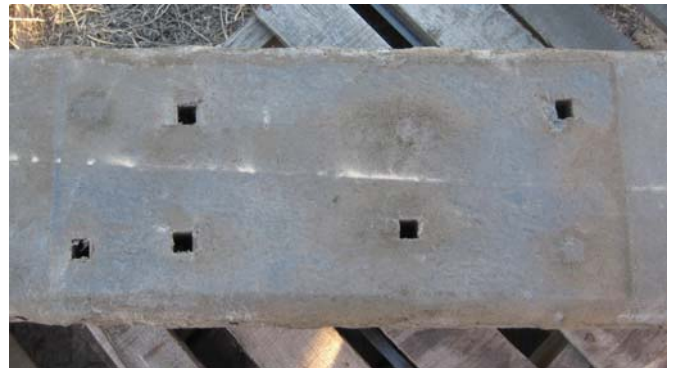
Figure 7 shows the condition under a tie plate of one of the Tie Tek plastic composite ties. After more than 280 MGT of HAL traffic, there was no significant deformation or damage. The wood ties also performed well during the test period.

Figure 7. Tie Tek Plastic Composite Tie with Minimal Damage in Tie Plate Area and Minimal Deformation of the Cut Spike Holes
